Part 21 Report No: P21-04302015, Rev. 1

Subject: **Update** - Report of potential 10CFR Part 21, Allen Bradley Timing Relay Model 700RTC – NRC Event Number 51030, Accession Number ML15134A016

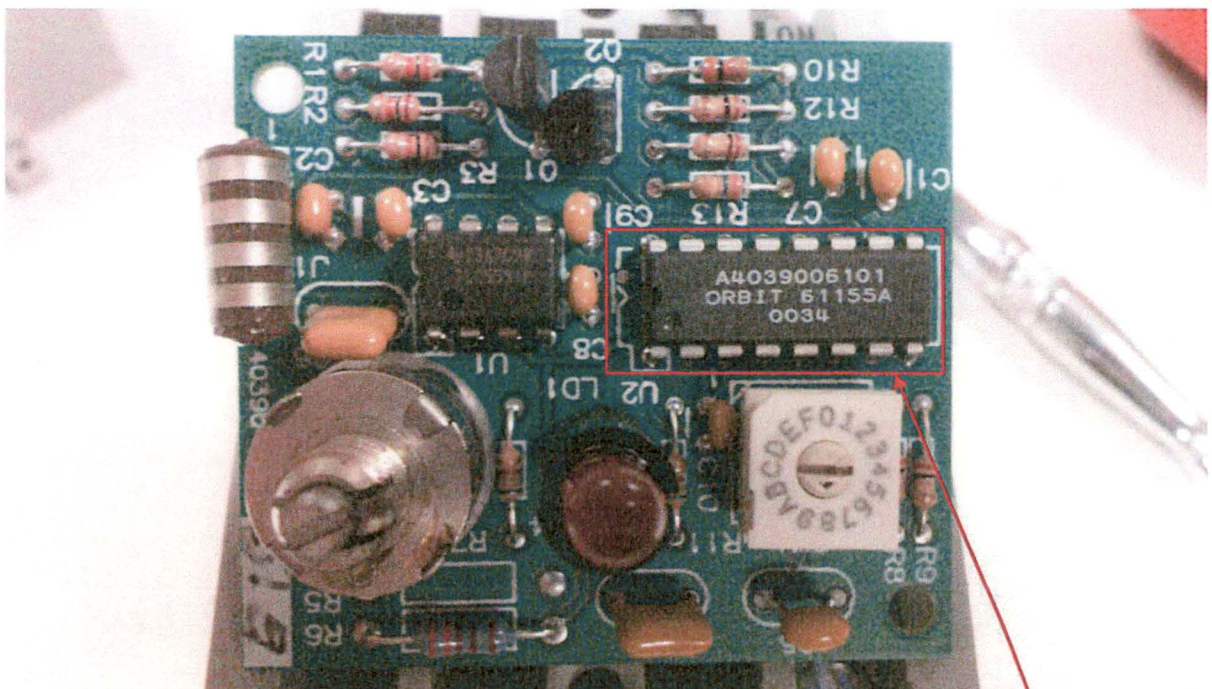
Figure 1- Original qualified design (prior to 2009).
Relays supplied prior to 2009 are not affected by this issue.

Original component

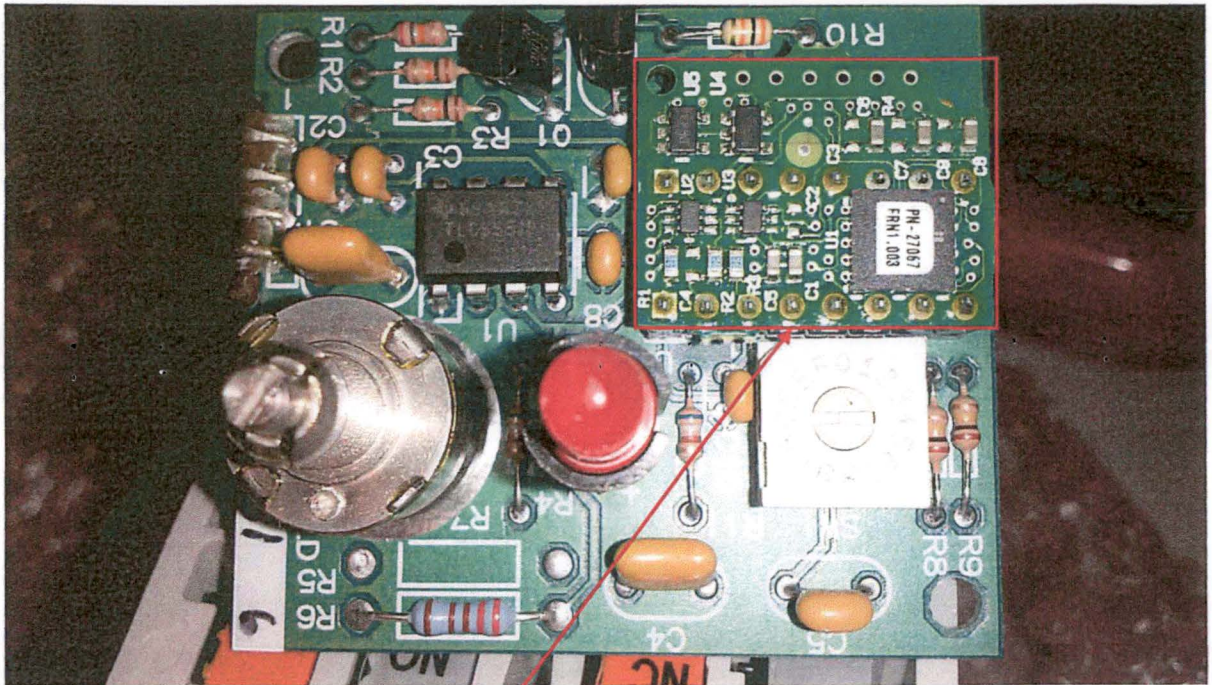
Between 2009-2010, Allen Bradley made a design change without changing the part number of the commercial relay or providing any documented evidence of a design change. The manufacturer specification data sheets maintain the classification that the relays are “solid state”, which would imply that there are no digital devices installed in the relay. However, after inspection of the internals of the timing relay (Figure 2), it has been identified that the unit does contain a CPLD which meets the definition of a digital device under the guidance of NEI 01-01. See Figures 1 and 2 below:

Figure 2 - New design circuit board and CPLD that replaced the original component.

The results were satisfactory with exception of the following condition: During Conducted Susceptibility CS114 onto the power lines, with the timing circuit in operation, the timing contacts exhibited chatter in the range of 2.6 MHz to 20.3 MHz. The unit requires a ferrite to be installed onto the input power lines of the relay with 3 turns through the ferrite core. In this modified configuration, the relay was not susceptible to Conducted Susceptibility and successfully passed the required test per CS114.

The relays are dedicated for generic application usage in timing applications. The specific plant application(s) is unknown by NLI. The EMC qualification of the relay is dependent on the installed configuration and location in the plant. The plant should evaluate whether the installed relays are subjected to the specific EMI/RFI condition Conducted Susceptibility CS114 between the frequencies of 2.6 MHz to 20.3 MHz identified above.
