The Reactor Cavity is designated as Reactor Containment Building Room 001.

Coatings Assessment

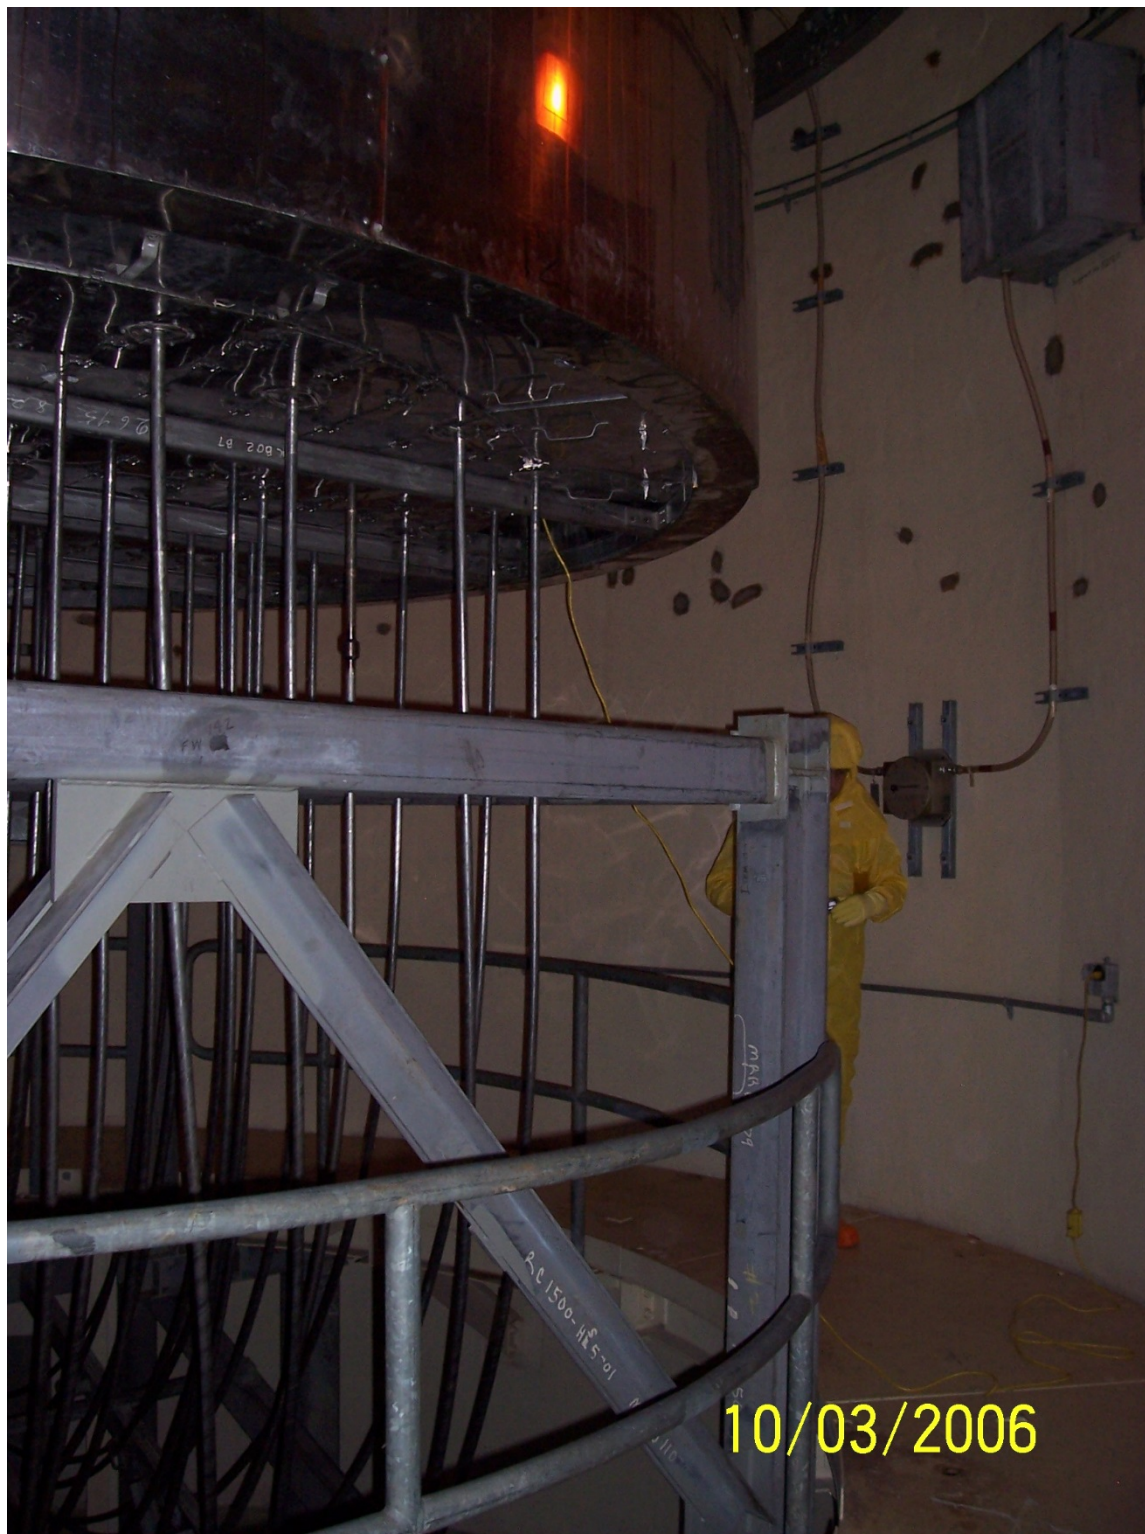
Unit 1 Photos

Just prior to the initial startup of Unit 1 in 1987 during hot functional testing, repairs were made to the concrete wall coating in the Reactor Cavity. Cracks in the originally installed coating were chased and the adjacent coating was removed. These areas were not top-coated due to the unavailability of that coating at the time. Instead the areas were left with only a base sealer. See Unit 1 photographs.

As seen in the photographs, the current condition of the coatings in both Units appears good.
