SUBJECT: NRC INSPECTION REPORT 40-8905/96-02

Report No.: 40-8905/96-02

Licensee: Quivira Mining Company

Facility: Ambrosia Lake Facility

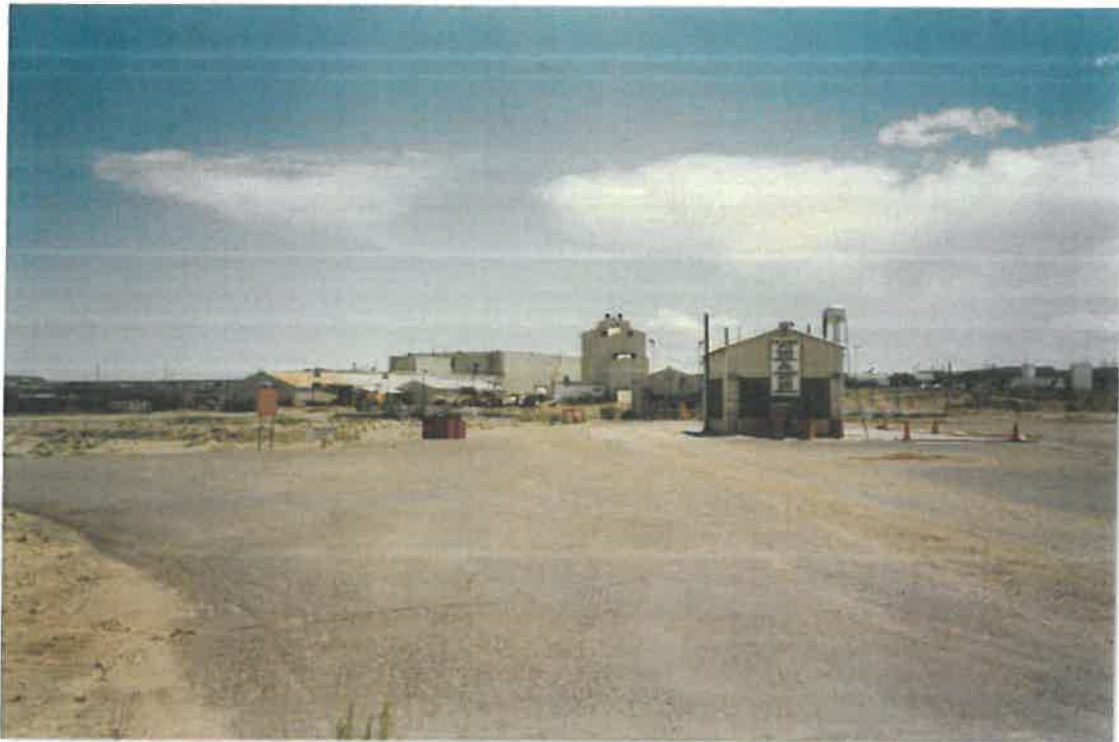
Photograph 1 - Quivira's Ambrosia Lake Facility.

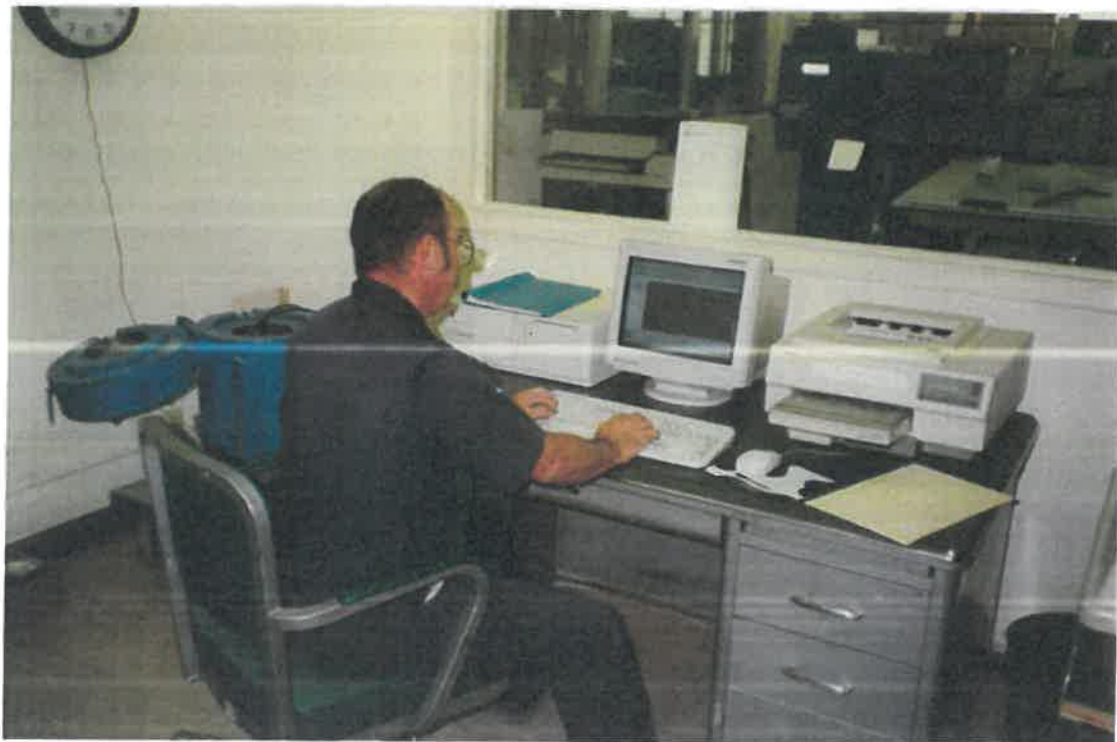
Photograph 2 - Environmental technician performing analysis of exposed charcoal for radon concentration.

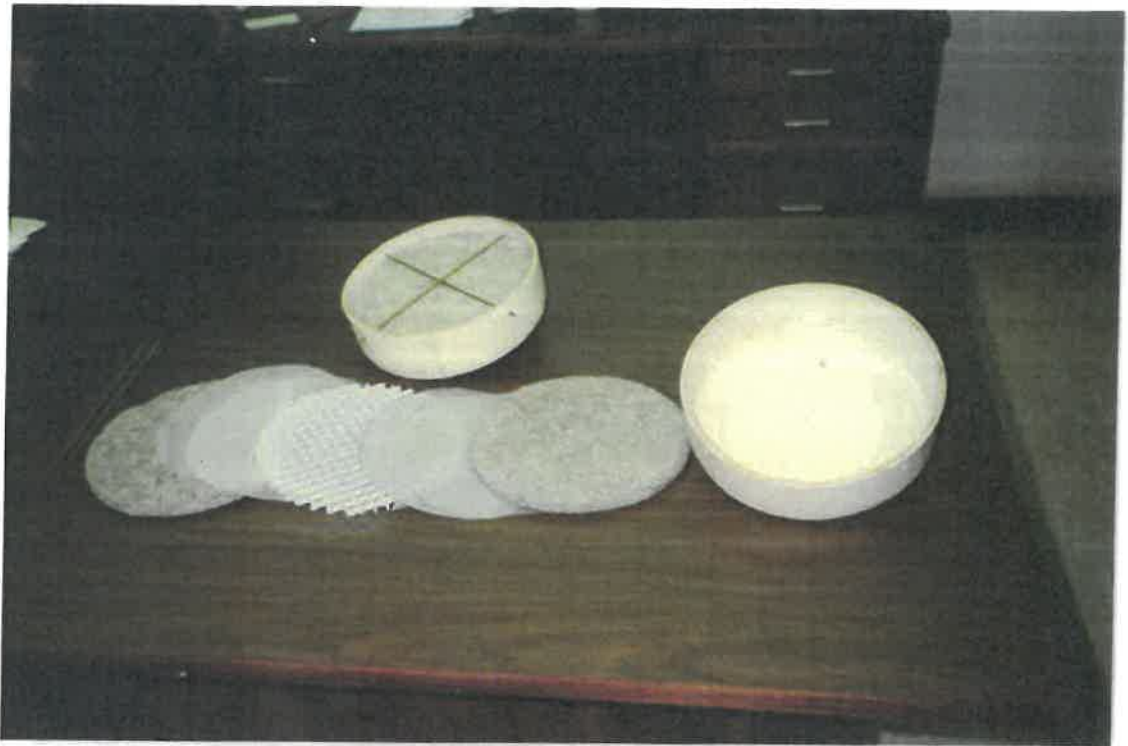
Photograph 3 - Two LAACCs, one assembled and the second disassembled.

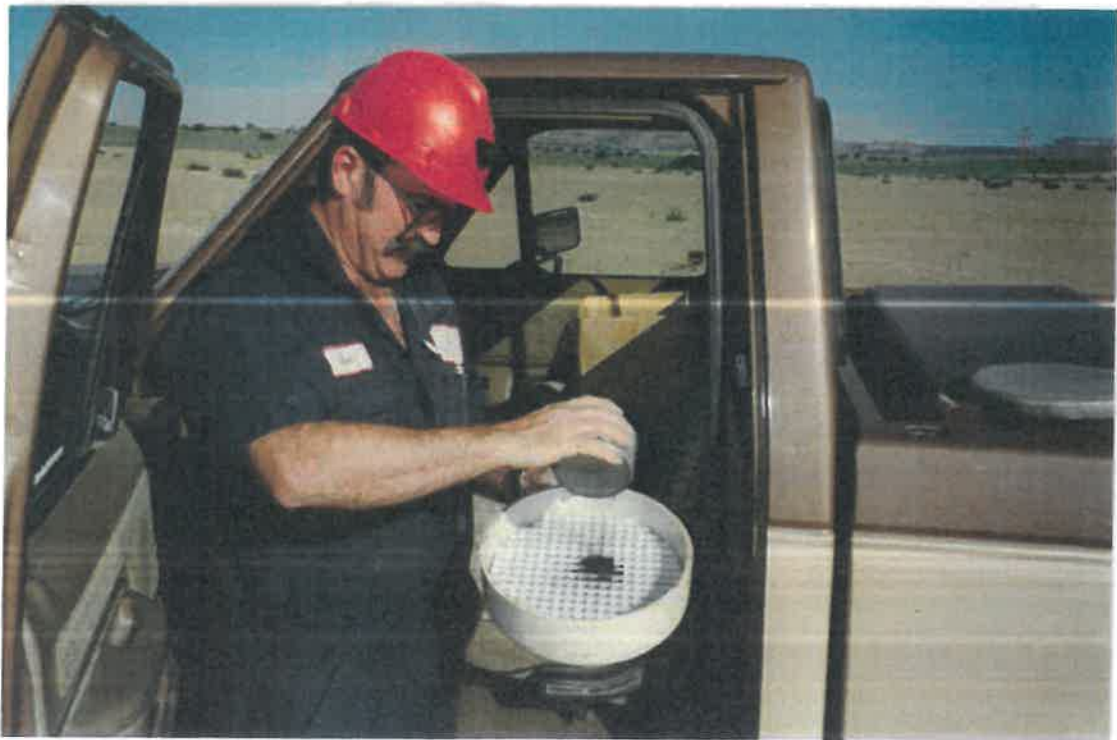
Photograph 4 - Environmental technician pouring charcoal into LAACC.
