SUBJECT: NRC INSPECTION REPORT 40-8905/96-01

Inspection Report: 40-8905/96-01

Facility Name: Ambrosia Lake Facility

Inspection Conducted: February 26-28, 1996

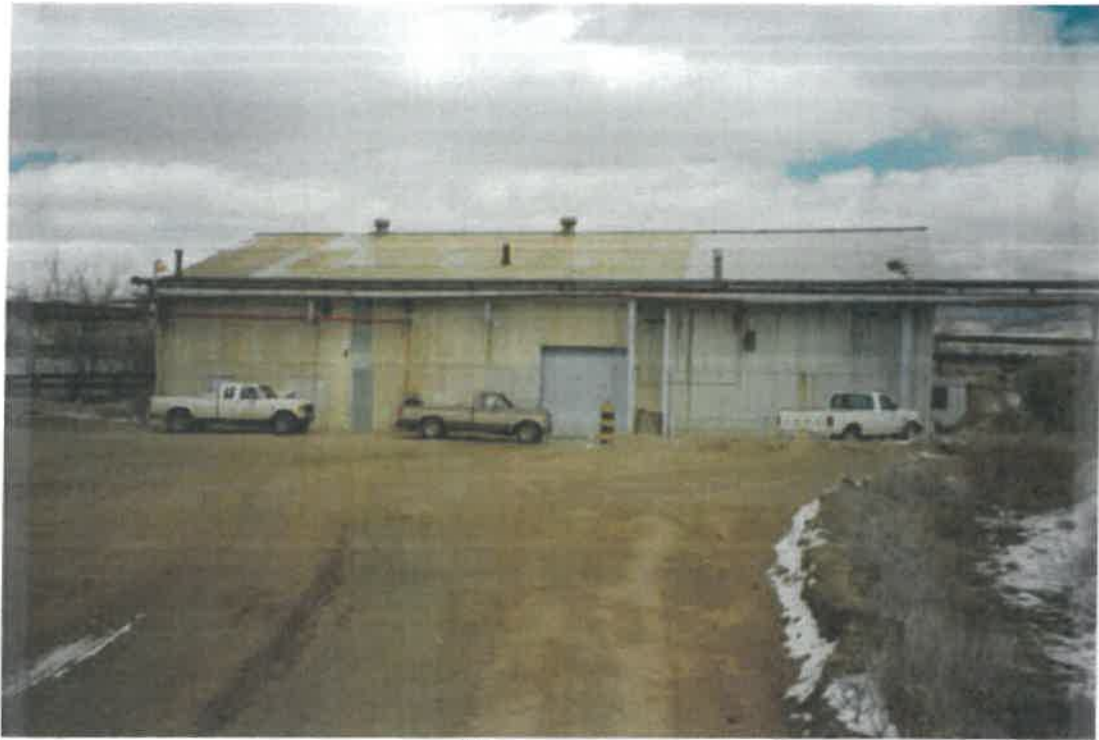
Photograph 3 - IX Plant Building, Currently in Use.

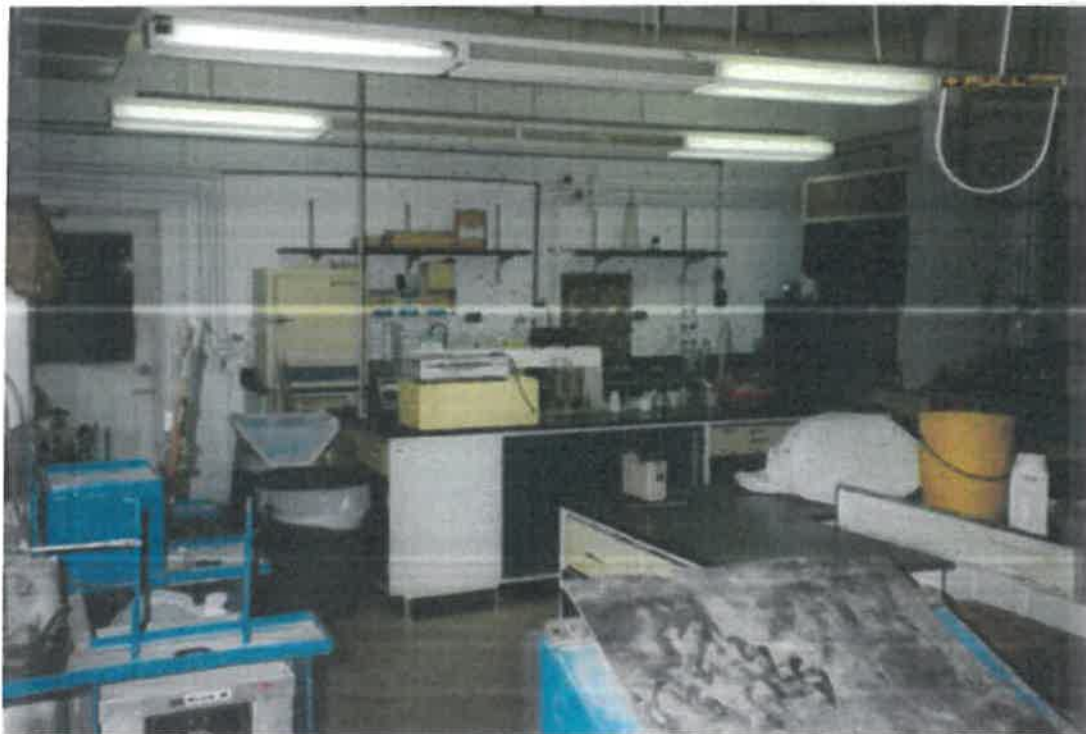
The manual specifies that non-routine radon daughter sampling will be performed in the "Met Lab," as well as other locations throughout the facility, on a quarterly basis. Records indicated that the licensee apparently had not performed radon daughter sampling in the Met Lab for approximately 7 years. However, the inspector noted that the area was not normally used by plant personnel and that other surveys had been performed in this area. This failure constitutes a violation of minor significance and is being treated as a non-cited violation consistent with Section IV of the NRC Enforcement Policy.

Although the root cause for the violation was not clearly identified, a contributing factor involved the development of the plant implementing procedures. The requirement to perform radon daughter sampling in the Met Lab had been inadvertently left out of the applicable implementing procedure. In response to the discussion of this finding, licensee representatives confirmed that they would perform radon daughter sampling in the Met Lab during subsequent routine site sampling evolutions.

Photograph 4 - The Met Lab.

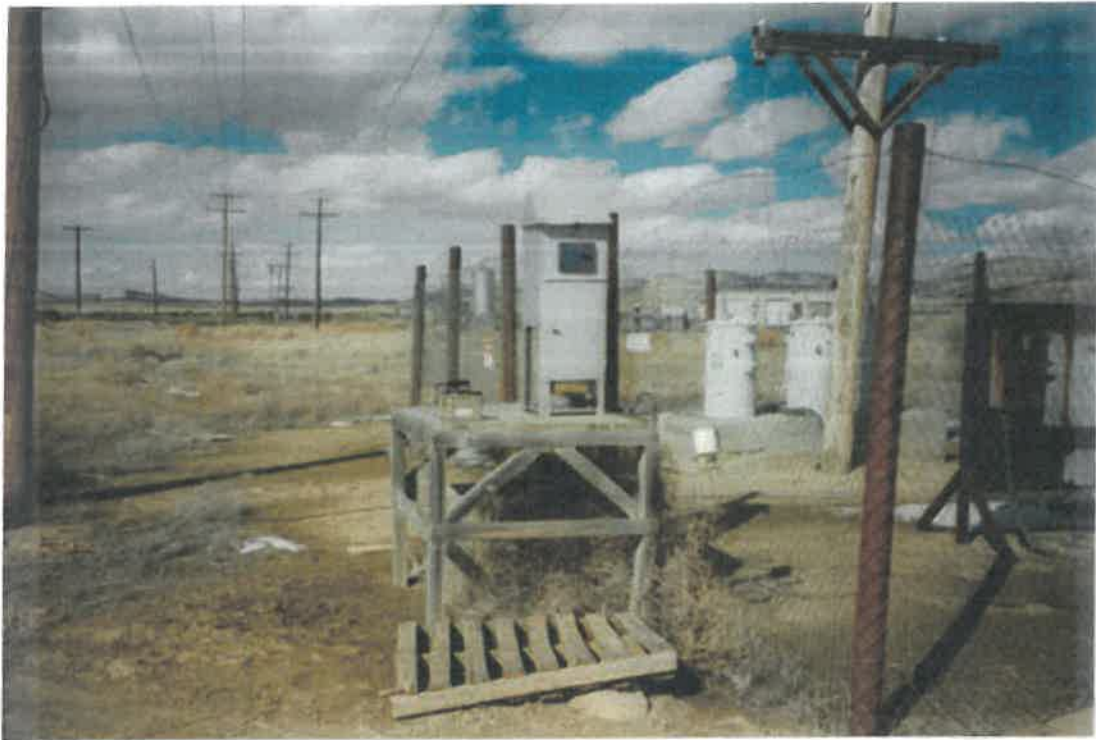
Soil and sediment sampling were required on an annual basis. Soil samples were taken at the five sample stations, and sediment samples were taken at four creek locations. The samples were analyzed for natural uranium, radium-226, thorium-230, and lead-210. The highest concentration measured was 10 picocuries per gram of thorium-230 at two locations, including the Mill Diversion station. The highest concentration measured for radium-226 was 5.1 picocuries per gram at the station designated as Section 30W-Vent Hole 6.

Photograph 5 - Sample Station 30W - VH6.
