SRR-LWE-2013-00214

## **Engineering Path Forward – Tanks 5 & 6: Record of Additional Grouting Actions**

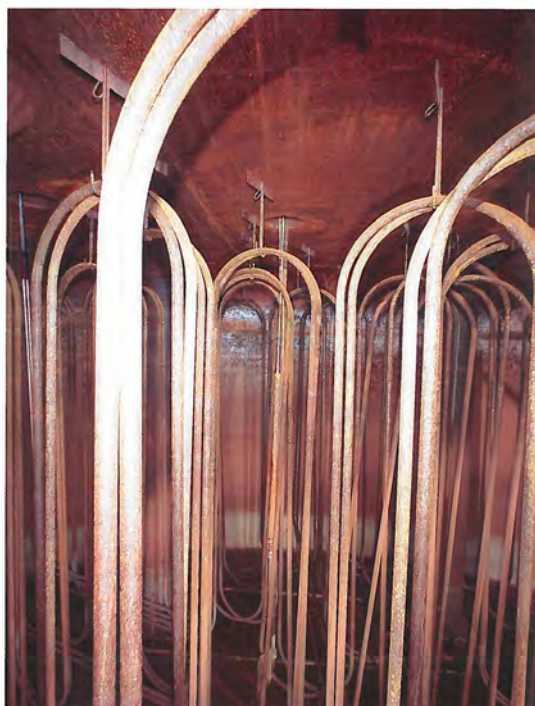
The configuration in P-DCF-F-00390 was not recognized. Furthermore, obstructions such as cooling coils and columns hindered efforts to accurately document the field state of the transfer jet. The in-tank video inspection was unsuccessful at capturing this condition and having it properly reflected in the document<sup>2</sup>. Figure 2.1.2-1 gives a view of the obstructions looking toward the Tank 6 Riser 4.

Figure 2.1.2-1: Obscured Jet in Tank 6, Riser 4  
(View Looking toward Tank 6 Riser 4)

<sup>2</sup> In November 2013, new information became available. Photographic evidence from an adjacent riser identified the Transfer Jet in Tank 6, Riser 4 was intact and not disassembled.

- The Tank 6, Riser 4 Transfer Jet has been grouted internally to the extent practical [2].
- The Tank 6, Riser 4 Thermowells have been grouted internally to the extent practical [2].
- The Grout Strategy Document, SRR-LWE-2012-00087, was revised to reflect the noted conditions. (See STAR Item 2013-CTS-015144)

Upon discovery of the new configuration, C&WDA was notified. A decision was made to grout the equipment and eliminate any potential for a vertical fast flow path. Subsequently the jet riser and thermowells have been grouted per WO# 001199254 [2].

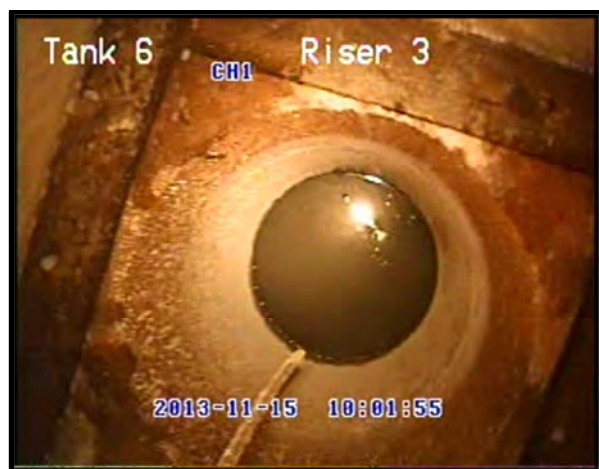
At the completion of the tank grouting, it was discovered that liquid was displaced by the tank fill grout and had been forced up into several of the risers associated with the two tanks. This liquid must be safely dispositioned before completing tank grouting to ensure there is not a spread of potential liquid contamination as the grout levels continue to rise. Figure 2.2-1 gives a typical example of what has been seen in these instances.

Figure 2.2-1: Liquid Present in Tank 6, Riser 3  
(View Looking Down Into Riser)

The liquid present in the risers is a direct result of the addition of liquid intended to lubricate the tank grout addition lines, thus ensuring the grout flowed continuously into the Waste Tanks. The amount of liquid present in the identified risers varies from “minimal” (less than a few inches) to “high” (12 inches or greater)<sup>3</sup>. A sufficient volume of liquid could have become a hindrance during the grouting process. For this reason, work packages were issued to allow the option to remove the liquid from the riser [6]. However, as a result of liquid reconstitution during grout addition and evaporation, the liquid level was deemed negligible and its removal unnecessary.

- A new Work Order Task was issued for Tanks 5 and 6 to allow, if required, the liquid in the riser to be removed [6].
