SBK-L-16058
Docket No. 50-443

Seabrook Station
Steam Generator Tube Inspection Report

OR17 Steam Generator Tube Inspection Report

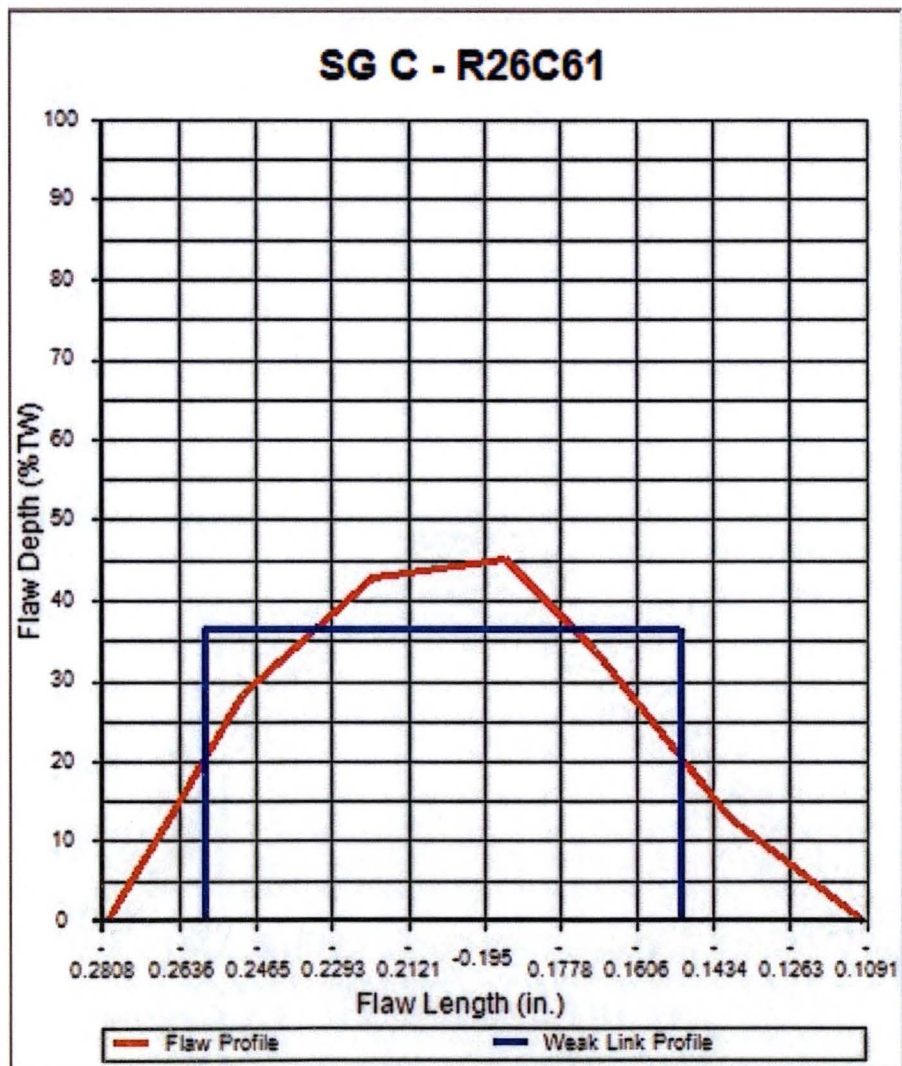
Figure B-1: OR17 Length/Depth Profiles of Axial ODSCC Indication in SG-C, R26C61
(ETSS I28431, Rev. 2)

A single indication of axial ODSCC (SAI) was detected in SG-C in the HL expansion transition region (TSH-0.22 in.) of tube R26C61. The indication length was 0.17 inches; this equates to a structural equivalent length (SEL) of 0.11 inch, with 0.14 Volts as the largest signal amplitude. The structural equivalent depth (SED) was determined to be 36.4% based on a depth profile of the flaw. The tube was re-tested with the Ghent probe which confirmed the +Point™ indication. The tube was last examined at this location using

a rotating probe (MRPC) during the OR14 inspection in 2011; there was no evidence of the flaw at that time. There are no bulges or over-expansions (BLG/OXP) at this location.

The ODSCC indication was assessed with regard to the need for in-situ testing. Using the known material properties for R26C61, the predicted burst pressure at 95% probability/50% confidence for the limiting indication is 7022 psid, which exceeds the $3\Delta P_{NOP}$ pressure differential for Seabrook of 3775 psid. The voltage threshold (V_{L-THR}) for leak testing for ODSCC cracks is given as 1.0V in the OR17 degradation assessment (DA). Similarly, the voltage threshold (V_{CRIT}) for significant SLB leakage is given as 2.5V for ODSCC in the OR17 DA. The maximum voltage for this indication is 0.14V; therefore, leak testing was not required and there is no significant potential for SLB leakage from this indication. The indication in tube R26C61 meets the CM criteria for leak and burst. The tube does not require in-situ testing.

The length/depth profiles of the ODSCC indication based on the amplitude sizing method of ETSS I28431 Rev. 2 is provided in Figure B-1 below:

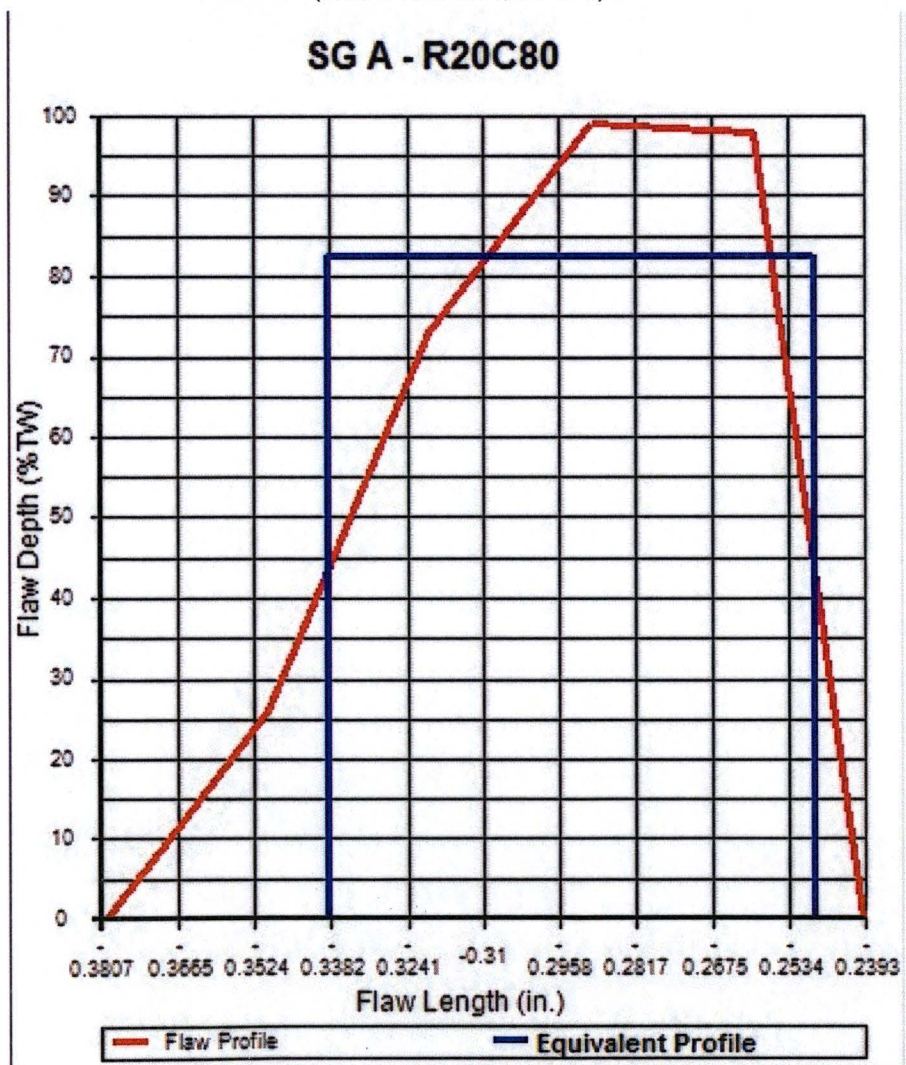
Figure B-2: OR17 Length/Depth Profiles of Axial PWSCC Indication in SG-A, R20C80
(ETSS 20511.1, Rev. 8)

A single indication of axial PWSCC (SAI) was detected in SG-A in the HL expansion transition region (TSH-0.26 in.) of tube R20C80. The indication length was 0.14 inches; this equates to a SEL of 0.09 inch, with 0.60 Volts as the largest signal amplitude. The SED was determined to be 82.63% based on a depth profile of the flaw. The tube was re-tested with the Ghent probe which confirmed the +Point™ indication. The tube was last examined at this location using a rotating probe (MRPC) during the OR13 inspection in 2009; there was no evidence of the flaw at that time. There are no BLGs or OXPs at this location.

The PWSCC indication was assessed with regard to the need for in-situ testing. Using the known material properties for R20C80, the predicted burst pressure at 95% probability/50% confidence for the limiting indication is 6659 psid, which exceeds the $3\Delta P_{\text{NOP}}$ pressure differential for Seabrook of 3775 psid. The voltage threshold ($V_{\text{L-THR}}$) for leak testing for PWSCC cracks is given as 1.5V in the OR17 DA. Similarly, the voltage threshold (V_{CRIT}) for significant SLB leakage is given as 4.0V for PWSCC in the OR17 DA. The maximum voltage for this indication is 0.60V; therefore, leak testing was not required and there is no significant potential for SLB leakage from this indication. The indication in tube R20C80 meets the CM criteria for leak and burst. The tube does not require in-situ testing.

The length/depth profiles of the PWSCC indication based on phase angle method of ETSS 20511.1, Rev. 8 is provided in Figure B-2 below:

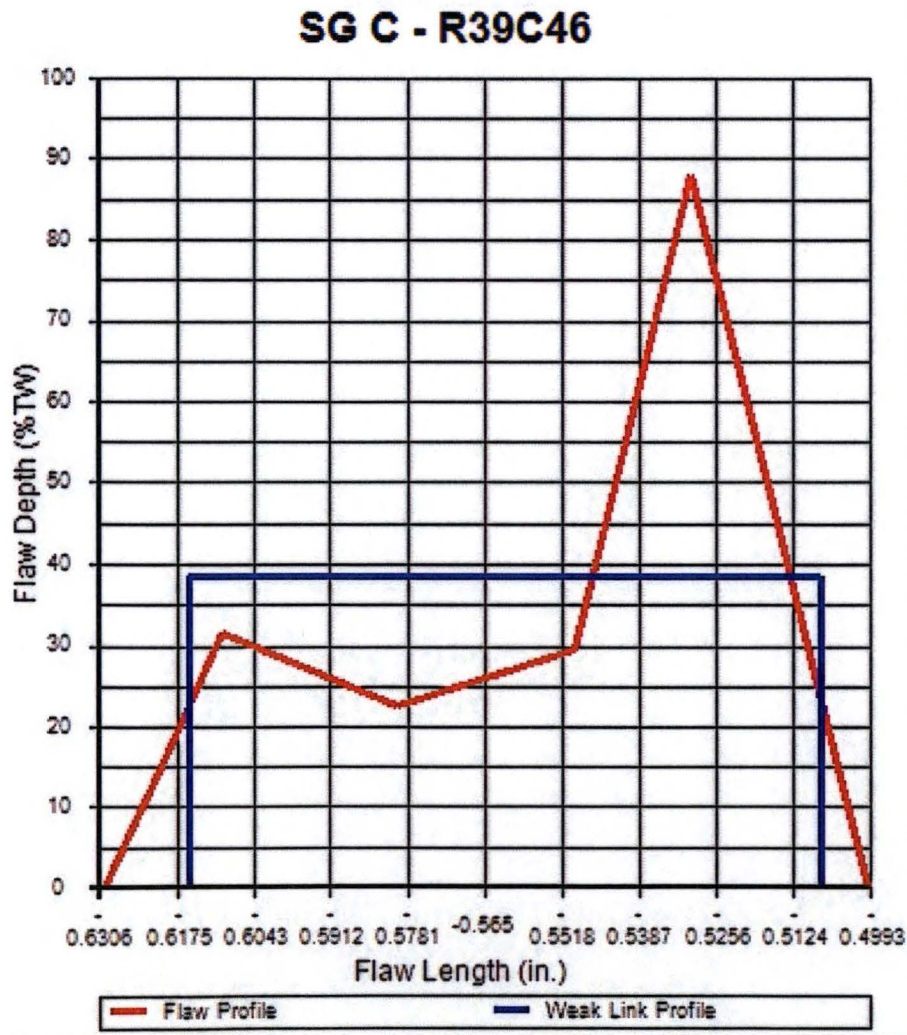
Figure B-3: OR17 Length/Depth Profiles of Axial PWSCC Indication in SG-C, R39C46
(ETSS 20511.1, Rev. 8)

A single indication of axial PWSCC (SAI) was detected in the tube-to-tubesheet expansion region, just below the HL (TTS-0.62) of tube R39C46 in SG-C. The indication length was 0.13 inches; this equates to a SEL of 0.11 inch, with 0.65 Volts as the largest signal amplitude. The SED was determined to be 38.46% based on a depth profile of the flaw. The tube was re-tested with the Ghent probe which confirmed the +Point™ indication. The tube was last examined at this location using a rotating probe (MRPC) during the OR14 inspection in 2011; there was no evidence of the flaw at that time. There are no BLGs or OXPs at this location.

The PWSCC indication was assessed with regard to the need for in-situ testing. Using the known material properties for R39C46, the predicted burst pressure at 95% probability/50% confidence for the limiting indication is 7149 psid, which exceeds the $3\Delta P_{NOP}$ pressure differential for Seabrook of 3775 psid. The voltage threshold (V_{L-THR}) for leak testing for PWSCC cracks is given as 1.5V in the OR17 DA. Similarly, the voltage threshold (V_{CRIT}) for significant SLB leakage is given as 4.0V for PWSCC in the OR17 DA. The maximum voltage for this indication is 0.65V; therefore, leak testing was not required and there is no significant potential for SLB leakage from this indication. The indication in tube R39C46 meets the CM criteria for leak and burst. The tube does not require in-situ testing.

The length/depth profiles of the PWSCC indication based on phase angle method of ETSS 20511.1 Rev. 8 is provided in Figure B-3 below:
