**CAMECO RESOURCES
CROW BUTTE OPERATION**

April 22, 2016

On April 20, 2016, during routine 5-year Mechanical Integrity Testing (MIT), well number I-1133 in Mine Unit 5, Wellhouse 17 failed the MIT criteria at the Crow Butte Resources (CBR) mine site. Isolation procedures indicated that the failure was the casing joint at the 20-foot level. Dave Carlson, of the NDEQ Chadron field office, and Ron Burrows, NRC Project Manager, were notified concerning this well on April 21, 2016.

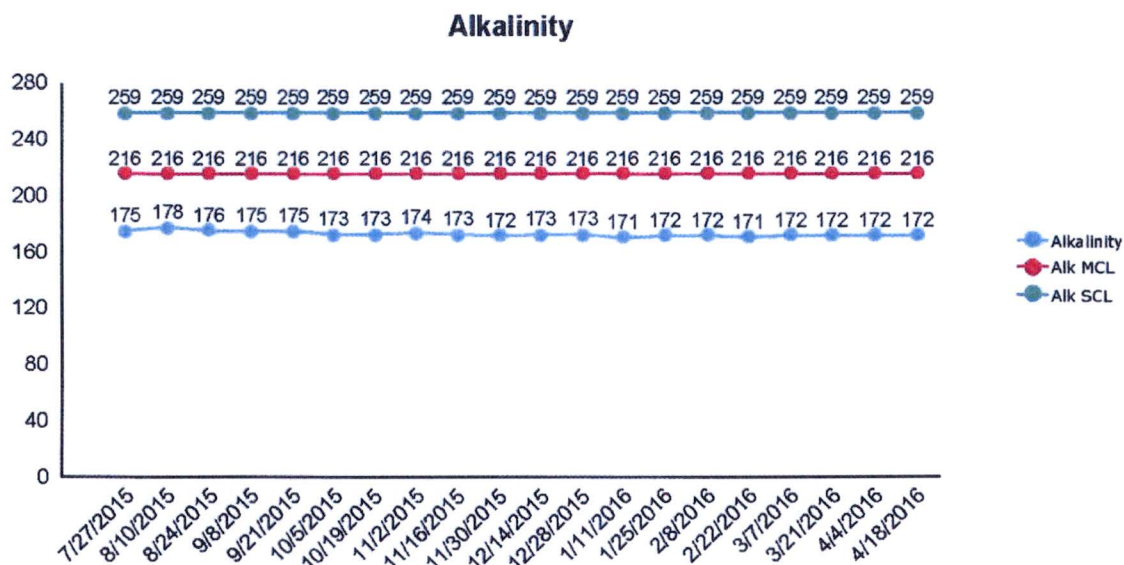
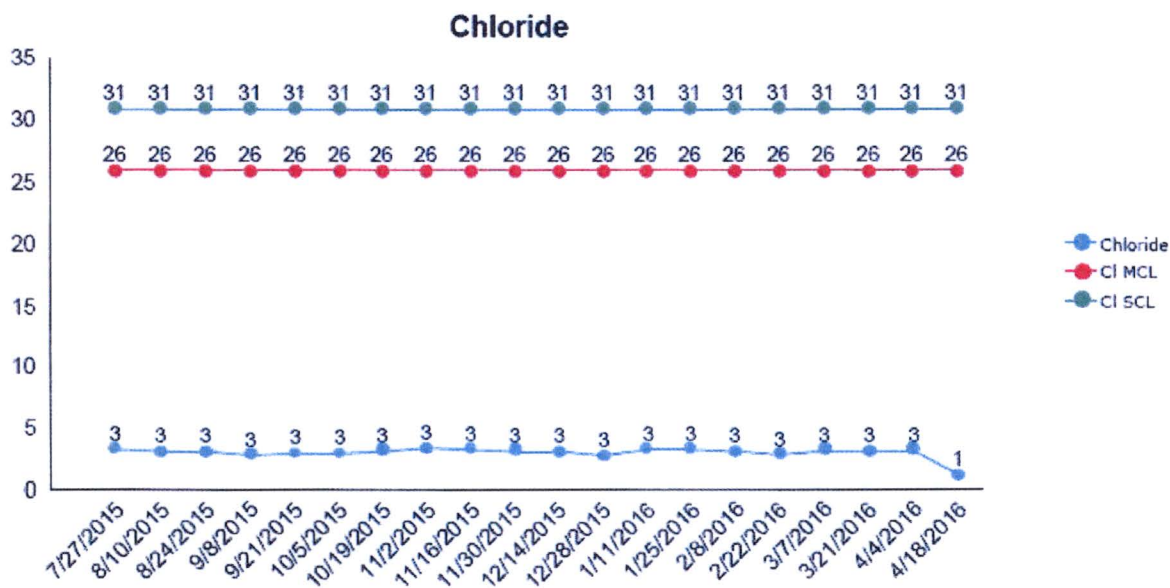
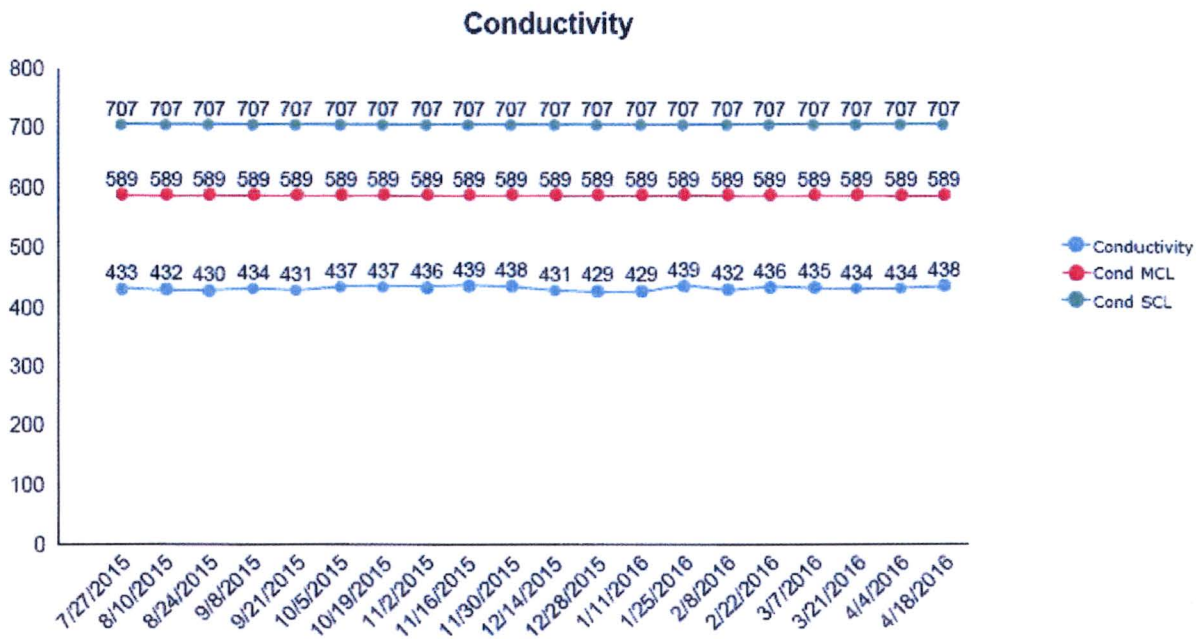
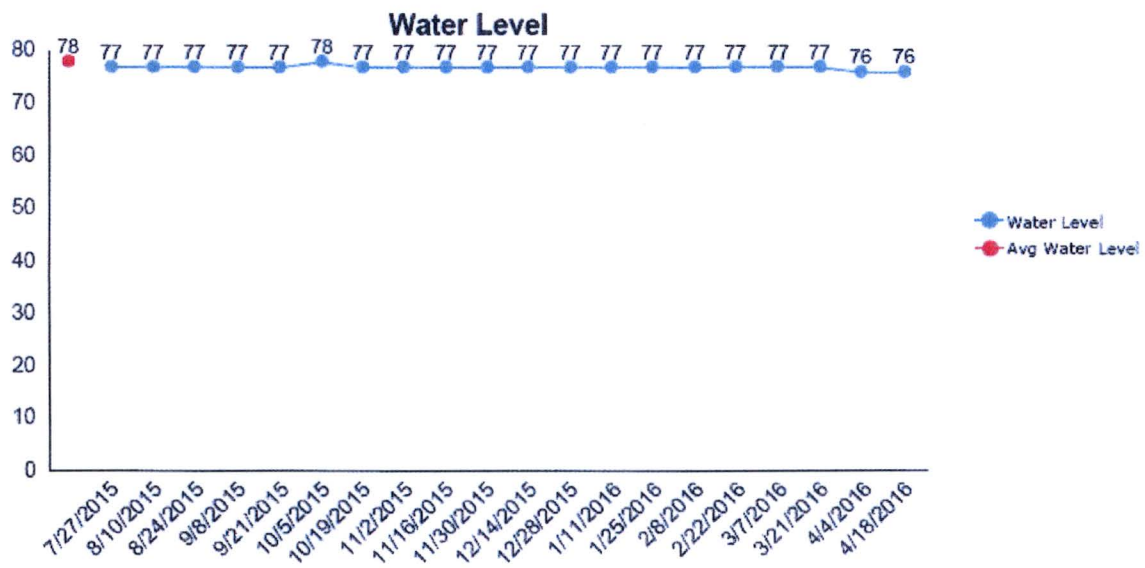
SM05-018

A graph of the sampling results for the nearest Shallow Monitor Well, SM 5-18, is included for your review. This well is located 150 feet north of I-1133.
