Licensee: Houston Lighting & Power Company (HL&P)  
Facility: South Texas Project (STP)  
License Nos.: NPF-76; NPF-80  
Docket Nos.: 50-498; 50-499  
Subject: MANAGEMENT MEETING CONCERNING ESSENTIAL COOLING WATER (ECW)  
SYSTEM AND EMERGENCY DIESEL GENERATOR (EDG) ISSUES

**ESSENTIAL COOLING WATER SYSTEM**

STANDBY DIESEL GENERATORS

# **METALLURGY AND FAILURE ANALYSIS OF** **ALUMINUM BRONZE WELDS FROM STP ECW SYSTEM**

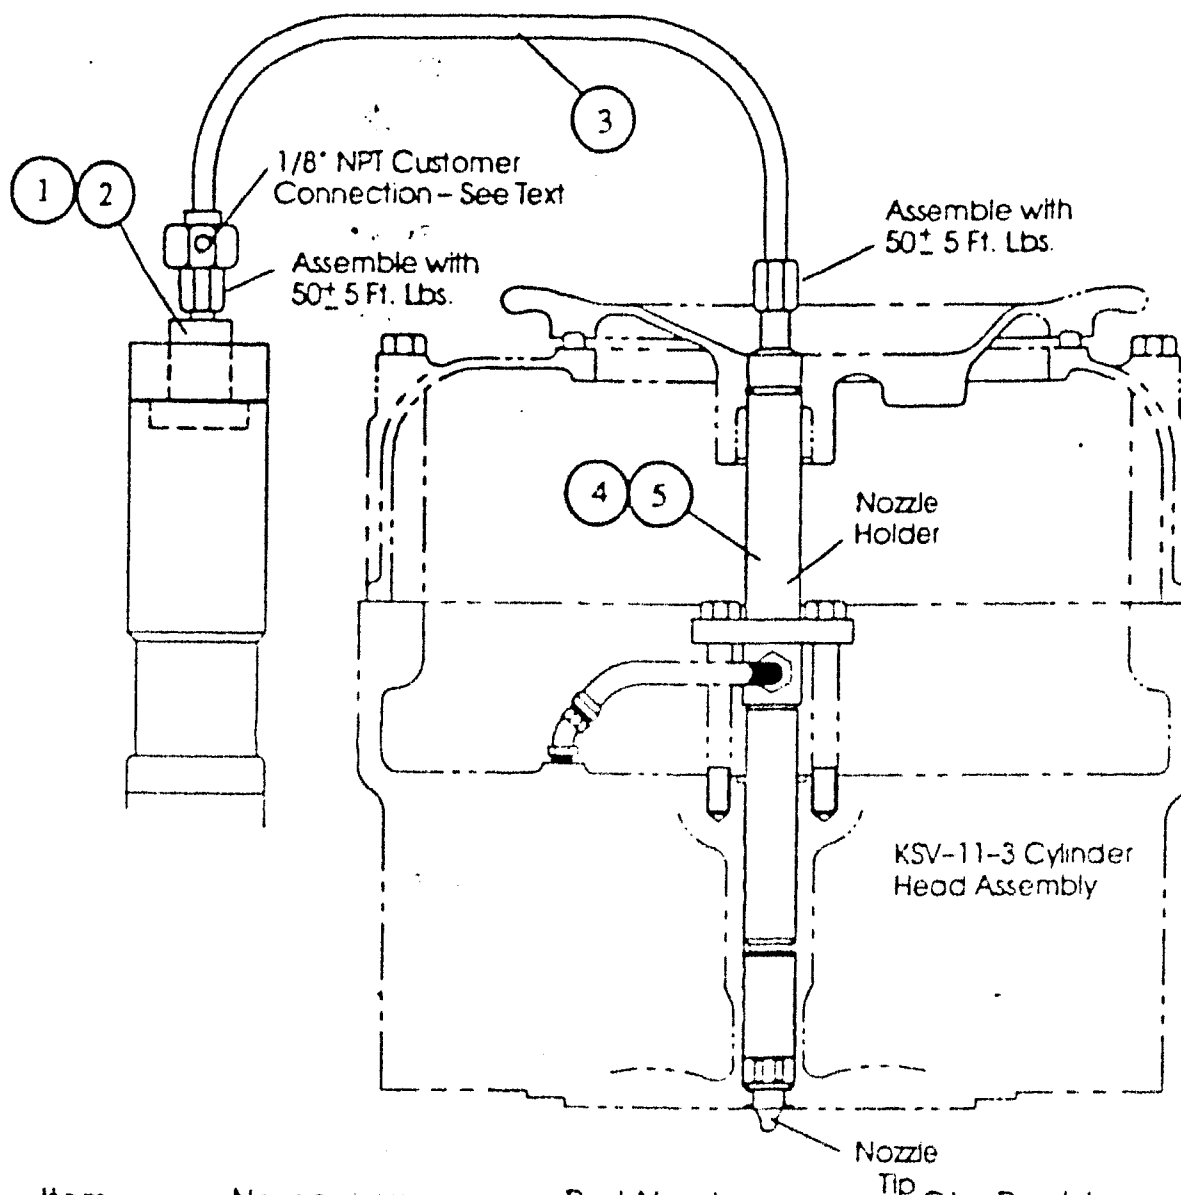
FIG.1 KSV - NEW HIGH PRESSURE FUEL LINE ASSEMBLY

- Since 1989: 13 cracked delivery valve holders  
4 cracked nozzle holders
- Cooper-Bessemer installation method causes high material stresses
- Revised method of installation reduces torque
- New swaged delivery valve holder, fuel line and nozzle holder to be installed 1RE04, 2RE03

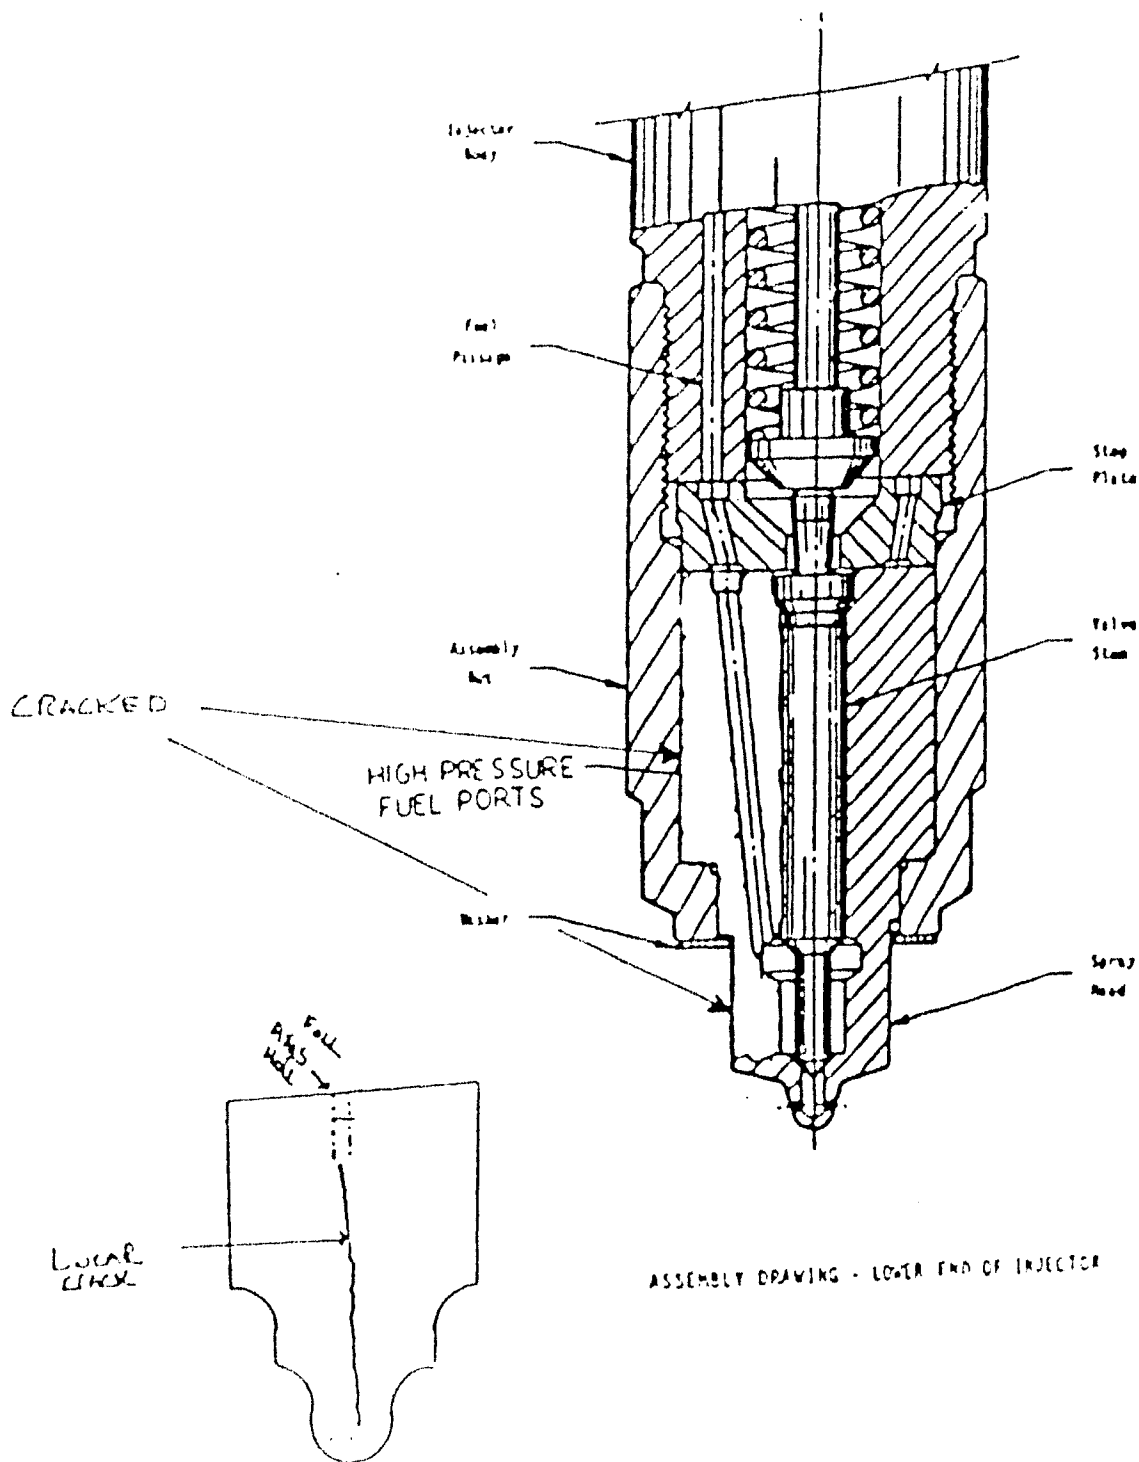
Figure 2  
SDG 13 Fuel Injector Nozzle Crack

- 1987 - STP found lot 001124 with 20 cracked tips
- 1988 - Cooper-Bessemer notified STP of bad lot 150008 at Commonwealth Edison
- 1991 - STP found cracked tips in lots 150010 and 150006
- Lots 150006, 8, 10 manufactured by Bendix

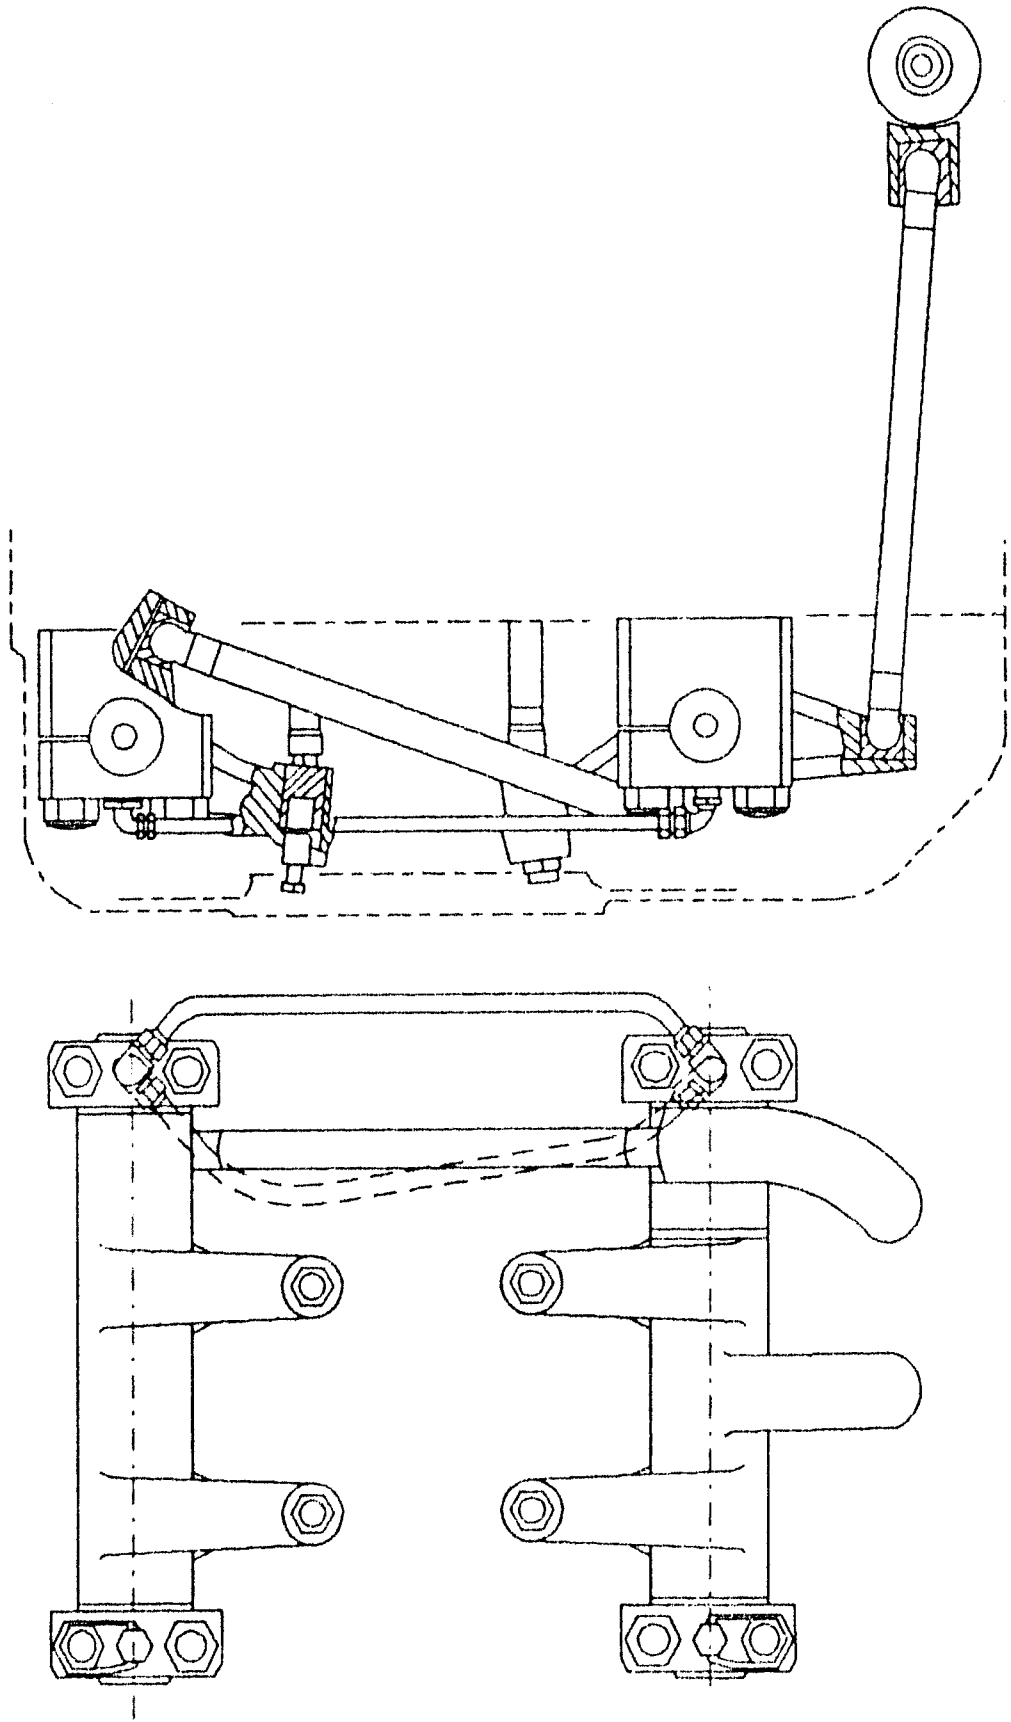
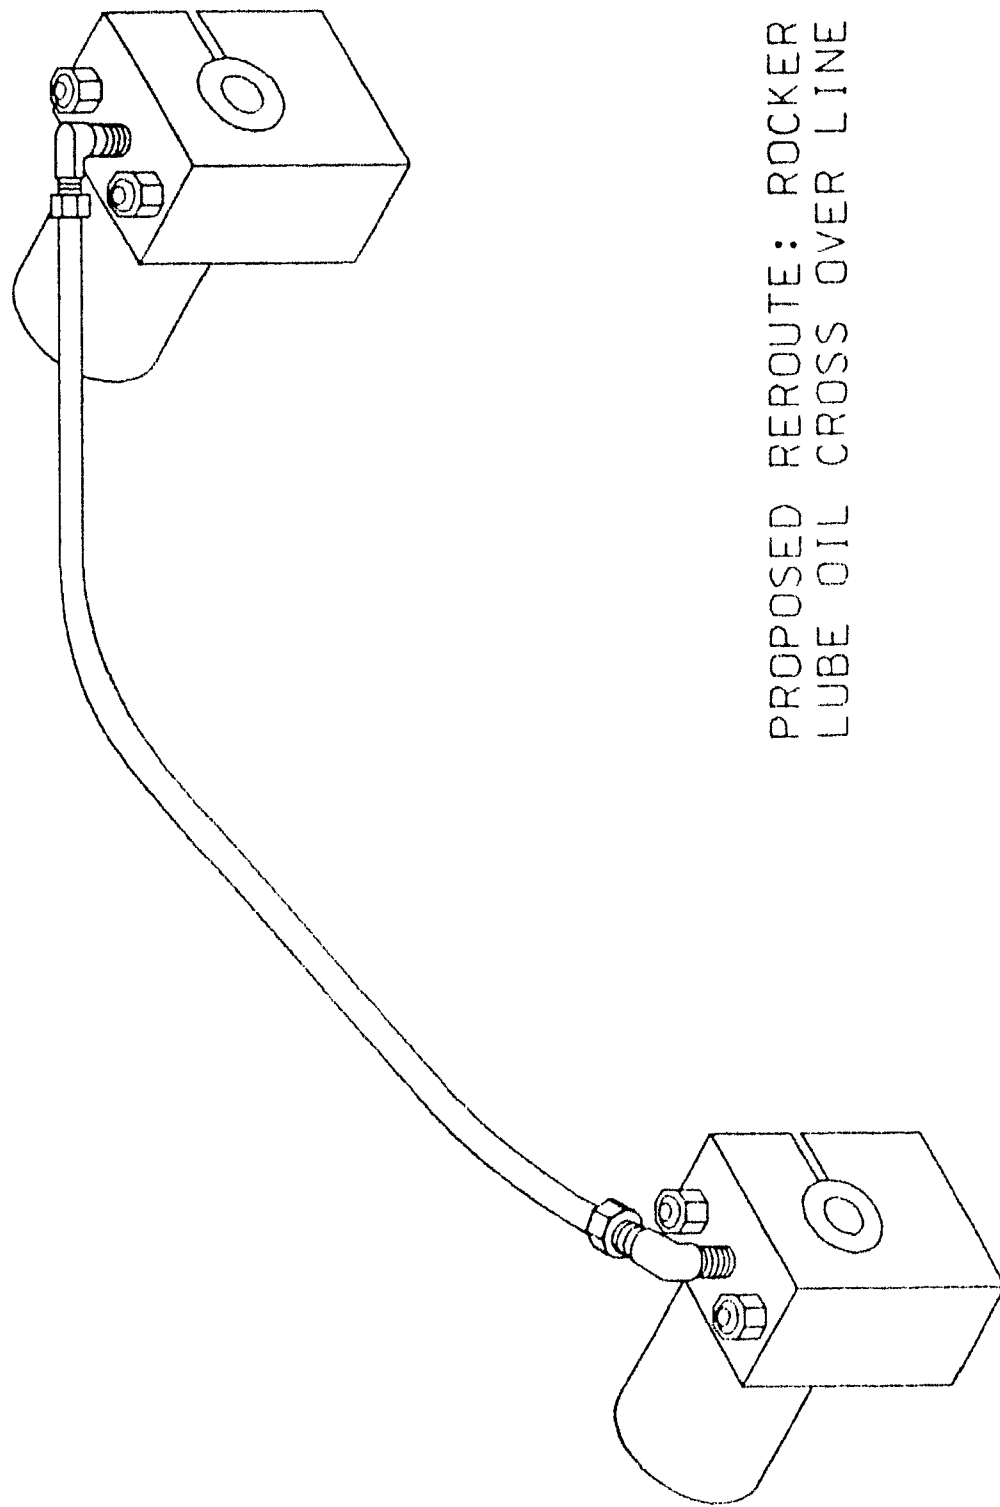
PROPOSED REROUTE: ROCKER ARM  
LUBE OIL CROSS OVER LINE

- One failure to date
- High cycle fatigue
- Misalignment and tight bend radii contribute
- Replace with 0.062" wall thickness tube and better bend radii
- Will try prototype on one cylinder for proposed refit

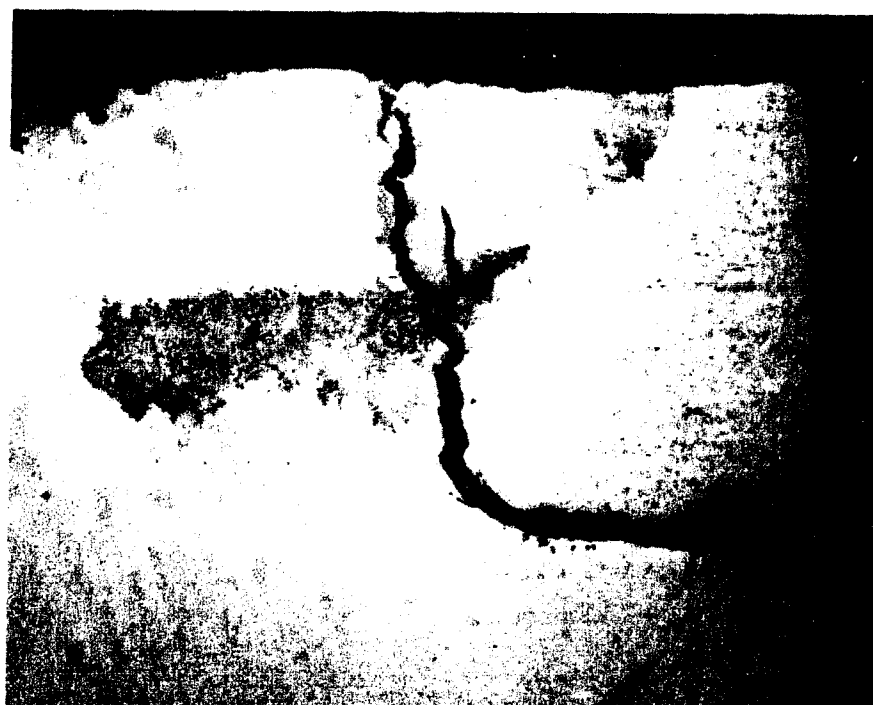
Figures 12 and 13. Photomicrographs of cross section #2 also in the through wall portion of the crack. Pre-existing defect includes lack of fusion with weld crack. (Magnifications: 2.2 and 10X, Ammonium Persulfate Etchant, MM 2477)

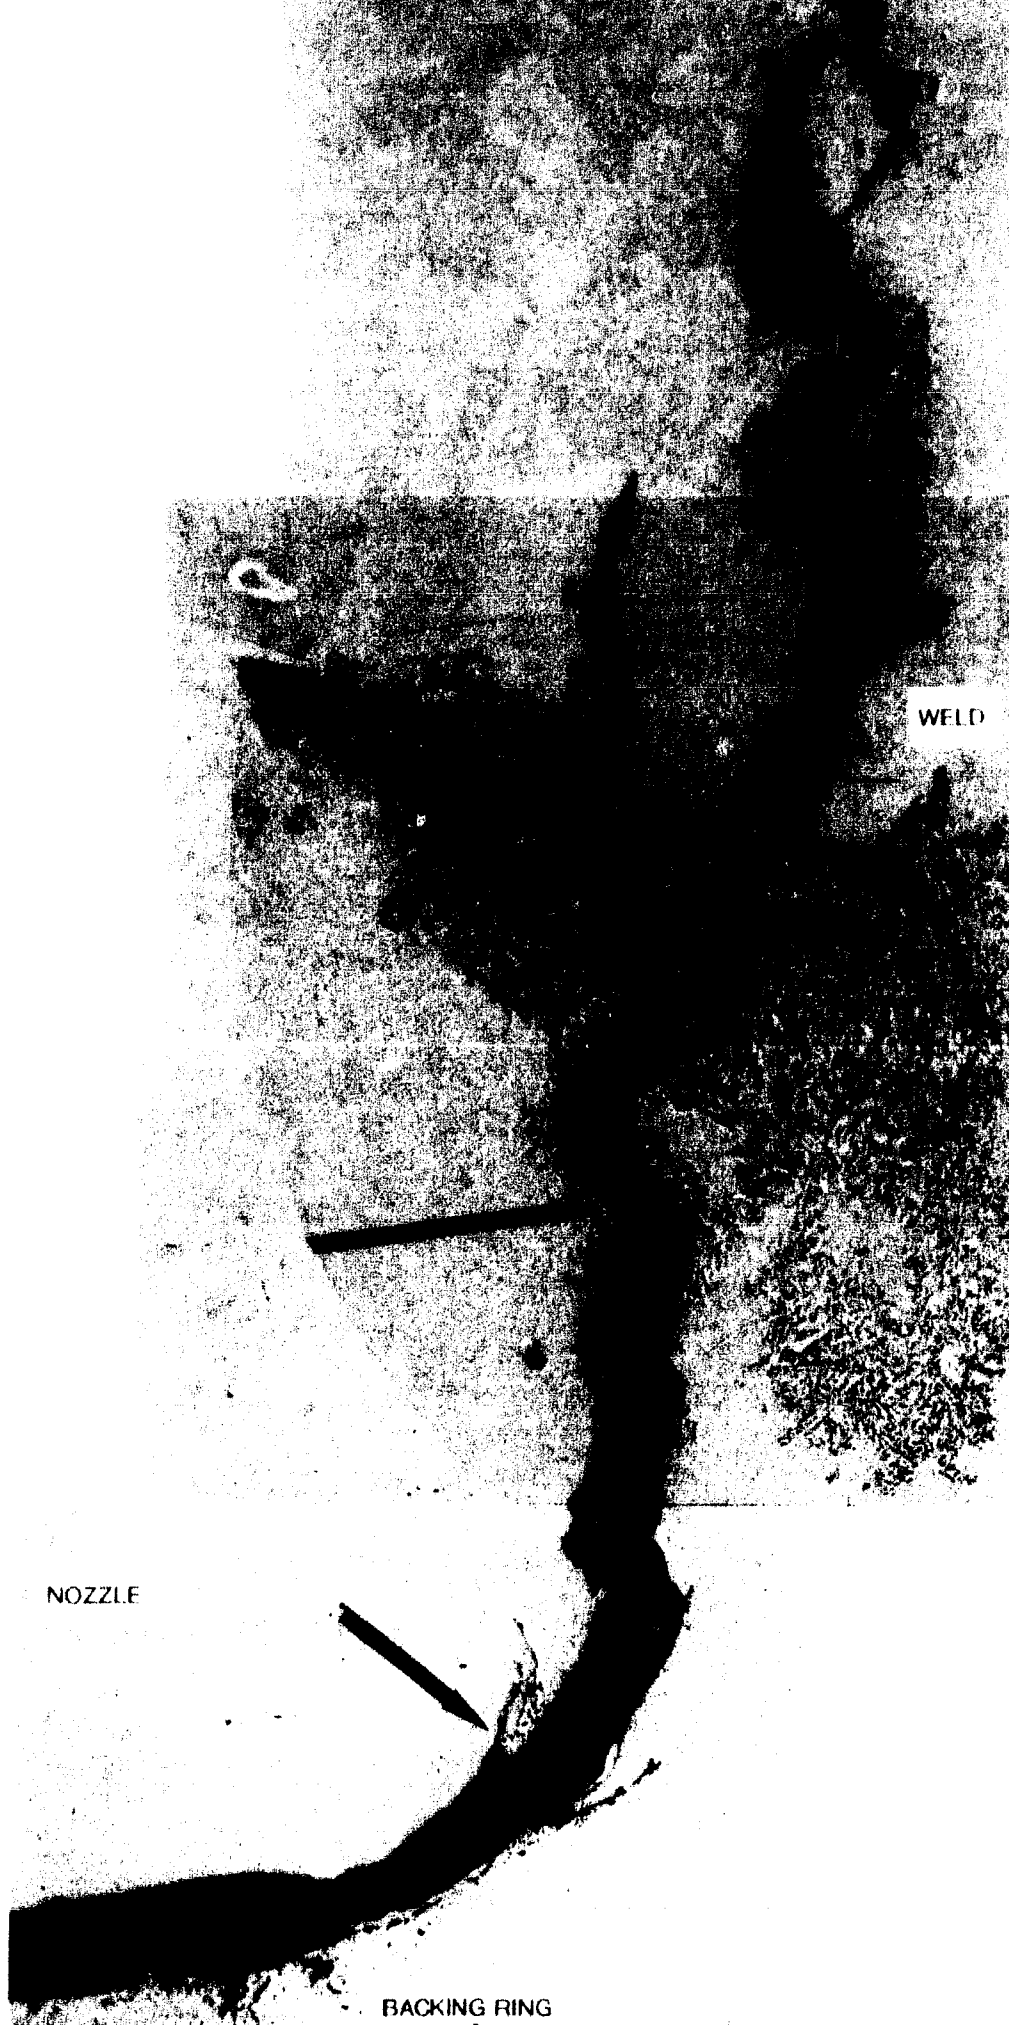
Figure 14. Higher magnification photomicrograph of cross section #2. Lower arrow shows extent of lack of fusion. Upper arrow shows estimated extent of pre-existing defect. (Magnification: Ammonium Persulfate Etchant, MM 2477)

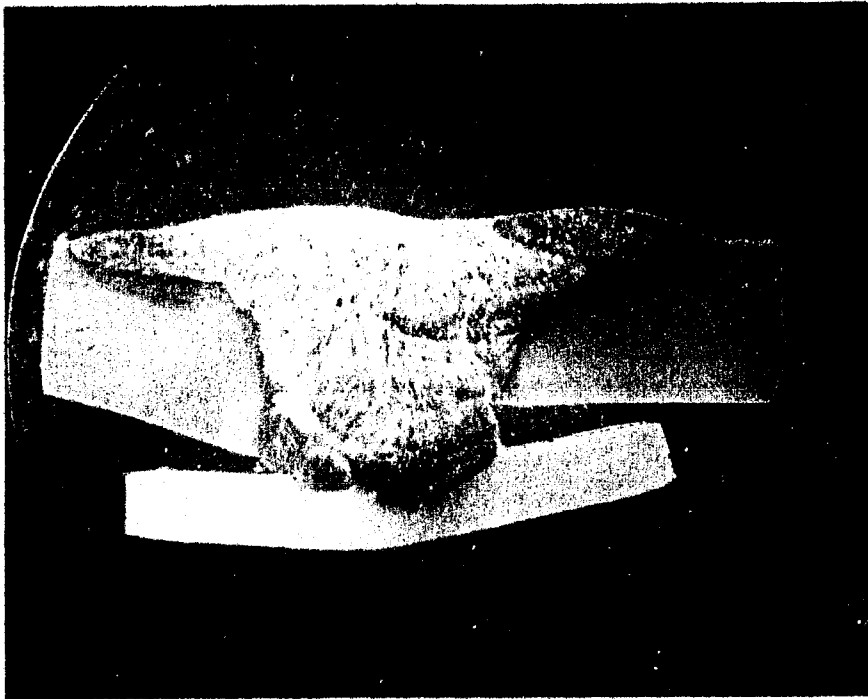
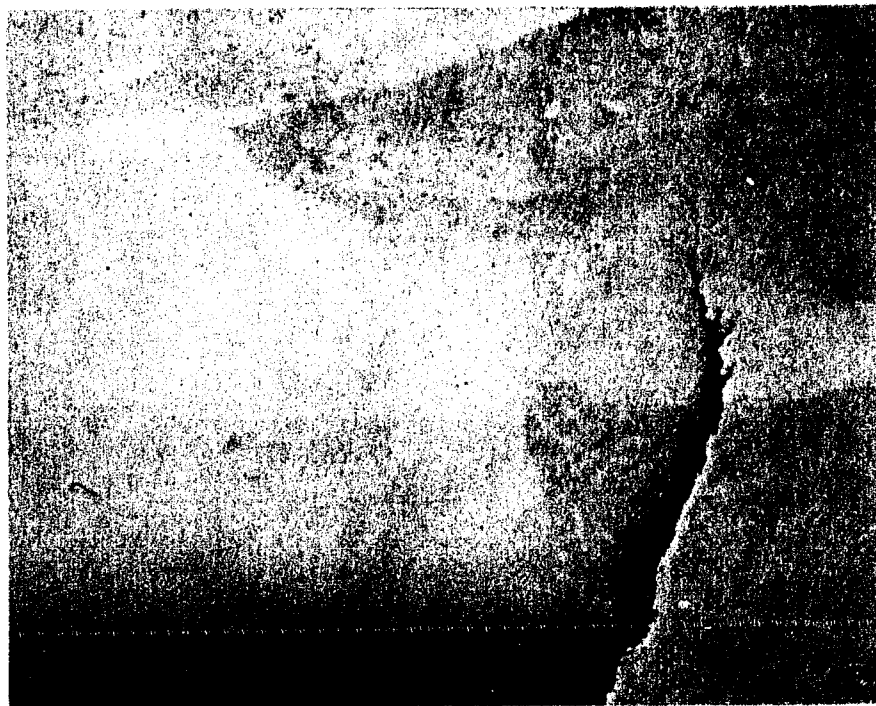
Figures 8 and 9. Photomicrographs of the cross section #1 taken outside the top end of the through-wall crack in an area of in service propagation. Optics of the microscope reverses the higher magnification image horizontally. (Magnification: 2.5X and 10X, Ammonium Persulfate Etchant, MM-2511)

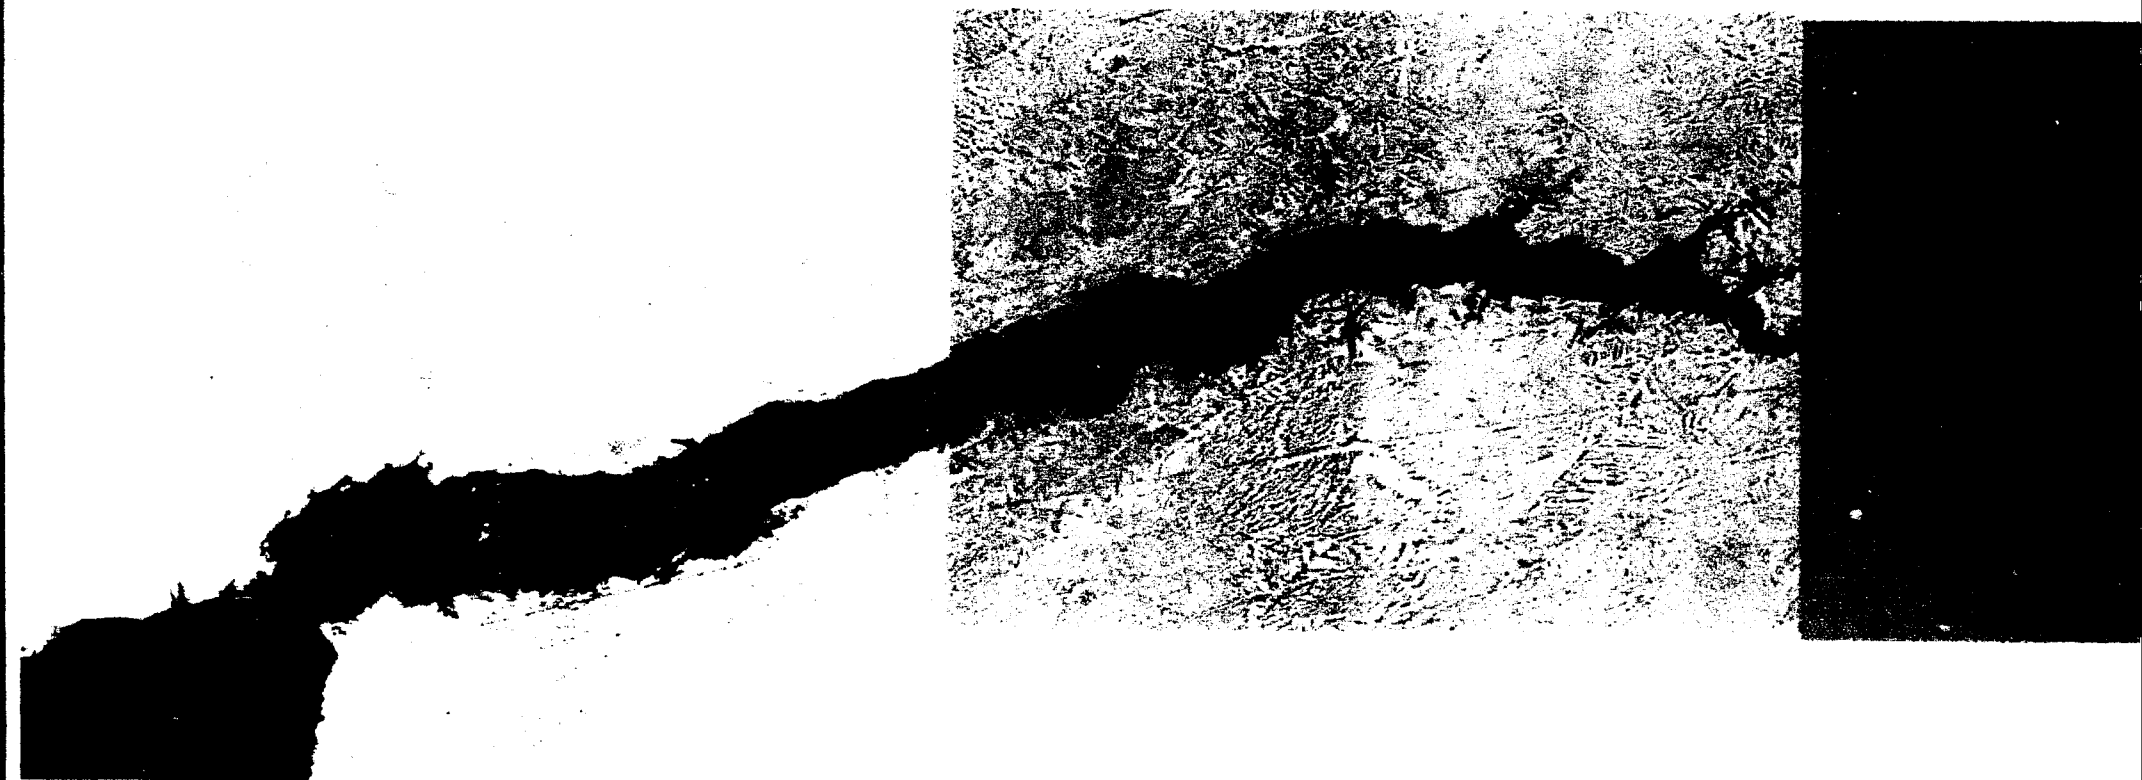
Figure 10. Higher magnification photomicrograph of cross section #1 showing the crack. Arrows show the boundaries of maximum lateral dealloying.  
(Magnification: Ammonium Persulfate Etchant, MM-2511)

- Cracks initiated at weld defects (lack of fusion or cracking)
- Crack propagation due to combined effects of dealloying and stresses at crack tip
- Dealloying due to crevice effects of backing ring and defect
- Stress needed for propagation = residual + operating stresses
