SUBJECT: LER 80-003/03L-0: on 800205, during routine tour, main feeder bus 1 was isolated when smoking bus connection was discovered. Apparently caused by differing secondary voltages resulting in transformer 3T carrying excessive load.

DUKE POWER COMPANY
OCONEE UNIT 3

Report Number: RO-287/80-3

Identification of Occurrence: Main Feeder Bus Isolated

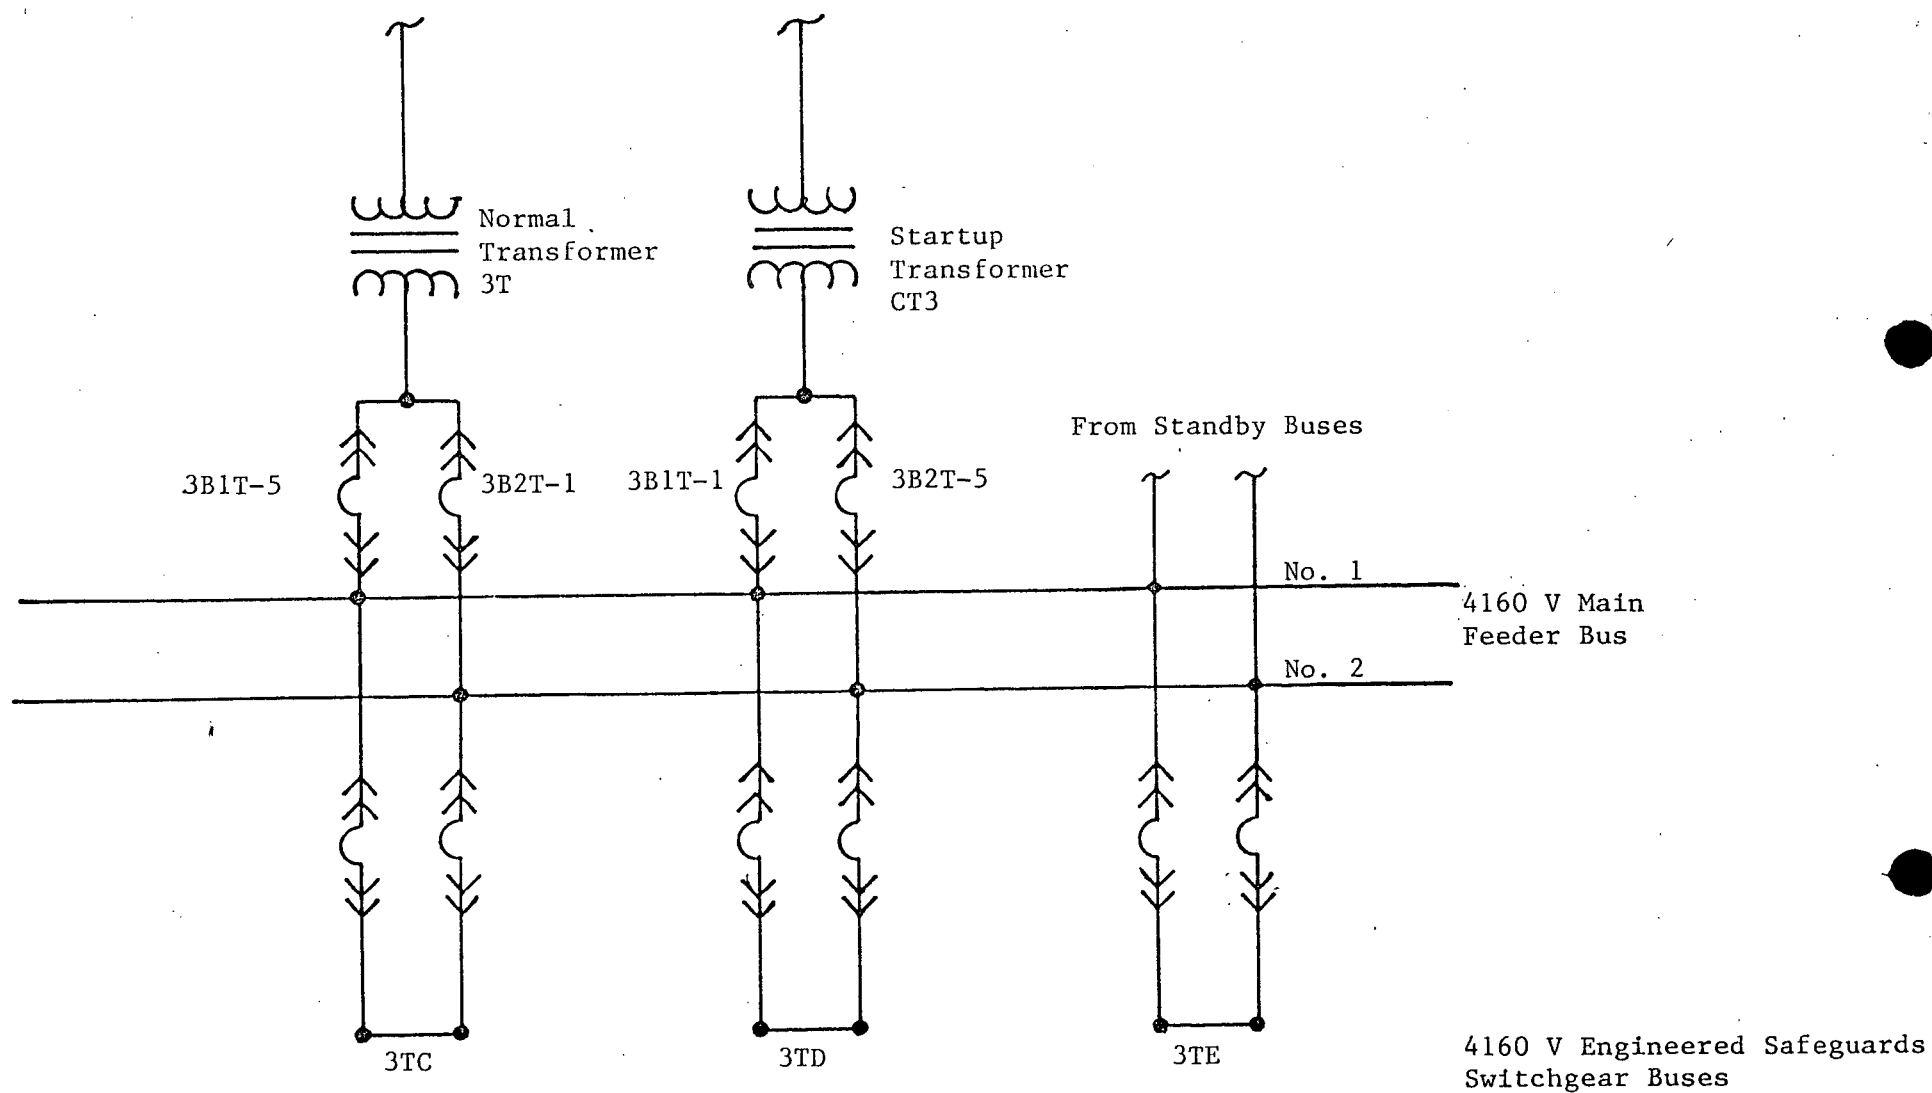
Figure 1

On February 4, 1980, breaker 3B2T-1, the 4160 volt normal feeder breaker to Oconee 3 Main Feeder Bus (MFB) 2, failed to close during performance of the monthly breaker operability test. Breaker 3B2T-5 was then closed, energizing MFB 2 from startup transformer CT-3. At 0620 on February 5, 1980, smoke was observed to be coming from a connection in cabinet 3B1T-3 during a routine tour of the Oconee 3 Blockhouse. MFB 1 was isolated, and the connection stopped smoking. An hourly firewatch was established since the smoke detectors had not alarmed. At 0010 on February 6, 1980, breaker 3B1T-5 was closed, energizing MFB 1 from transformer 3T. The breaker from MFB 1 to switchgear group 3TC was then closed, but tripped on overcurrent approximately 5 seconds later. Breaker 3B1T-5 was reopened, and the breakers energizing switchgear groups 3TC, 3TD, and 3TE from MFB 1 were closed. Breaker 3B1T-5 was then reclosed, and no problems were observed. However, a review of hourly megawatt readings indicated that during the period that MFB 1 was energized by transformer 3T and MFB 2 was energized by transformer CT3, transformer 3T was reading approximately 15 megawatts higher than normal, and transformer CT3 was supplying no power. Breaker 3B1T-1 was closed and breaker 3B2T-1 was opened, so that MFB 1 was energized by transformer CT3. On February 7, 1980 investigation of the problems with breaker 3B2T-1 was completed, and it was returned to service. A simplified schematic of the power distribution system is attached.

During the period that MFB 1 was energized by the normal transformer and MFB 2 was energized by the startup transformer, both transformers were feeding the same loads in parallel. This should only be done if both transformers have the same characteristics. It appears that approximately 15 megawatts was flowing from transformer 3T through transformer CT3 back into the 230 KV switchyard, possibly due to differing secondary voltages for the two transformers. The resultant excessive current caused the bus connection in cabinet 3B1T-3 to overheat and burn off the adjacent epoxy insulation. With no flame present, the smoke produced was of very low thermal energy and would tend to stratify, so that it did not reach a smoke detector located on the ceiling. In addition, the detector in the area had a somewhat lower sensitivity than others in use.

Investigation of the problem with breaker 3B2T-1 revealed a ground on the DC system. When the ground was cleared, the breaker operated properly. The overheated bus connection was inspected and cleaned thoroughly after it was determined that no damage had occurred. The overcurrent trip protective relaying, which should have prevented the overheating, are being investigated. The possibility of welding all aluminum-to-aluminum connections in the 4160 volt switchgear is also under review. In addition, consideration is being given to installing an electrical interlock to prevent the main feeder buses from being energized by the normal and startup transformers in parallel. The 4160 volt breaker operability test may be revised to avoid placing the transformers in parallel. The existing smoke detector will be replaced, and an ionization detector will be installed above each switchgear cabinet to identify overheating problems.
