PART 21 IDENTIFICATION NO. 80-252-000 COMPANY NAME B+WDATE OF LETTER 7/11/80 DOCKET NO. numerousDATE DISTRIBUTED 7/18/80 ORIGINAL REPORT ☒ SUPPLEMENTARY ☐

July 11, 1980

Subject: Cracked Steam Generator Manway Studs at Oconee III

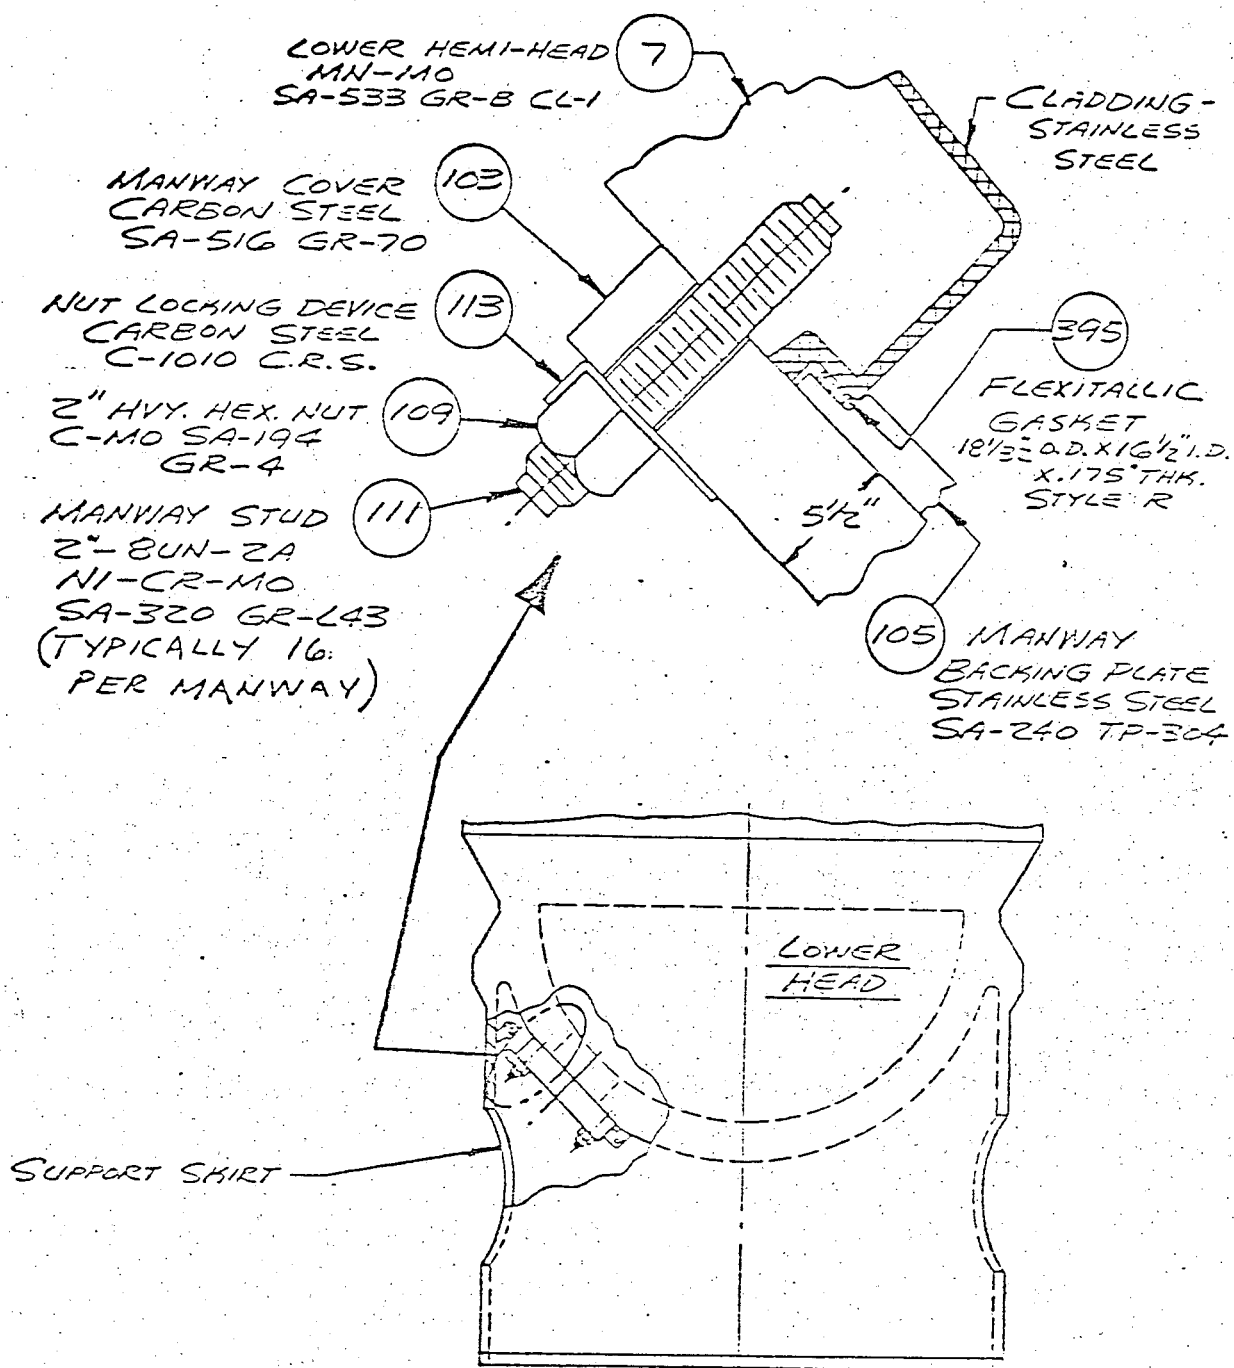
TYPICAL MANWAY CONFIGURATION

The general configuration and material listing of a typical lower OTSG manway is shown on the attached sketch. The upper manway on each steam generator is quite similar. This configuration and material are used on all of the following plants:
