SUBJECT: Forwards Request for Relief 89-08 from inservice insp requirements of Section XI of ASME Boiler & Pressure Code.

Subject: Oconee Nuclear Station  
Docket Nos. 50-287  
Second Ten Year Interval  
Request for Relief No. 89-08

Duke Power Company  
Oconee Nuclear Station  
Second Ten Year Interval  
Request for Relief No. 89-08

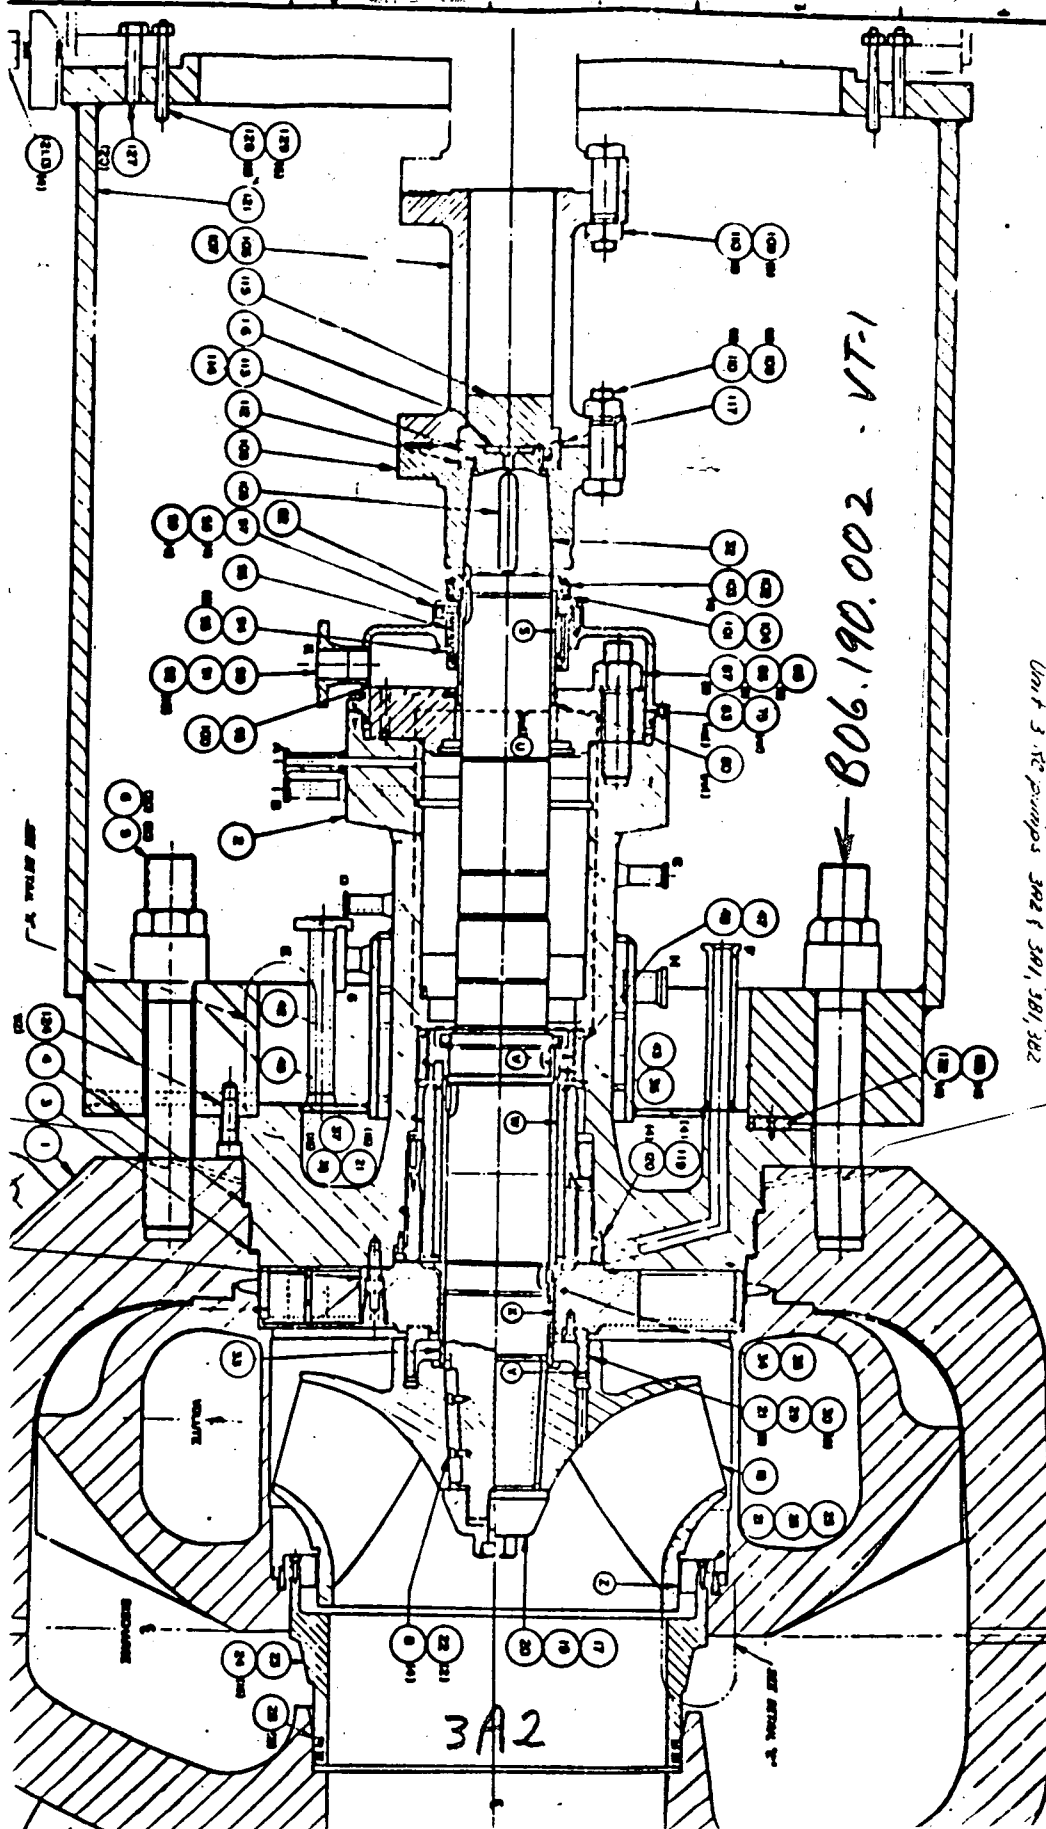
The damage to the stud hole threads is not due to cracks in the base metal or pitting caused by boric acid corrosion but instead more characteristic of damage done during the process of removing the studs. The damage to the threads on the 3A2 RCP casing is typically seen after removing a stuck stud. The damage on 3B1 RCP casing is typical of damage due to stud handling during removal and installation.

Each refueling outage the flange joint and surrounding area will be inspected for any accumulation of boron or visible stud degradation. If any degradation is noted, actual dimensional checks will be made of the studs. Additionally, when a RCP is disassembled for maintenance activities, all stud holes will be inspected as required by the Code. Stud holes will be examined during the third ten year interval as part of the Inservice Inspection program.
