MRP Materials Reliability Program _____ MRP 2016-008

Subject: Biennial Report of MRP-227-A Reactor Internals Inspection Results

ENCLOSURE TO MRP 2016-008

MRP-227 Related Inspections Performed from 2014-2015

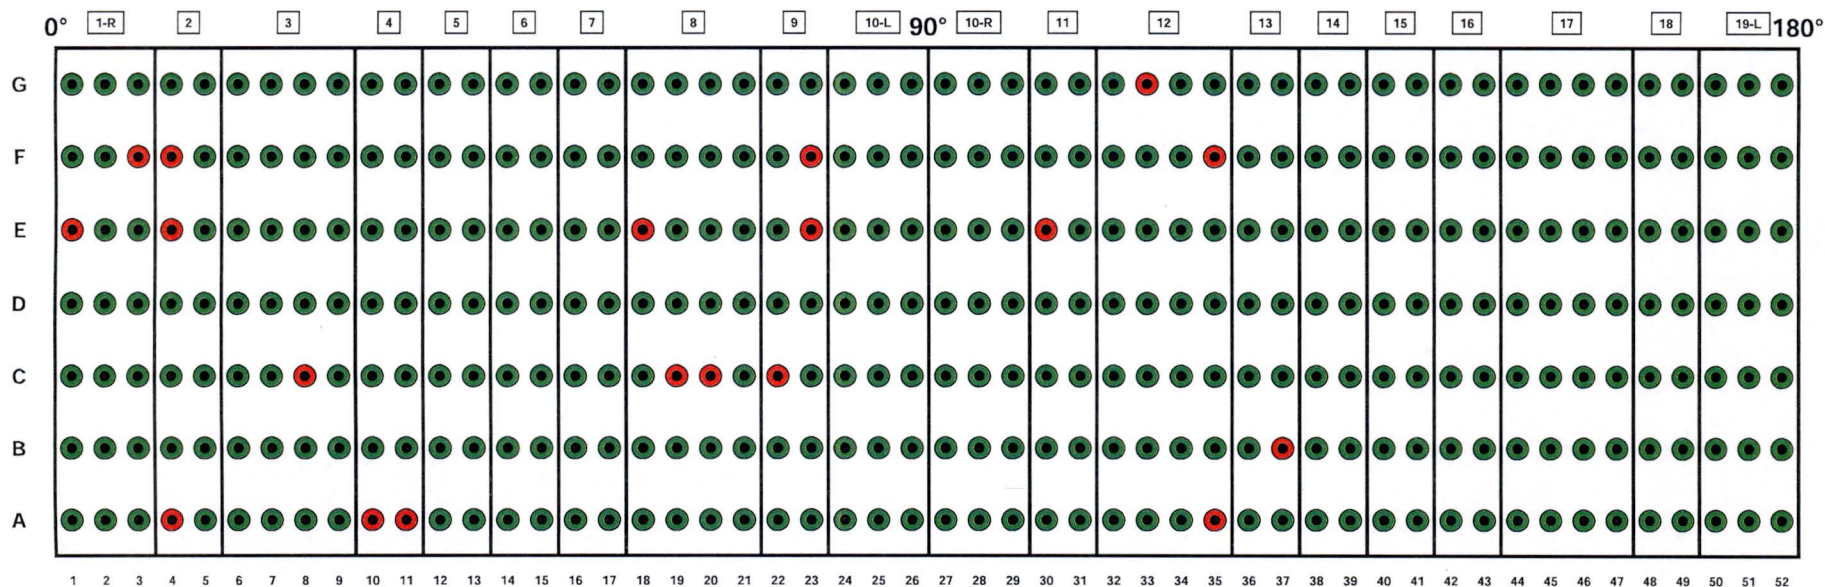
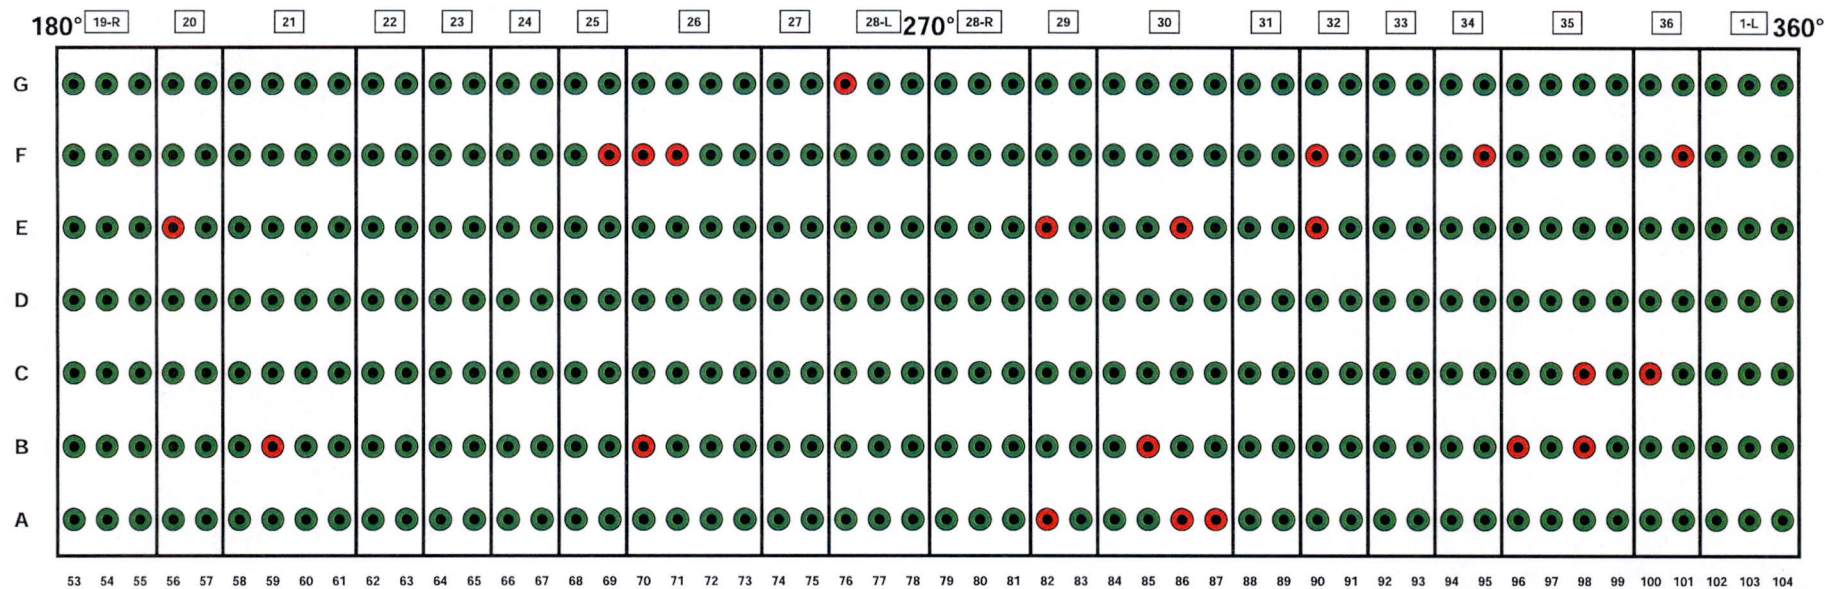
status of 10-23-14 09:38 AM

Item	Examination Method	Required Examination Coverage	Coverage Achieved	Examination Findings (Note 1)
Baffle-Former Assembly Baffle-edge bolts	Visual examination (VT-3)	Bolts and locking devices on high fluence seams. 100% of components accessible from core side (Note 3). See Figure 4-23 of MRP-227-A.	100%	No Relevant Indications
Comments:				
Baffle-Former Assembly Baffle-former bolts	Volumetric examination (UT)	100% of accessible bolts (Note 3). Heads accessible from the core side. UT accessibility may be affected by complexity of head and locking device designs. See Figures 4-23 and 4-24 of MRP-227-A.	728 out of 728 bolts	40 bolts with indications. 688 bolts had no indications. No expansion was triggered. The extent of the bolt failures was bounded by minimum pattern analysis plus margin term per WCAP-17096
Comments: (See attached map.)

- acquisition to do
- no acquisition
- acquisition ok
- retest
- without indication
- with indication
- not testable (UT)
