Subject: **Palo Verde Nuclear Generating Station
Unit 3
Docket No. STN 50-530
Response to Request for Additional Information Regarding Relief
Request 54, Alternative to Flaw Removal**

Response to Request for Additional Information Regarding Relief Request 54, Alternative to
Flaw Removal

TR-FSE-15-3, Rev. 0
Palo Verde Nuclear Generating Station Unit 3
Evaluation of Potential Loose Part for Life of Plant Operation -
Reactor Coolant Pump Instrument Nozzle Weld Fragment

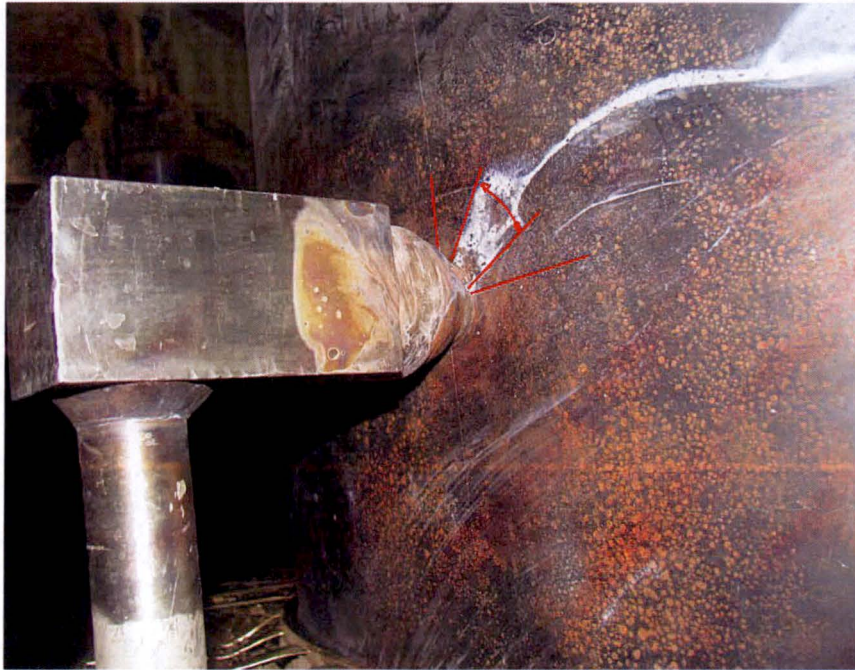
Figure 1
Pressure Instrument Nozzle – Showing Leakage

During the 3R18 PVNGS Unit 3 refueling outage, APS identified signs of leakage (i.e., boric acid) stemming from a pressure instrument nozzle located on the suction nozzle safe-end of the 2A CE-KSB Type 101 RCP. Refer to Figure 1.

The APS repair effort performed a half-nozzle repair to replace the 1-inch instrument nozzle. The modification will replace the external portion of the instrument nozzle and leave in place a short segment of the original nozzle and nozzle weld at the inner surface of the pump suction safe-end (see Figure 2).

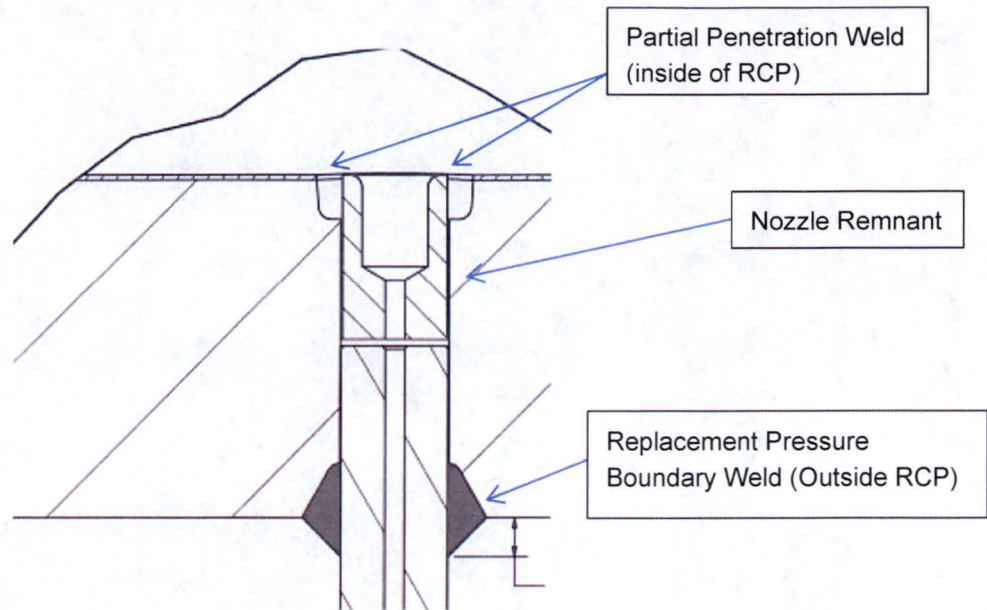
Figure 2
Half-Nozzle Repair Illustration

Because the repair process involved leaving a small remnant of the nozzle inside the penetration, APS asked Westinghouse to address the possibility that portions of the partial penetration weld holding the RCP nozzle remnant in place could further degrade and become a potential loose part inside the RCS before the current planned end of plant life, which is 60 years.

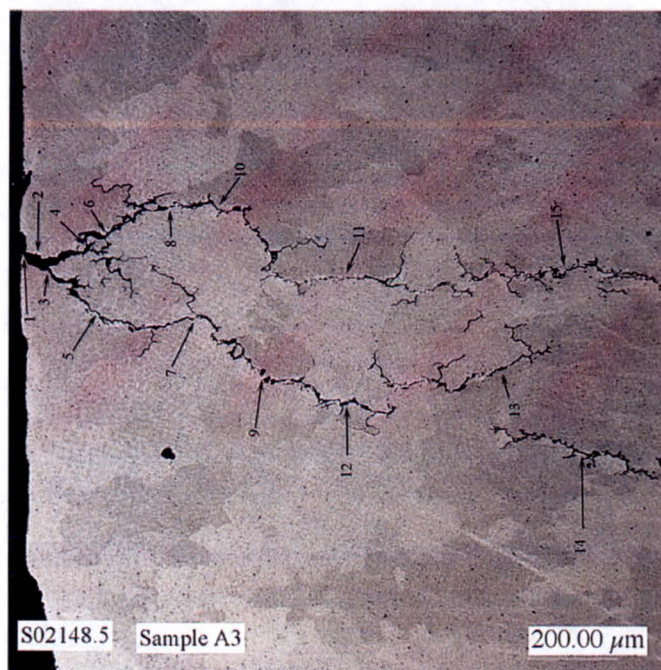
Figure 4
Cross-section of a PWSCC Crack in Filler Metal 82/182 Weld
(from Schuster et al., Reference 8.13)

A single crack propagating through either the weld or the nozzle is very unlikely to produce cracking that could result in the release of free sections of material. PWSCC cracking development results in a tortuous crack path that is mostly observed as a very "tight" array of cracking. It does result in leakage from constraining structures, but does not readily provide for the release of material from constrained sections. Cracking in type 82/182 weld metal, while occurring generally more often than in comparable wrought alloy, is influenced by the dendritic structure of the weld resulting in an even more branched fracture morphology than in the corresponding wrought alloy. Figure 4 shows

the tortuous nature of such a crack. Loss of material sections from such cracking is not observed in practice or during laboratory testing of Alloy 600 or its weld metals.
