Final ASP Program Analysis - Reject

Accident Sequence Precursor Program – Office of Nuclear Regulatory Research			
Callaway Plant, Unit 1		Auxiliary Feedwater Control Valves in Motor Driven Pump Train Inoperable due to Faulty Electronic Positioner Cards	
Event Date: 8/11/2015		LERs: 483-2015-003 and 483-2015-004 IR: 50-483/2015-009	CCDP= 1.1×10 ⁻⁶
Plant Type: Westinghouse 4-Loop PWR with Large Dry Containment			
Plant Operating Mode (Reactor Power Level): Mode 3 (0 Percent Reactor Power)			
Analyst: David Aird	Reviewer: Keith Tetter	Contributors: N/A	BC Approved Date: 6/7/2016

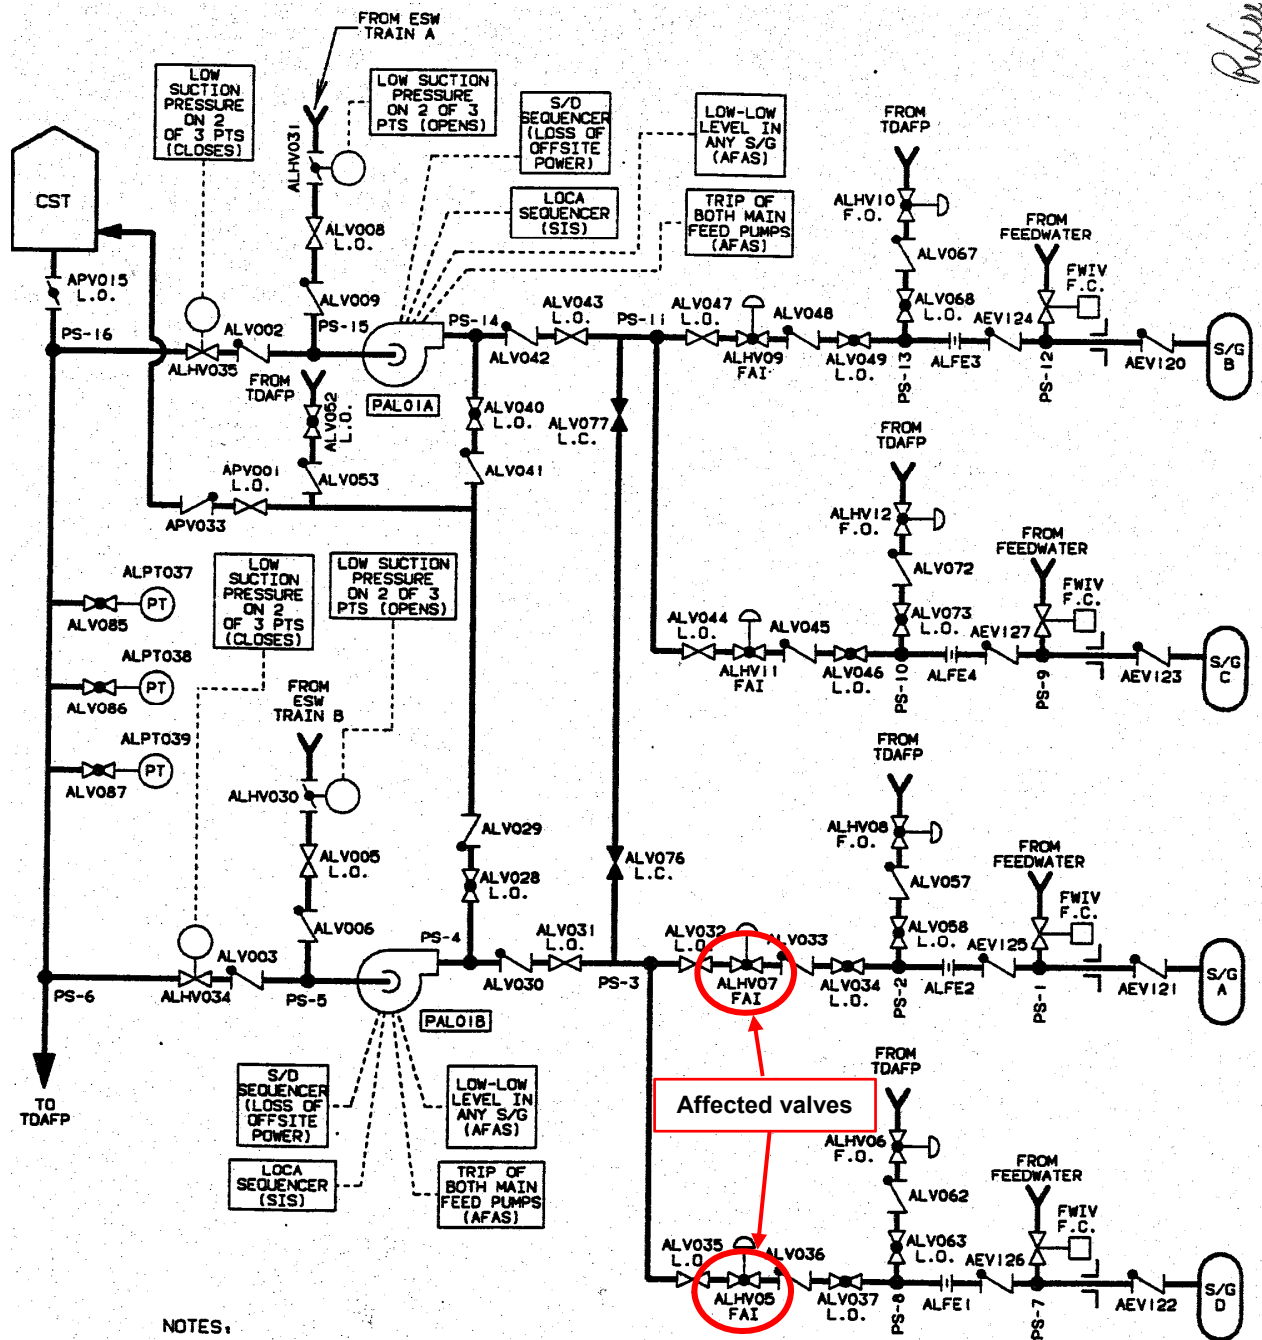
Figure 2: Drawing of Motor-Driven Auxiliary Feedwater Pump Trains for Callaway

As part of the trip response, all four flow control valves (FCVs) in the two MDAFW pump trains closed as a result of the adequate flow supplied by the TDAFW pump. Approximately 300 gpm is required for each steam generator (SG) in this operating mode. The TDAFW pump can provide adequate flow for all of the SGs. See Figure 2 in Appendix C for a diagram of the MDAFW pump trains.

In accordance with normal operating procedures, operator action was later initiated to transfer flow to the MDAFW pumps in order to secure the TDAFW pump. In preparation for securing the TDAFW pump, the operator was unable to reopen MDAFW FCV ALHV0007 from the main control room. A technician was dispatched and partially opened the valve using the handwheel; however, the control room operator was still unable to regain remote electrical control of the valve. The valve was manually closed and declared inoperable. Additional information is provided in LER 483-2015-004 (Ref. 2). Flow to the SGs was maintained by the TDAFW pump. The plant was stabilized in Mode 3 (Hot Standby).

Cause. In 2014, the electronic positioner cards for the four MDAFW FCVs were reverse-engineered for Callaway by a vendor due to obsolescence issues. The electronic positioner cards in the 'B' train MDAFW FCVs (ALHV0005 and ALHV0007) were replaced in late October and early November 2014 with the new reverse-engineered circuit cards. The 'A' train MDAFW FCVs were not modified. It was later identified that the new reverse-engineered circuit cards used bridge rectifiers with a lower than required current rating for the operating conditions. Overloading of the bridge rectifier was experienced. Without the bridge rectifier in the circuit card, remote control of the valve is not possible.

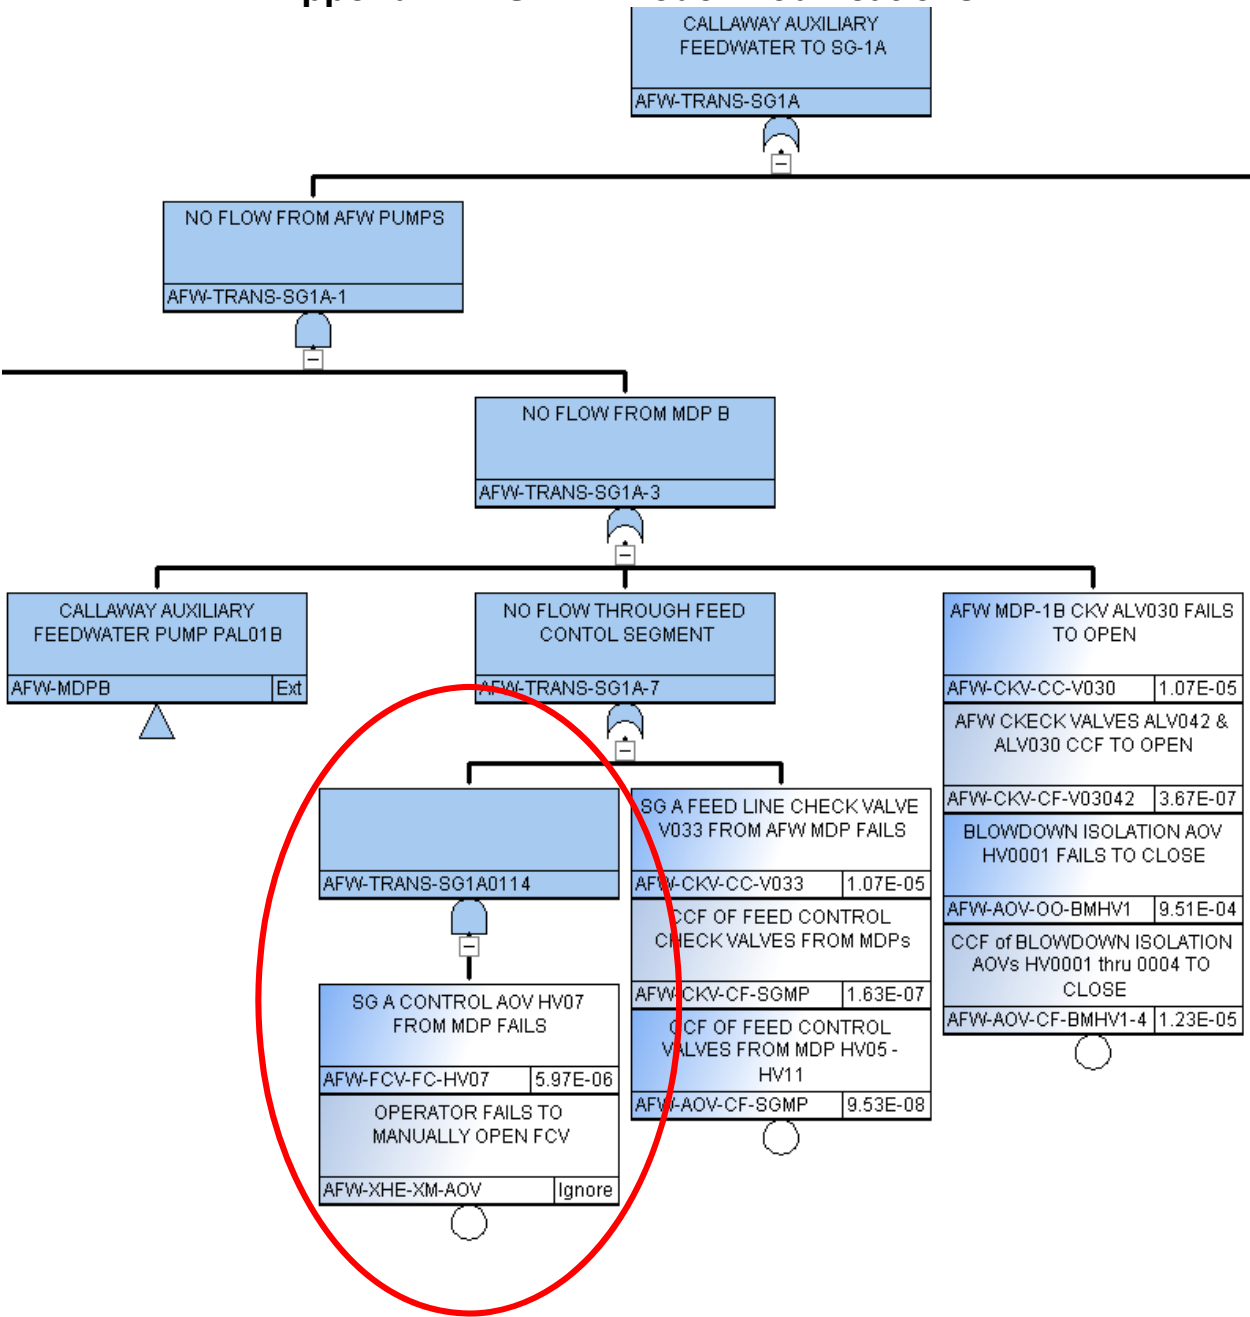
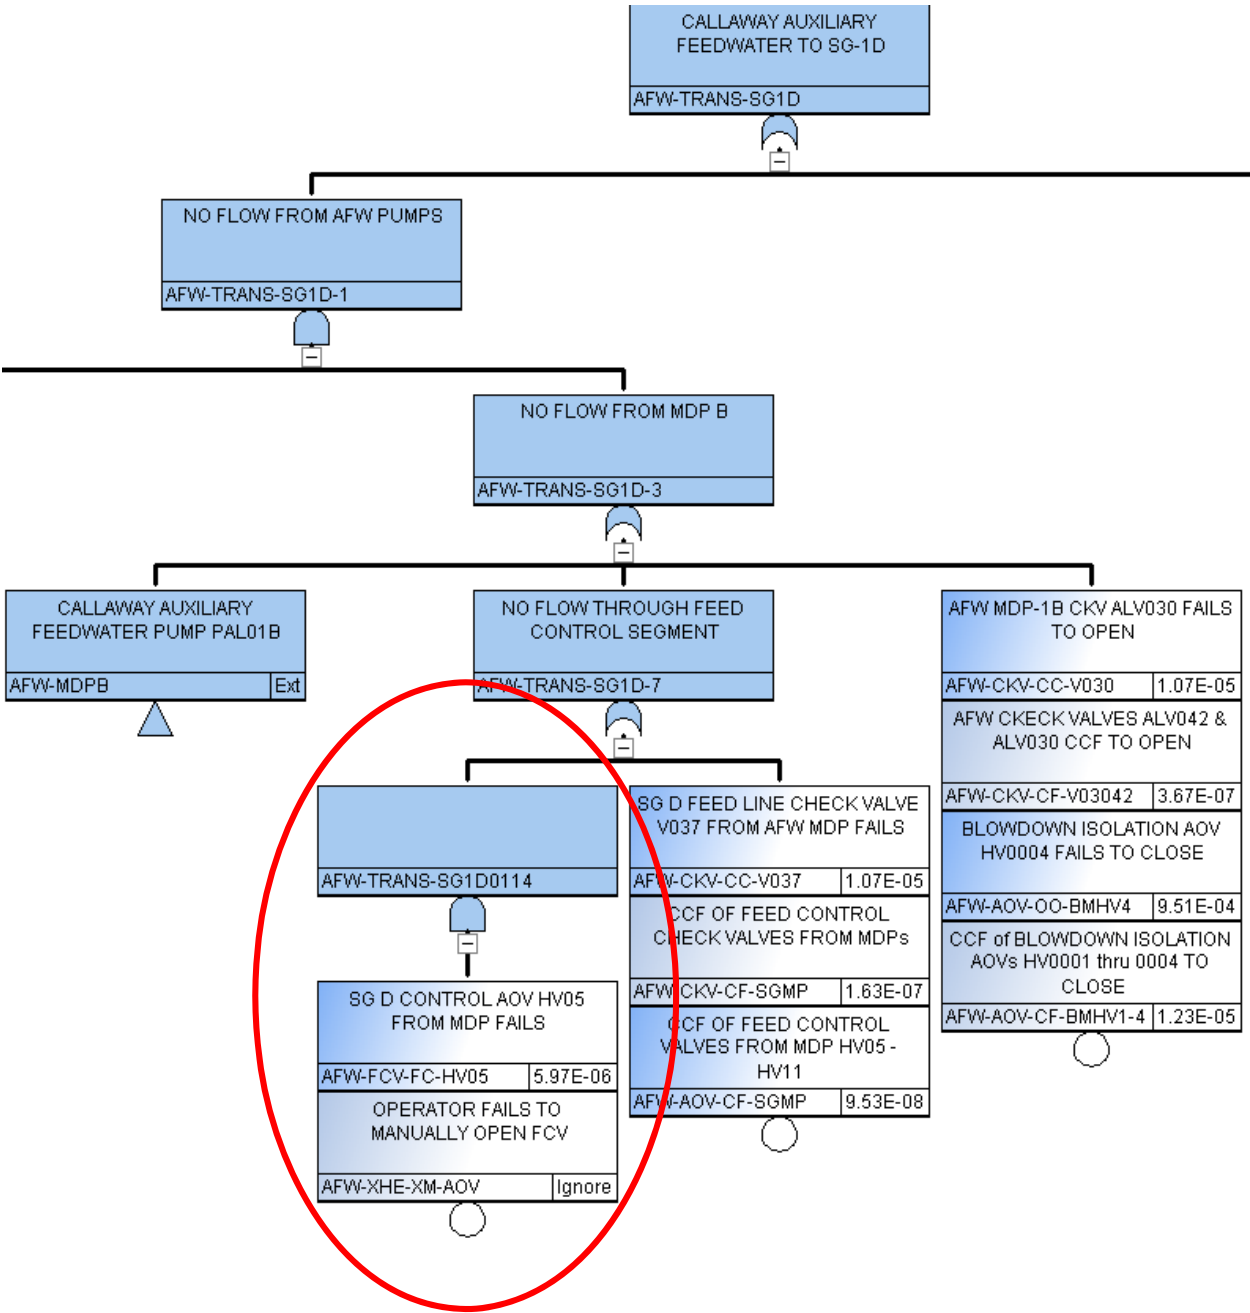
Figure 4: Change to AFW-TRANS-SG1D Fault Tree

SPAR Model Modifications. A new basic event was added to the model and inserted into two fault trees. New basic event AFW-XHE-XM-AOV (*Operator Fails to Manually Open FCV*) was created and set to IGNORE. In the AFW-TRANS-SG1A fault tree, the new basic event AFW-XHE-XM-AOV was inserted under a new AND gate with existing basic event AFW-FCV-FC-HV07 (*SG A Control AOV HV07 From MDP Fails*). Similarly, in the AFW-TRANS-SG1D fault tree, the new basic event AFW-XHE-XM-AOV was inserted under a new AND gate with existing basic event AFW-FCV-FC-HV05 (*SG D Control AOV HV05 From MDP Fails*). Figures 3 and 4 in Appendix D illustrate these changes.

This SPAR model change was required to provide operator recovery credit to manually open and throttle the MDAFW ‘B’ train FCVs in order to provide flow to SGs ‘A’ and ‘D’ if flow from the TDAFW pump is or becomes unavailable. Under the most limiting scenario (design basis accident occurring immediately after plant shutdown when core decay heat is at its peak), operators would have over 45 minutes to open the MDAFW FCV before reaching a critical level in the SG. Procedure OTN-AL-00001, for manually starting the AFW pumps, directs the
