Part 21 (PAR)

PART 21 - NOTIFICATION OF DEVIATION OF K-LINE CIRCUIT BREAKER SECONDARY TRIP LATCH

Subject: 10CFR Part 21 Notification of Deviation re. K-Line Circuit Breaker Secondary Trip Latch

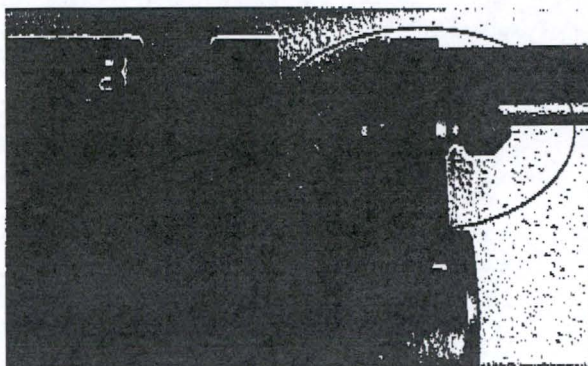
Correct – pin is centered

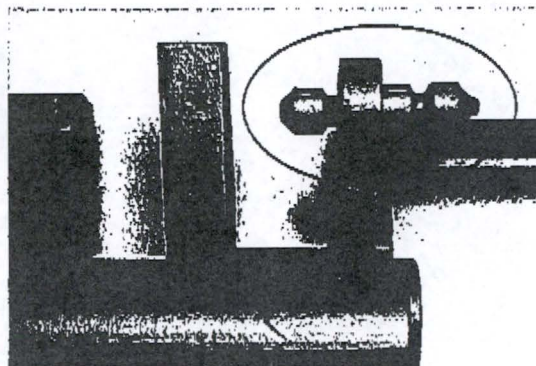
The pin that holds the return spring in place was not properly installed. The defect is believed to have occurred during the assembly process of the latch bar. The latch used in the Prairie Island Nuclear Plant circuit breaker was fabricated in 2013. Please see the photos below for an illustration of the correct, and incorrect, configuration of the pin installed in the secondary trip latch.

Incorrect – pin is not centered

- a. Quarantined and inspected P/N: 716789E00 and 167710T01/167710T03 assemblies in inventory. (Action complete)
- b. Notified vendor of the issue via the ABB Supplier Corrective Action Request process. (Action complete)
- c. Revised Critical Characteristic card for P/N: 716789E00 to incorporate measurement of the pin in question. (Action complete)
- d. Conducted training with QA and Operations personnel for awareness (Action complete)

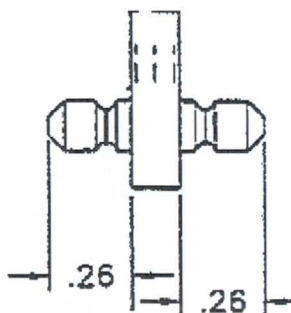
The pin should protrude 0.26 (+/- 0.02) inches out of both sides of the section of the latch bar assembly. Please see the diagram below for a visual representation.

Because of the large potential variety of usages of the potentially affected circuit breakers, ABB (Medium Voltage Service) cannot determine if the potential for a substantial safety hazard exists at any licensee's facility if the circuit breaker fails to operate. It is recommended the Licensees inspect the in-service components at the next convenient maintenance opportunity and components in stock prior to installation.

If the latch is installed on a K-Line circuit breaker, the latch can be inspected from the bottom side of the mechanism without disassembly.
