# MASONRY WALL FAILURE CONSEQUENCE ANALYSIS

GPU NUCLEAR CORPORATION  
OYSTER CREEK NUCLEAR GENERATING STATION

IMPELL CORPORATION  
AUGUST, 1983

Report No. 02-0370-1132

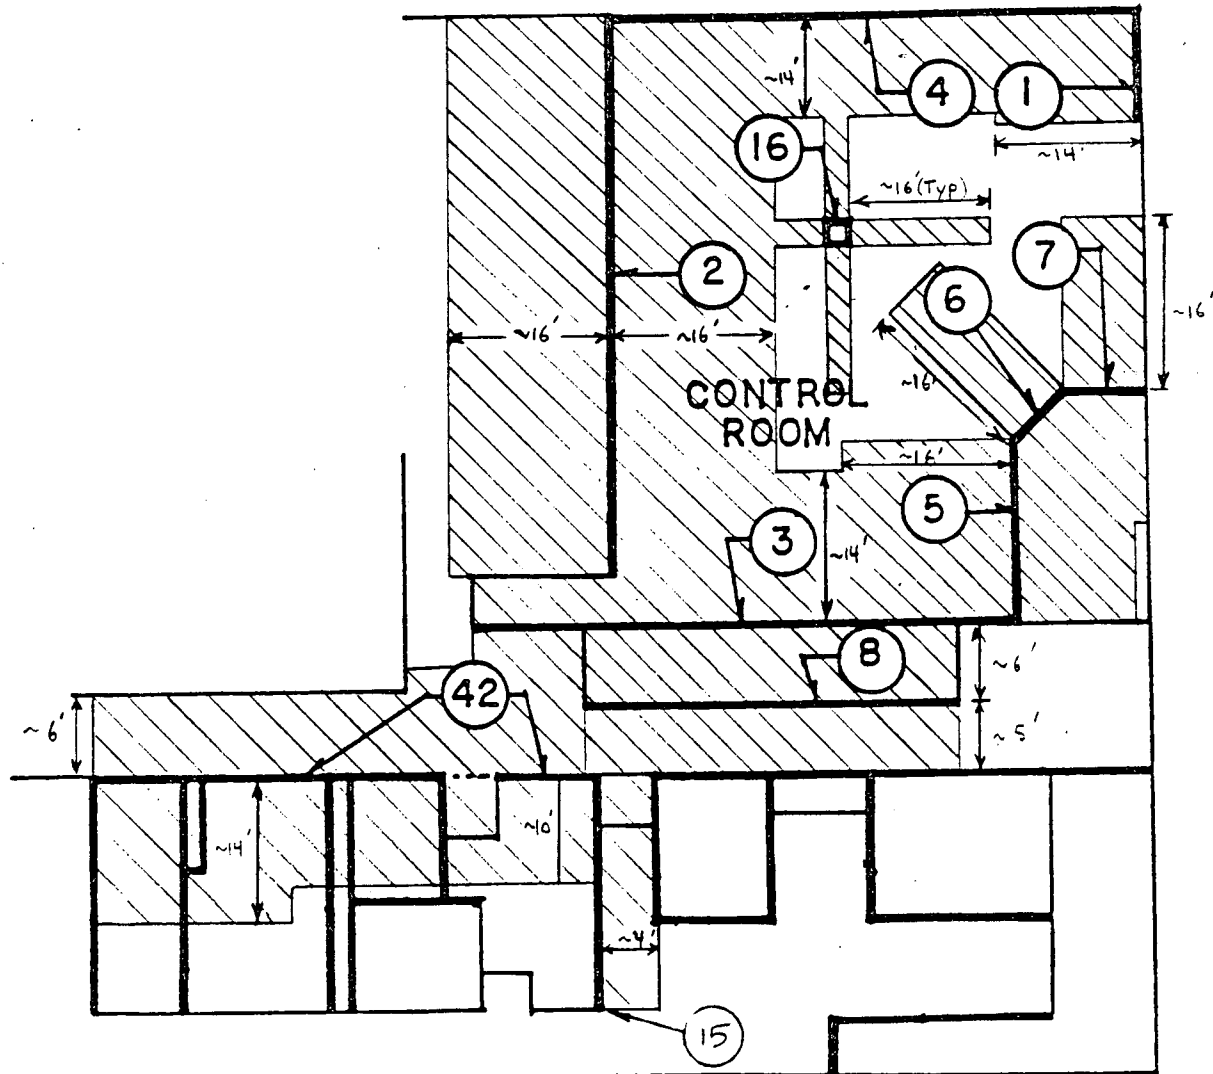
SHADED AREAS INDICATE AREAS OF  
INFLUENCE DEVELOPED BY FAILURE  
OF WALLS 1 THRU 8, 15, 16 & 42.
