Watts Bar Nuclear Plant, Unit 2
Facility Operating License No. NPF-96
NRC Docket No. 50-391

Subject: **Licensee Event Report 391/2016-005-00, Main Feedwater Pump Trip on
Loss of Condenser Vacuum Leads to Turbine Trip and Reactor Trip**

4. TITLE
Main Feedwater Pump Trip on Loss of Condenser Vacuum Leads to Turbine Trip and Reactor Trip

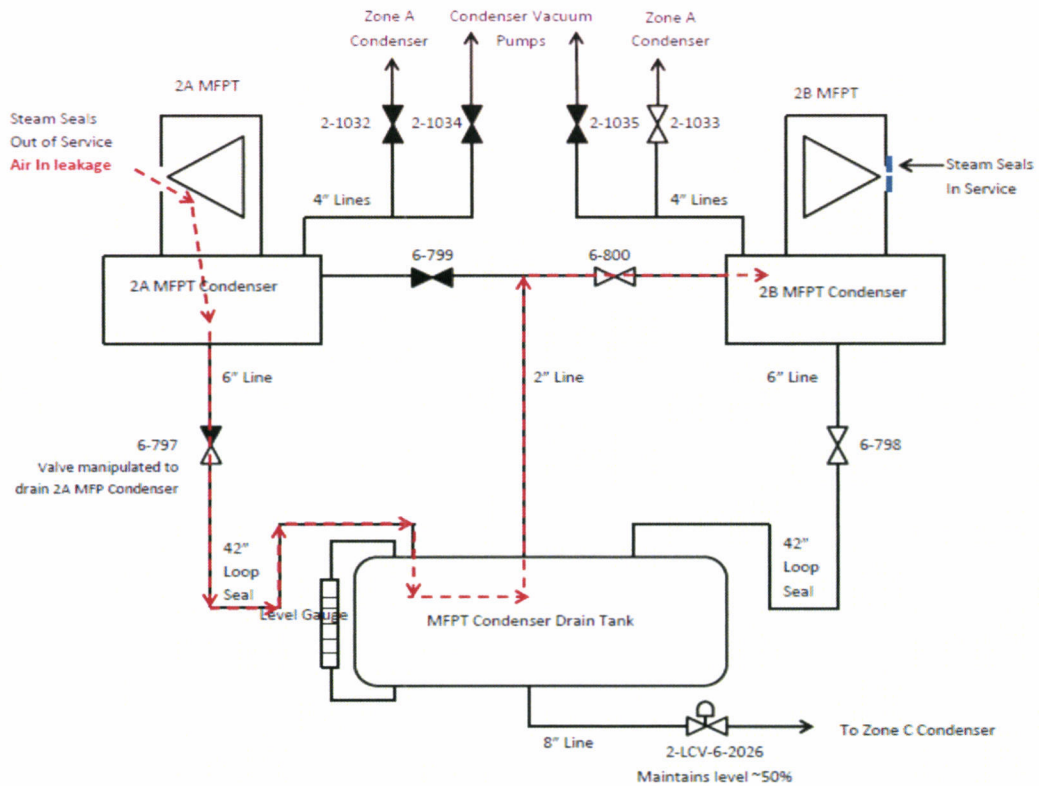
Figure 1

Operations staff did not recognize that, based on the system alignment present shown in Figure 1, that lowering the 2A MFPT condenser below a certain point would cause a loss of vacuum on the 2B MFPT condenser. Additionally, when taking manual control of steam generator water level, the TTDs for steam generator level were already actuated, and operators should have manually tripped the reactor prior to reaching an automatic trip.

The MFPT Condensers for the 2A and 2B MFPs share a common MFPT Condenser Drain Tank. When AUOs drained the 2A MFPT Condenser completely, an air in leakage path was created from the turbine steam seals on the 2A MFPT (steam seals were out of service) through the 2A MFPT Condenser to the MFPT Condenser Drain Tank to the 2B MFPT condenser (see Figure 1). This resulted in a loss of vacuum on the 2B MFPT Condenser and a trip of the 2B MFPT.

U2 Main Feed Pump Turbine Condenser Drain Schematic

The trip was reviewed and the human performance issues that led to this event were identified and coaching provided.

The event is considered a performance issue for operations to precisely control the plant. Additional training in response to this event will be performed.
