**UNITED STATES
NUCLEAR REGULATORY COMMISSION**
REGION II
245 PEACHTREE CENTER AVENUE NE, SUITE 1200
ATLANTA, GEORGIA 30303-1257

EN 52090

**SUBJECT: NUCLEAR REGULATORY COMMISSION AUGMENTED INSPECTION TEAM
REPORT NO. 70-1151/2016-007**

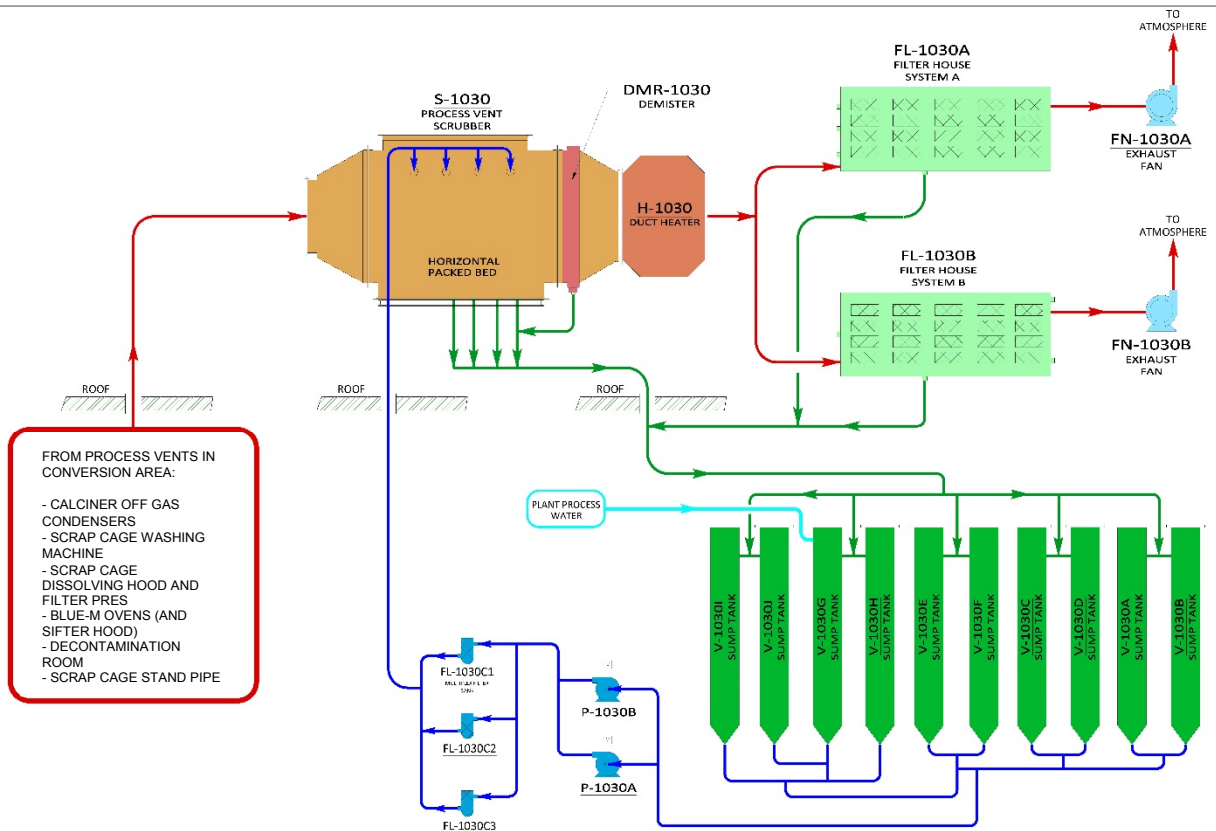
The feed streams all tie together through a network of duct work of various diameters to a large diameter section before entering the transition into the S-1030 scrubber. The large surface area reduces the linear velocity of the incoming stream as it enters the scrubber body. This speed reduction allows for greater reaction time between the scrubber solution and the incoming streams. The scrubber body contains a specialized packing to increase the surface area of the scrubber liquid. The increase in surface area allows for more absorption of gaseous contaminants into the scrubber liquid. The following diagram provides a visual representation of the S-1030 scrubber and related feed streams; this diagram does not show the inlet spray nozzles.

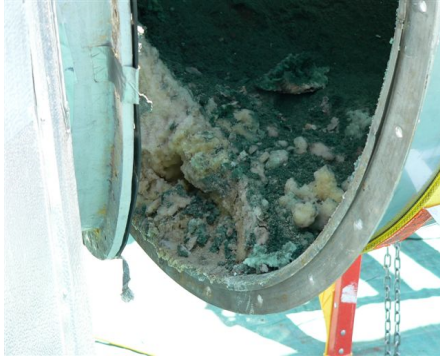
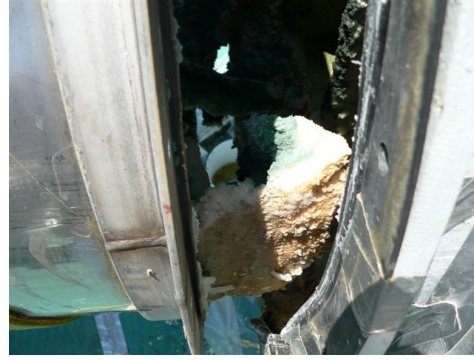
2007	<ul style="list-style-type: none"> • <i>S-1030 Transition Piece and elbow removal Clean-out indicate significant build up</i>

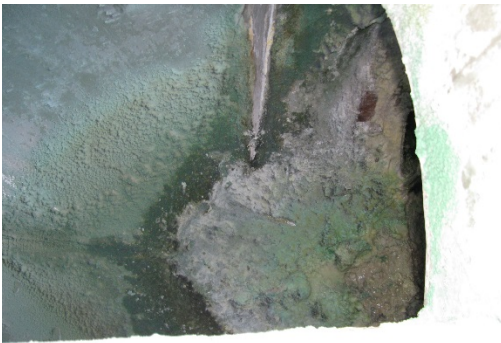
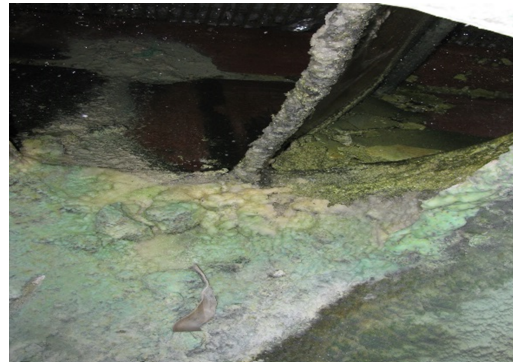
- S-1030 Transition and inlet elbow cleanout
- 5/5/09**
- High U material was removed (but less than the 1956 kg U limit at the time)
(WO 479924)

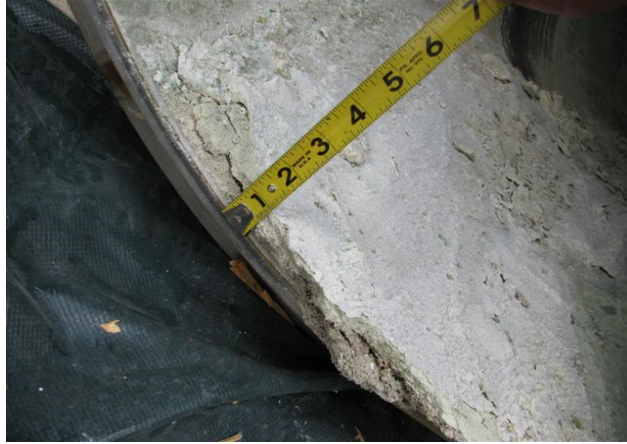
May 27, 2016 Inlet Transition Elbow

-
- Annual outage (Shutdown); planned annual scrubber clean-out;
 - Removed 6-7 polypacks of material from the right and left side of the transition section. Removed 2.5 additional 55 gallon bags of contaminated packing (tellerettes). Pressure washed the transition sections and some of the bottom of the packing. Identified a buildup of material in the center section of the transition that will need to be cleaned out – appears to be 5-7 polypaks worth of material. Recommend dropping the elbow to gain access to the center.
 - Red Book Item 71195 indicating 5-7 popcorn buckets; Criticality safety evaluated this accumulation and stated it did not challenge the safety basis.

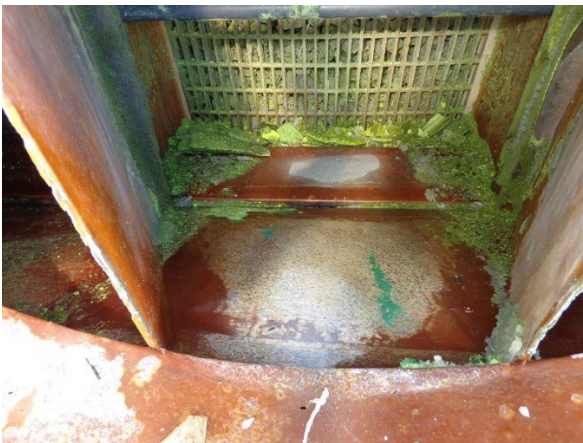
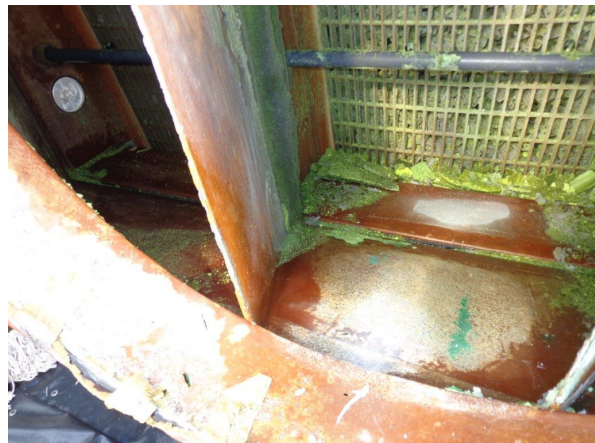
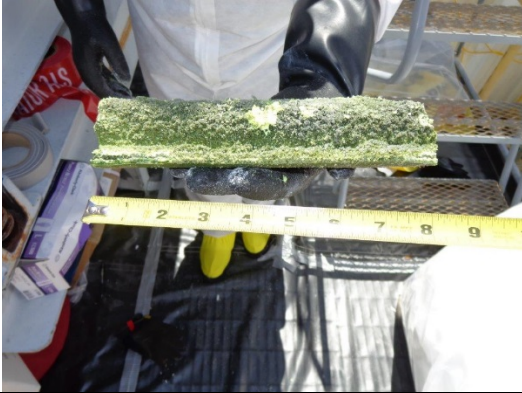
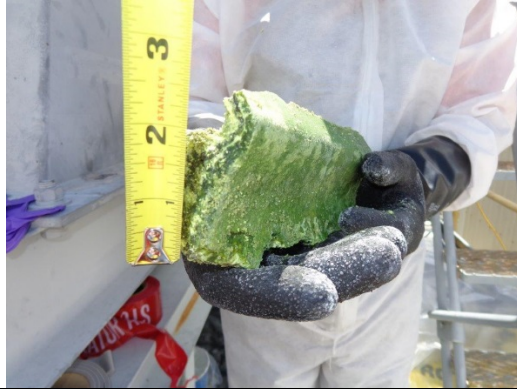
- Process engineer provided weights and uranium concentration results of the first 7 samples to NCS Engineer and NCS Manager.
-
- 5/31/16**
- Westinghouse removed inlet elbow and began removing material from center section of inlet transition.

6/1/16	<ul style="list-style-type: none"> • A total of 36 popcorn buckets of material were removed from inlet transition for a total of 197 kgs (net weight) of wet, green sludge, and solid green chunks and 1 popcorn bucket of material removed from inlet elbow. • Process engineer received additional uranium concentration sample results.
6/2/16	<ul style="list-style-type: none"> • Process Engineer received the remaining uranium concentration sample results. • Discovery that “popcorn” buckets not dimensionally verified (failed IROFS) which resulted on NRC Event Notification (EN) 51974 • S-1030 scrubber was restarted.
6/20/16	<ul style="list-style-type: none"> • Red Book 71195 was updated stating that the total accumulation removed weighed approximately 463 lbs (gross weight) • Material from 37 buckets placed in 22 cream cans to be dissolved for isotopic analysis
6/21/16	<ul style="list-style-type: none"> • Personnel changes (New acting NCS manager)
