Subject: 2016 Annual Pond Inspection Report
Source Materials License SUA-1534
Docket Number 40-8943

**CROW BUTTE MINE
DAWES COUNTY, NEBRASKA**

2016 POND INSPECTION REPORT

By: David V. Coe, PE
Nebraska Registration No. E - 4295

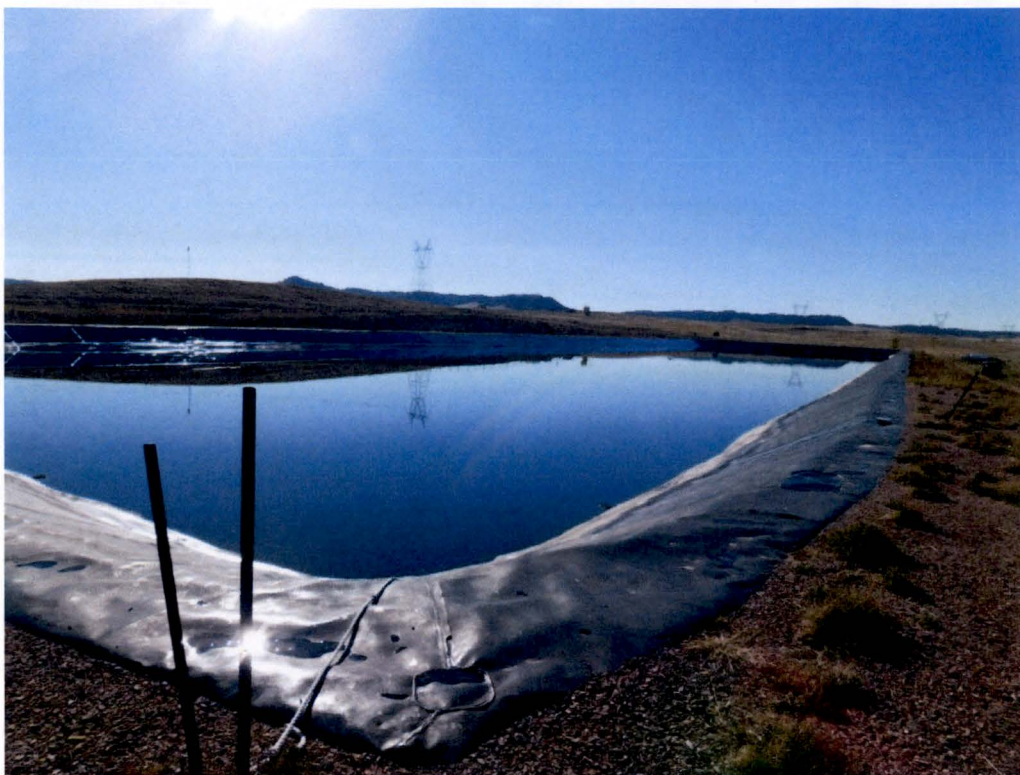
#1 Southeast view of evaporation pond #1, date: 10/07/16

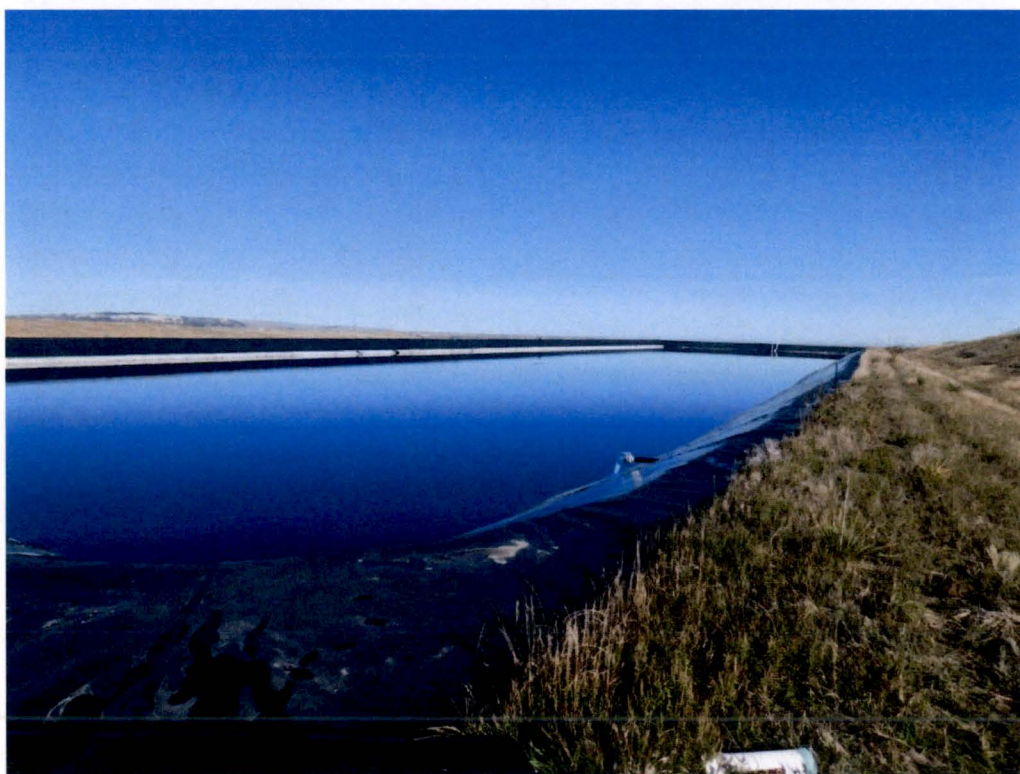
#2 Northwest view of pond #1. Date: 10/07/16

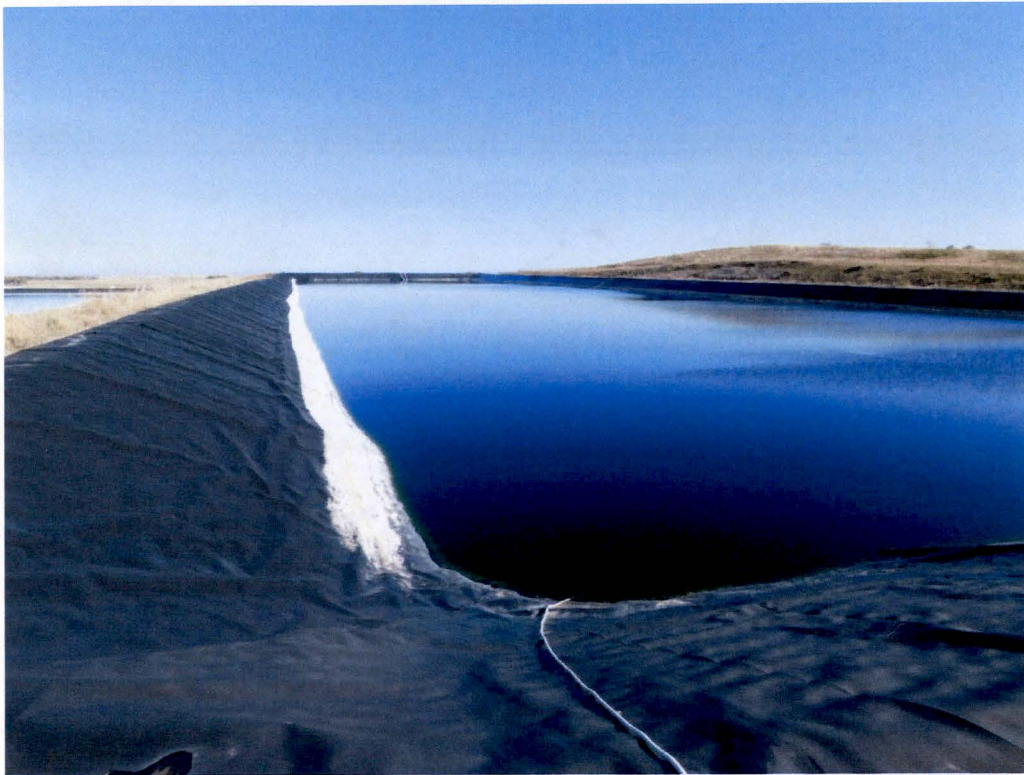
No problems in the existing embankment alignment or sloughing were detected during the visual inspection of the ponds, diversion ditches and embankments. There were no signs of seepage in the embankments or at the toe of the embankment slopes. The drainage channel between ponds 3 & 4 is in good shape. The drainage off the road along the northeast corner of Pond #1 is in good shape, but there was some slight erosion beginning to show up.

Northeast view of pond #1. Date: 10/07/16

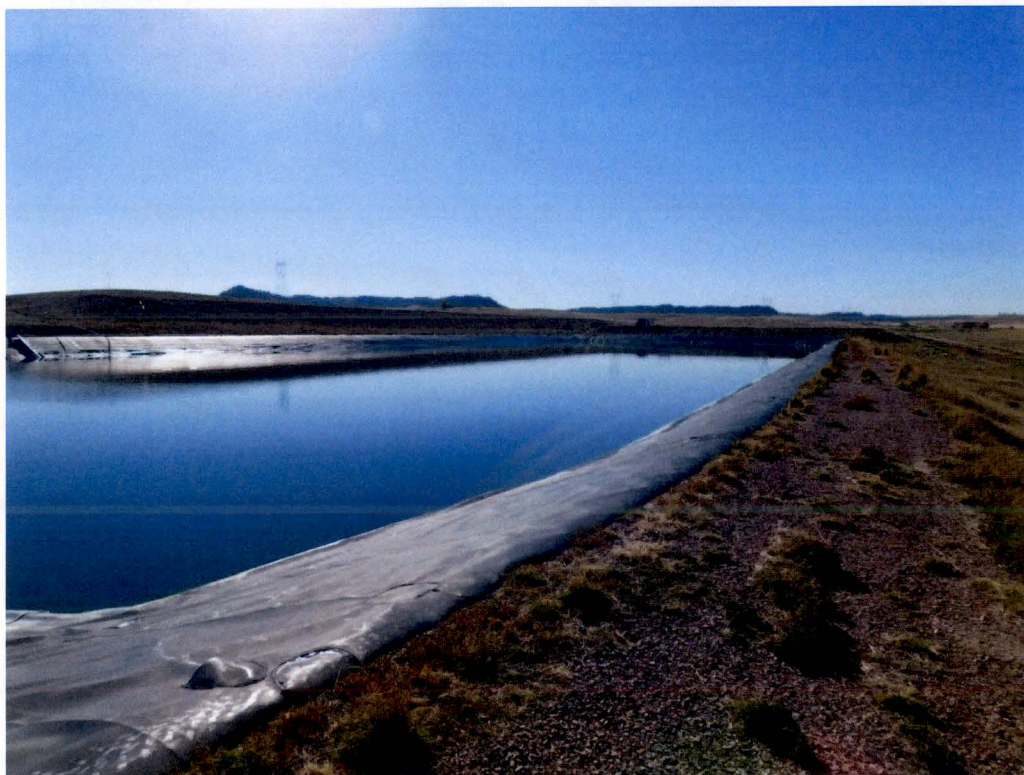
Southeast view of Pond #3. Date: 10/07/16

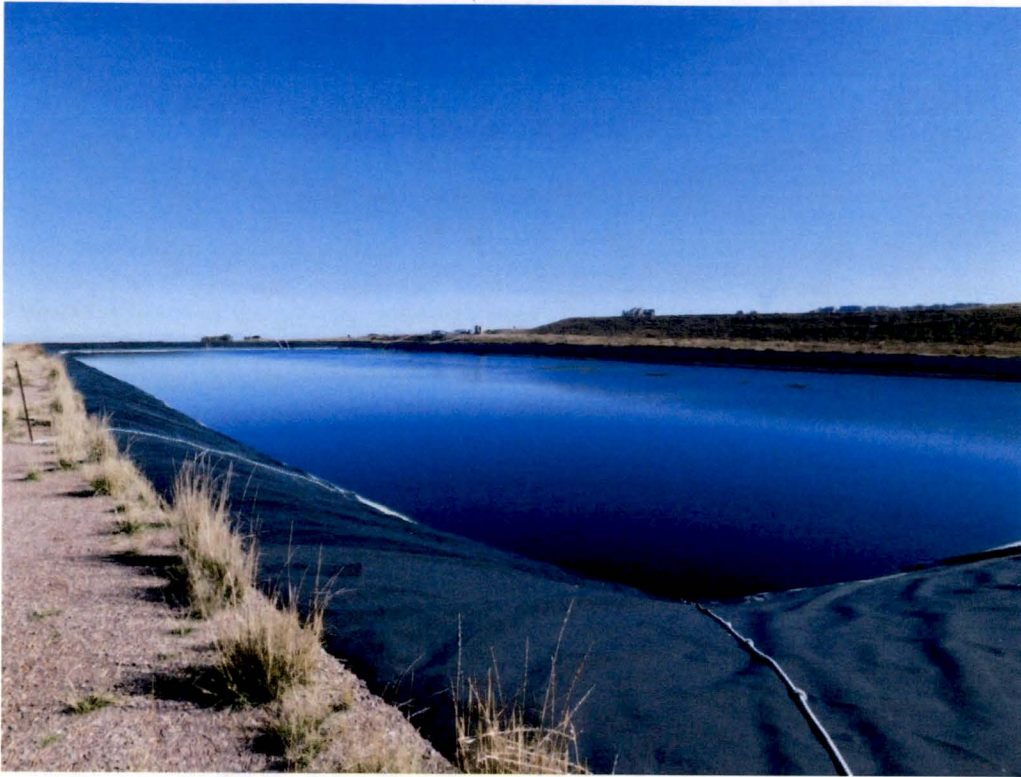
We then began inspection of pond #3 at the northeast corner and walking to the west and then along the west embankment of pond #3. The vegetation is excellent on the fill slopes of pond #3. There was no evidence of leaking along the toe of the exterior embankment. The pond water depth was 8.3 leaving 9.2 feet of freeboard.

Northeast view of Pond #3, about 9.2' of free board. Date: 10/07/16

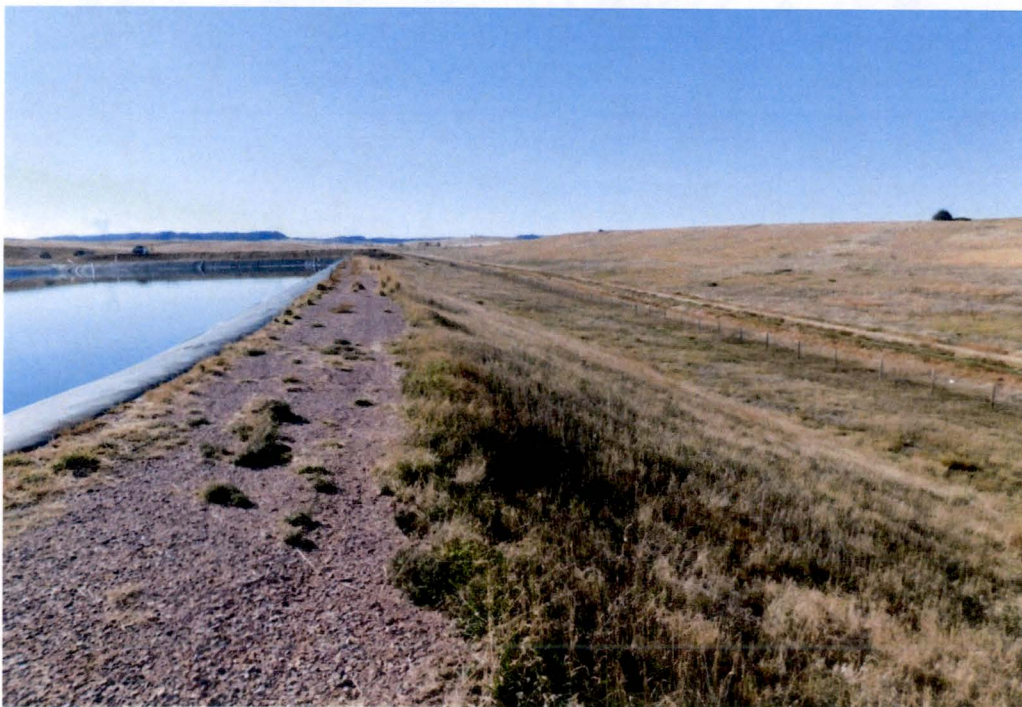
I reviewed the vegetation establishment and drainage between ponds #3 & #4. This has been graded to drain and there were no standing water between the two embankments. The riprap embankment of the slope below the two ponds is in good shape. The vegetation between the two ponds was excellent. I did not notice any sloughing along the west embankment slopes of pond #3 and #4.

West embankment of Pond #3 Date: 10/07/16

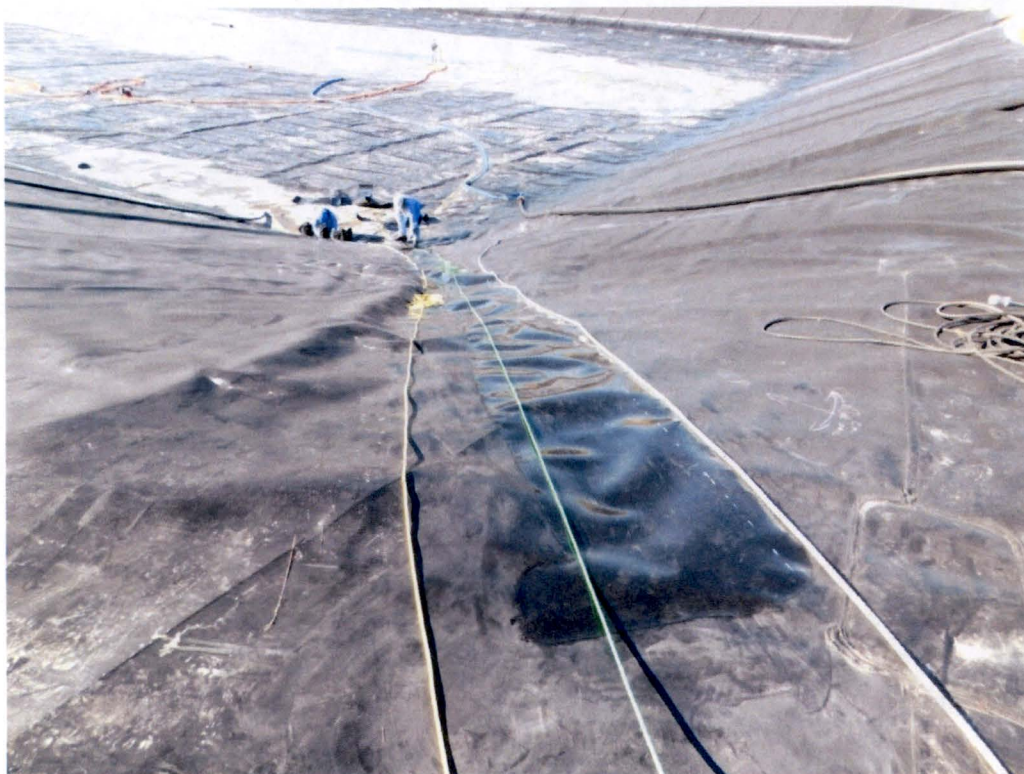
The pond depth of #4 was zero, leaving 17.5 feet of freeboard. Colorado Liner Company was at the site making repairs to the top liner. The liner company was installing a liner extension near the northeast corner of the pond. This attachment was along the vertex of the northeast corner. A Crow Butte crew was vacuuming sediment from the pond bottom. They were also removing rain water which had collecting near the center bottom of the pond. This sediment is transported to the Research & Development ponds for disposal.

Southwest view of Pond #4. Colorado Liner Co. repairing liner. 10/07/16

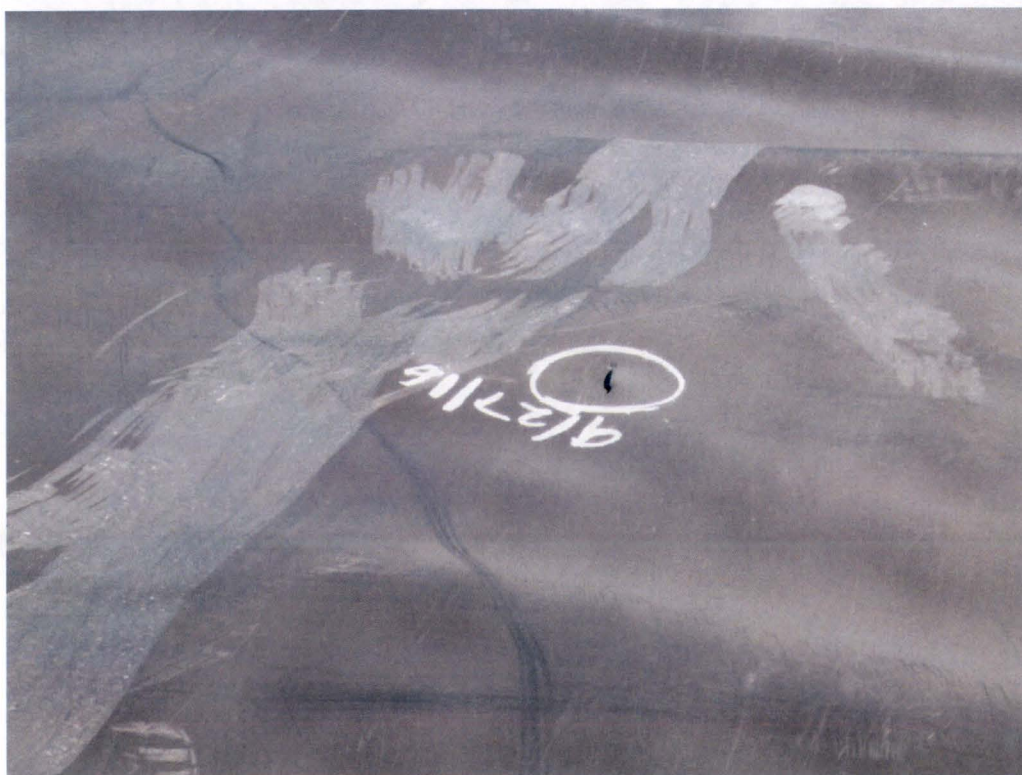
The spray heads used for evaporation were operating in Pond #3. The Mine experienced a liner leak in Pond #3 sometime around the month of May, The Mine have been running weekly tests on the monitoring wells since the leak took place.

Small rip in liner of pond #3: Date: 10/07/2016

On the west berm of pond #1 there is vegetation mixed with a limestone gravel surface. The vegetation is good. The vegetation along outside slope of the pond is good and well established. I did not see any evidence of sloughing along the embankment of Pond #1. I did not observe and evidence of gopher activity, but Walt indicated they have had some problems with gophers. Minor gopher control is currently accomplished by hand with Crow Butte employees, about on a weekly basis. The sheet erosion along the east cut bank, middle part of pond did not change much since the last inspection. There is still evidence of sheet erosion, but no significant change since 2015. There are no signs of leaks along the toe of the dam embankment. There was a small liner tear on the interior slope of the west bank liner. The tear occurred when the crew was lowering the sprinkler system into the pond. Walt indicated that the original sprinkler heads were brass and they are changing the sprinkler heads to Teflon which will be less likely to tear the pond liner. The Mine worker made a temporary patch on the tear and Walt plans to have Colorado Liner Company install a larger permanent patch over the small rip in the liner.

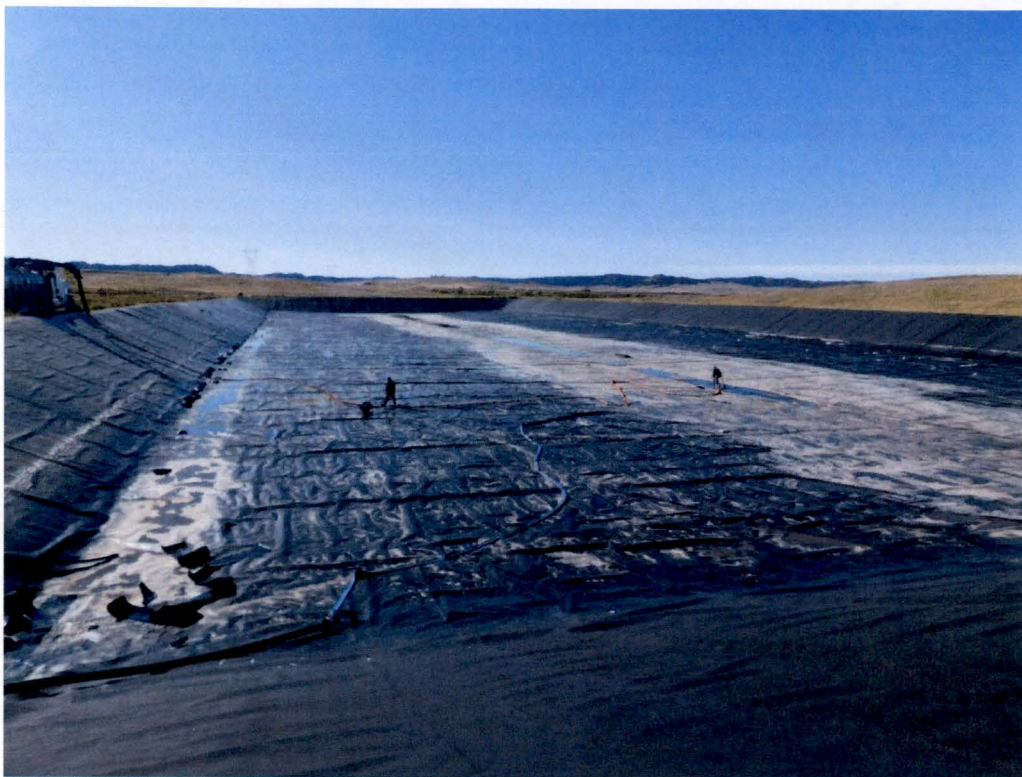
South view of Pond #4, 10/07/2016

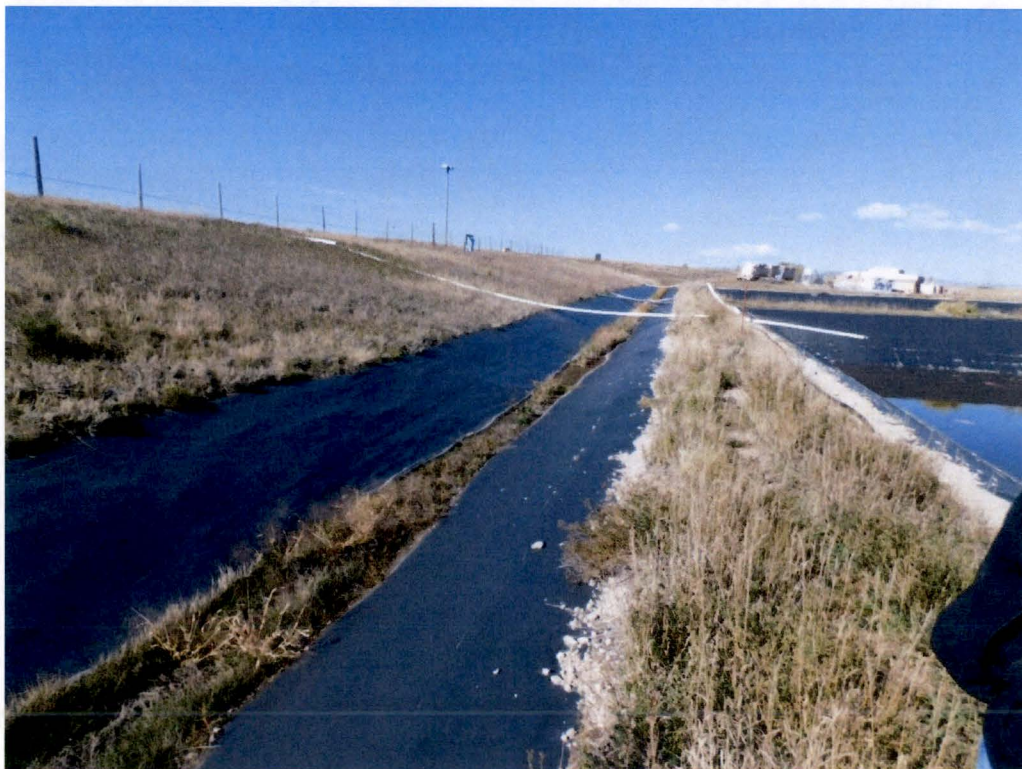
The pond depth in the east pond was 7.9' leaving a free board depth of 7.1'. The west pond depth was 6.9 feet leaving a freeboard of 8.1 feet. I noticed CBR was storing water in these ponds between 5 to 9 feet. This leaves about 6 to 10 feet of freeboard. The two ponds have a cutoff dike on their south side. The cut off dike does not drain and there was no standing water in the bottom of the trench. This has occurred occasionally during the past eight years. The cut-off dike is lined. There is vegetation in the bottom of the cut off dike. I haven't noticed any significant change in the cut off dike for the last nine years.

View of diversion ditch on the south side of the R & D ponds. Photo taken 10/07/16

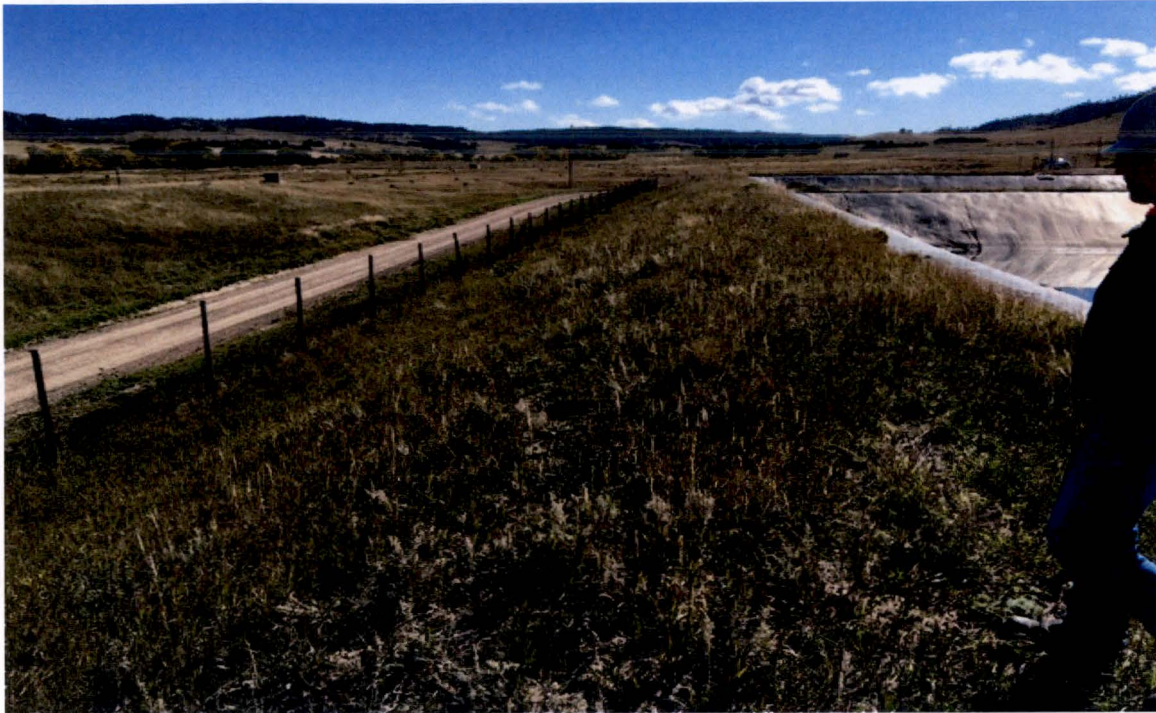
North embankment slope of R & D ponds; Good vegetation. 10/07/16

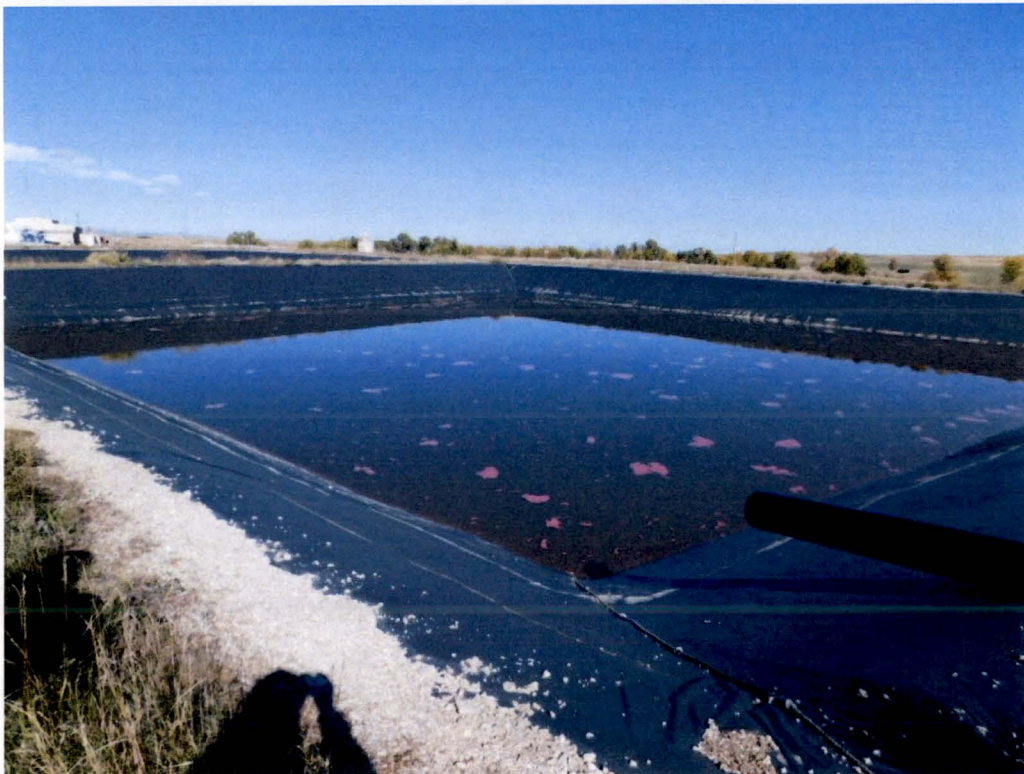
One could see a slight blue tint in the water stored in the west pond. Walt indicated a blue dye is used in the storage water to enhance the rate of evaporation. I noticed some red patches of sediment on the surface water on the east pond. The Crow Butte crew is washing the sediment towards the center of the pond so they can maintain about three foot of water cover over the sediment build up in the R&D ponds. There was a dumping

Northwest view of East R&D pond, 10/07/16

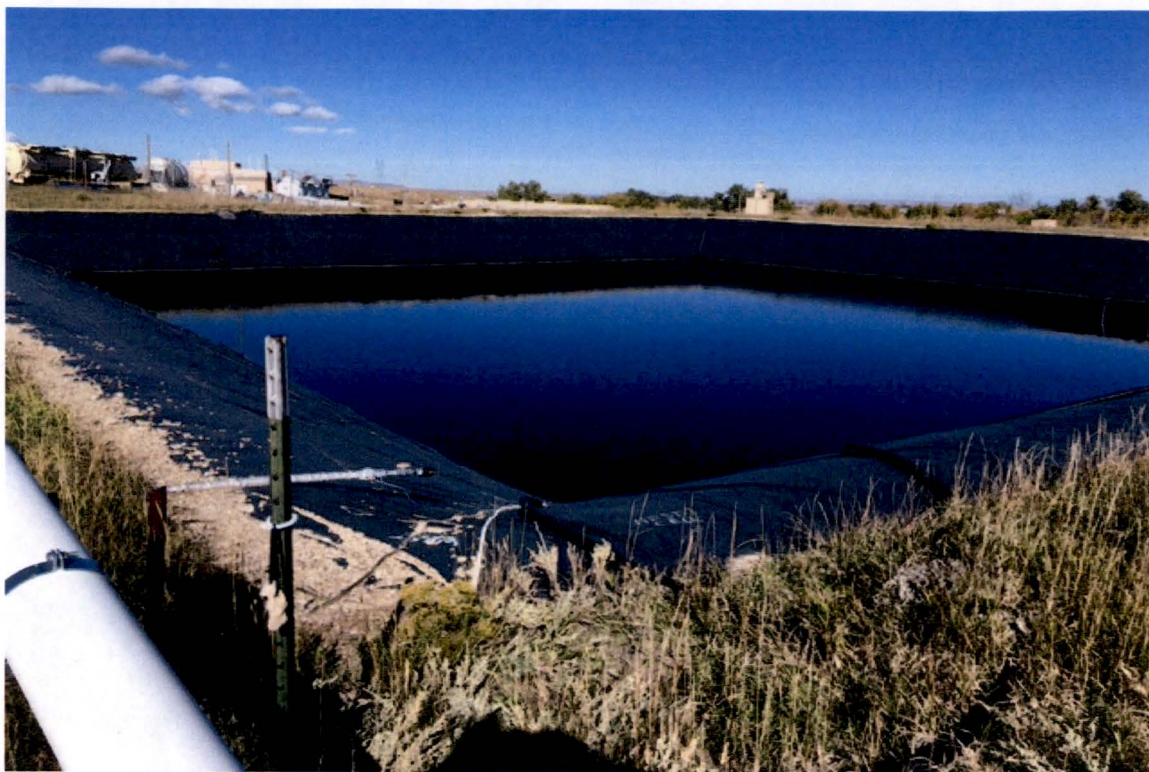
Northwest view of R&D ponds, west pond in foreground, 10/07/16

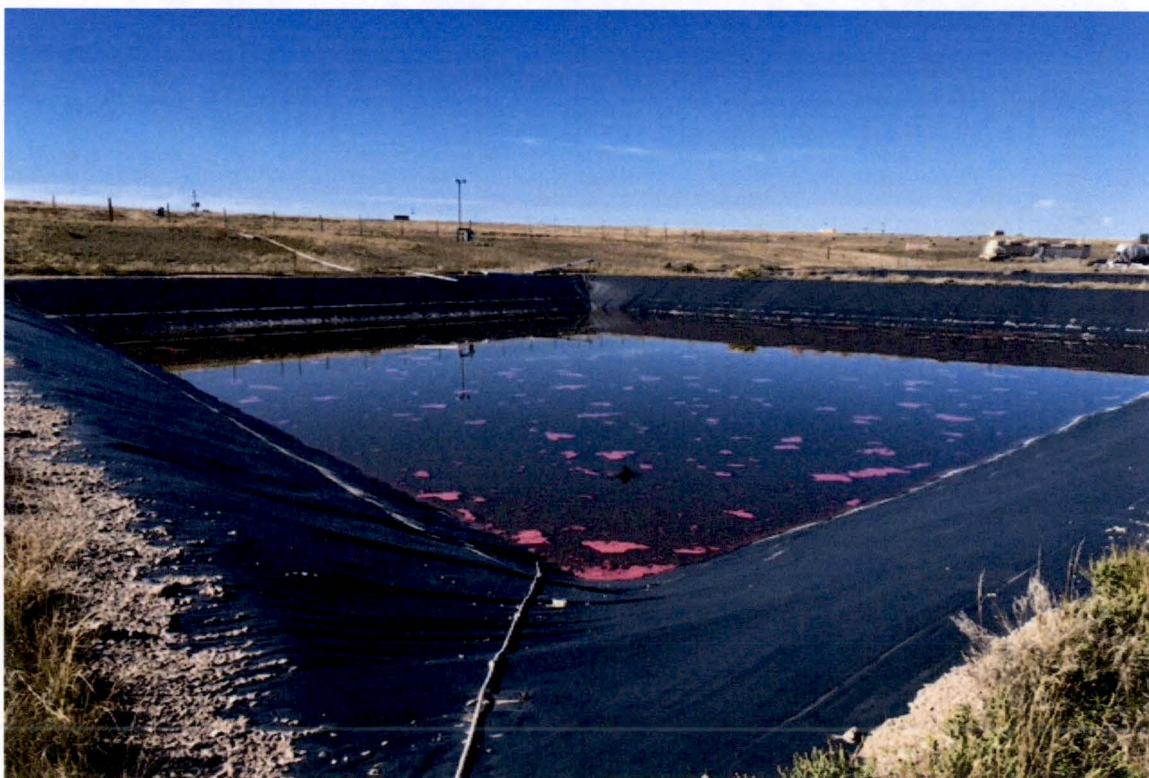
Southwest view of east cell, R & D Ponds, 10/07/16
