Enclosure C  
L-16-327

Technical Basis for Optimization or Elimination of Liquid Penetrant Exams  
for the Embedded Flaw Repair, Beaver Valley, Unit 2,  
Letter LTR-PSDR-16-008-NP, Revision 0, dated October 2016  
(Nonproprietary Version)

# **TECHNICAL BASIS FOR OPTIMIZATION OR ELIMINATION OF LIQUID PENETRANT EXAMS FOR THE EMBEDDED FLAW REPAIR BEAVER VALLEY UNIT 2**

October 2016

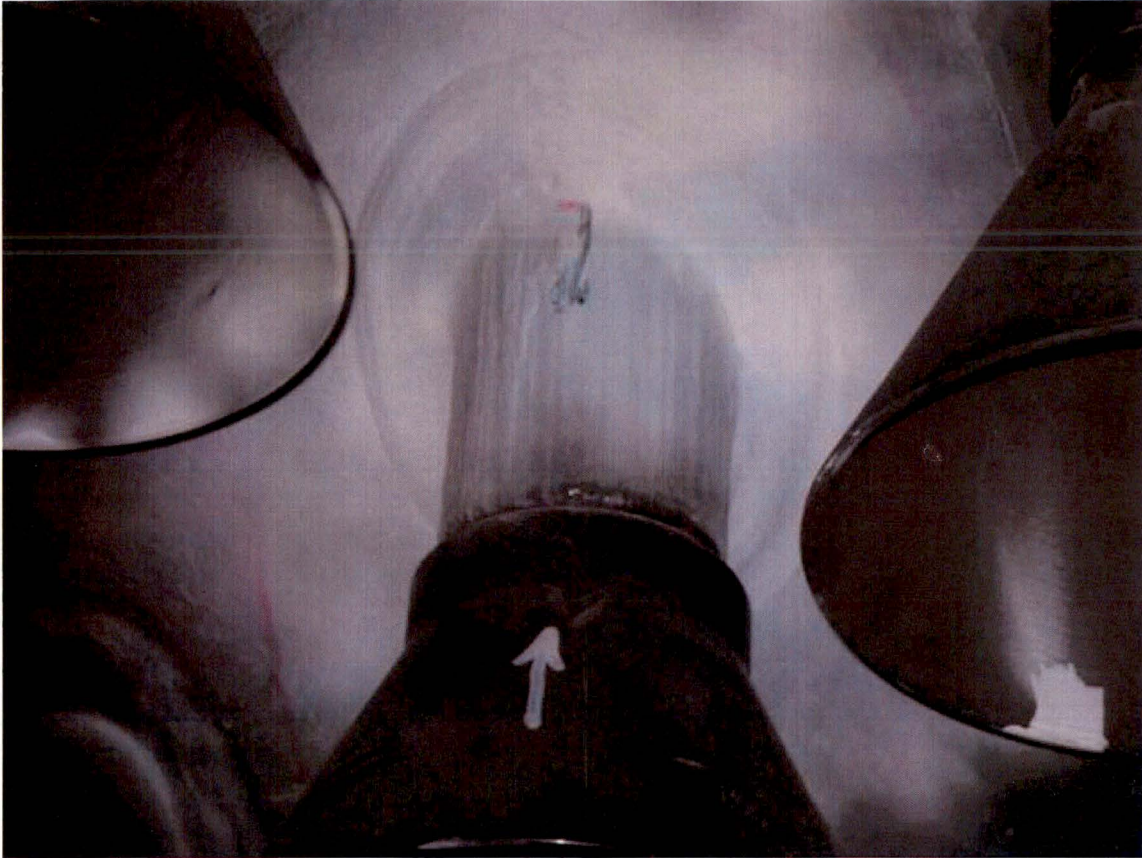
A similar situation may occur in areas where separate weld passes/beads join together. These areas often constitute geometric discontinuities, and (as explained previously) can cause penetrant to become entrapped. Operating conditions may cause minor additional changes in the surface geometry in these locations, and these slight changes can increase the risk of penetrant entrapment. An example is shown in Figures 1 and 2. These changes may then preclude effective cleaning during subsequent PT examinations. When these situations occur, metal removal is typically required to smooth the area, and restore a configuration suitable for PT acceptance. Again, these minor configuration changes do not constitute weld failure of the EFR; they constitute only a condition warranting surface conditioning to facilitate the PT process, thus confirming the integrity of the weld. This situation is the most common source of indications which are found in subsequent PT inspections. Since the OD of the head penetrations near the J-groove weld is located in a very high dose region, subsequent surface preparation by grinding has a significant impact on personnel radiation exposure, and is only performed when absolutely necessary to facilitate the PT process.

**Figure 1: Example of an indication at the boundary of the vertical weld passes on the penetration tube, and the elliptical weld passes on the head**

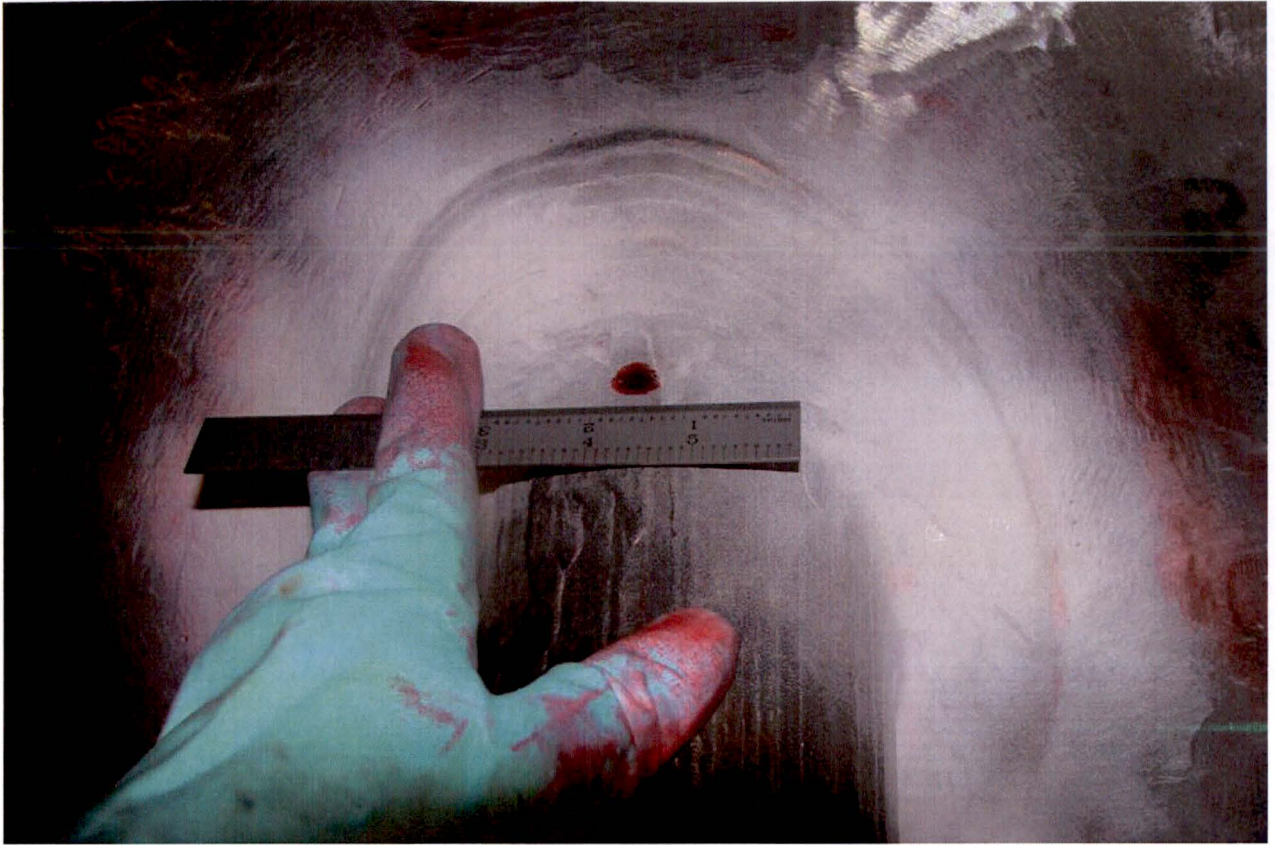
**Figure 2: Closer View of the indication of Figure 1**

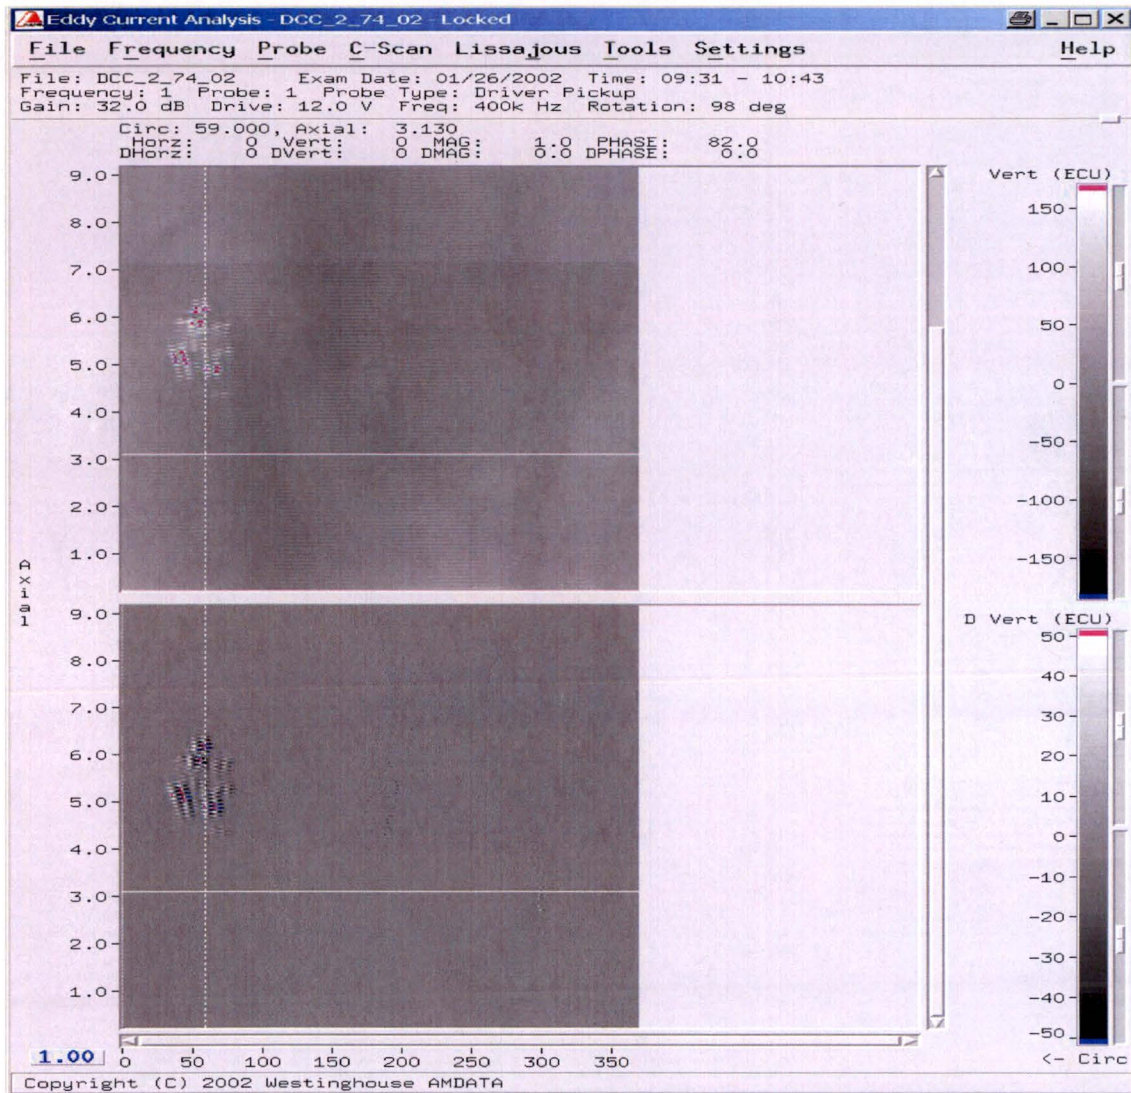
**Figure 1**  
**ECT View of Craze Cracking**

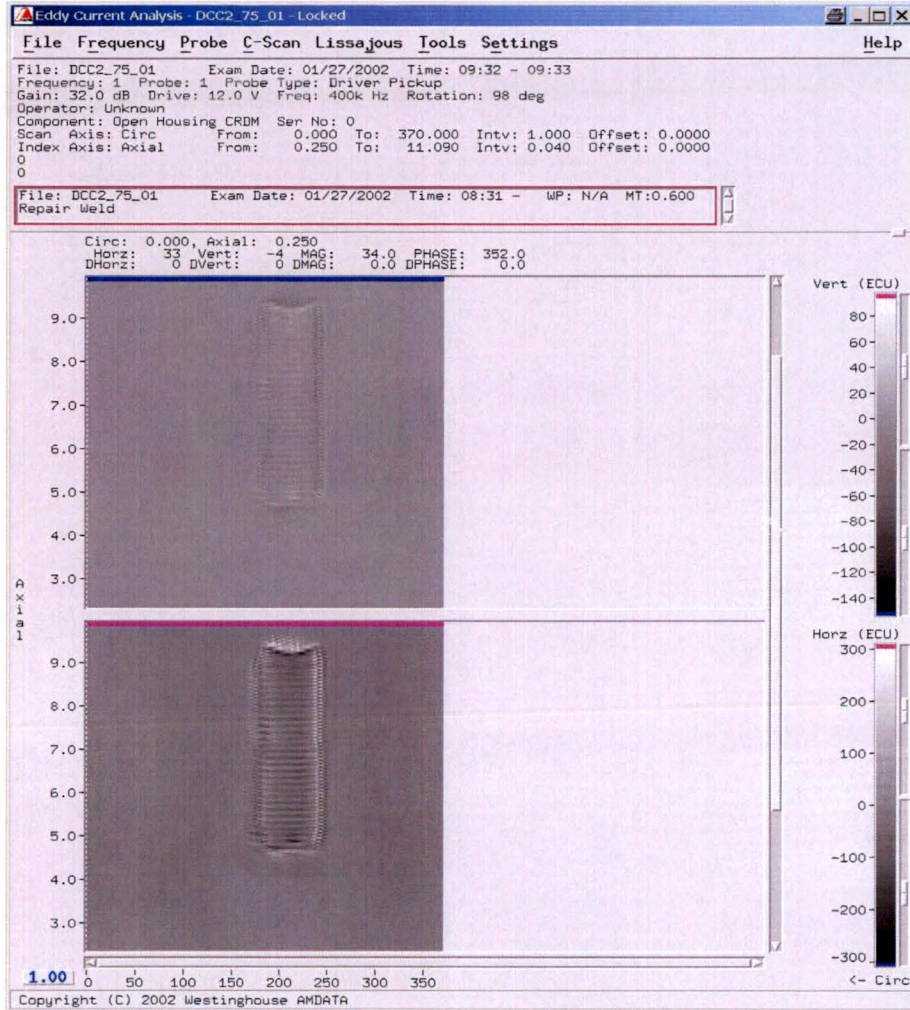
This eddy current testing and display process was applied to the D.C. Cook penetration 75 in January 2002, and the results are shown in Figure 2. The results show no evidence of cracking after six years of service. Further inspections conducted up until the head was replaced in 2006 also showed no evidence of cracking. Therefore, the ID embedded flaw repair was confirmed to last at least 10 years with no deterioration.

**Figure 2**  
**ECT View of 1996 Repair, Taken in 2002**
