Subject: 2016 Annual Site Inspection and Monitoring Report for Uranium Mill Tailings
Radiation Control Act Title II Disposal Sites

2016 Annual Site Inspection and Monitoring Report for Uranium Mill Tailings Radiation Control Act Title II Disposal Sites

November 2016

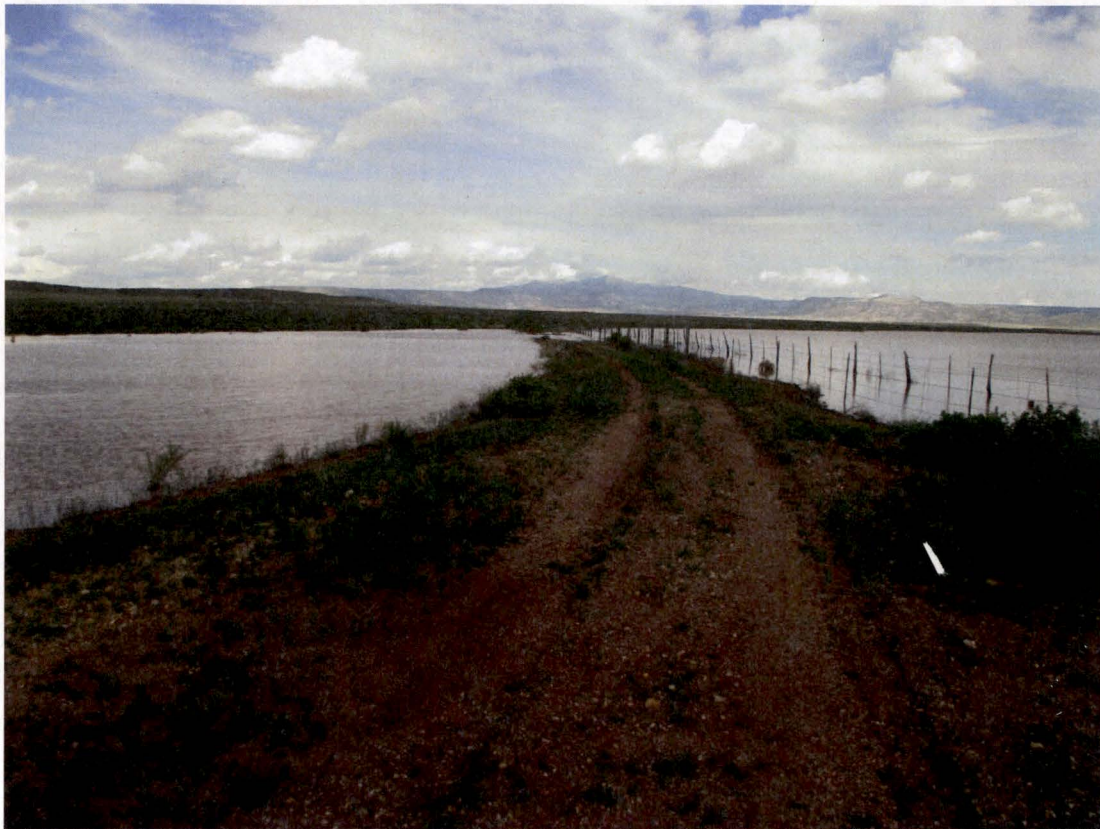
Interior tertiary roads used to access DOE assets consist of a dirt track covered at places with crushed basalt. The roads are susceptible to erosion and are repaired when they become impassable. All roads were passable except for a location that was covered by a large ephemeral pond (PL-1).

PL-1. Large Ephemeral Pond in East Portion of Site

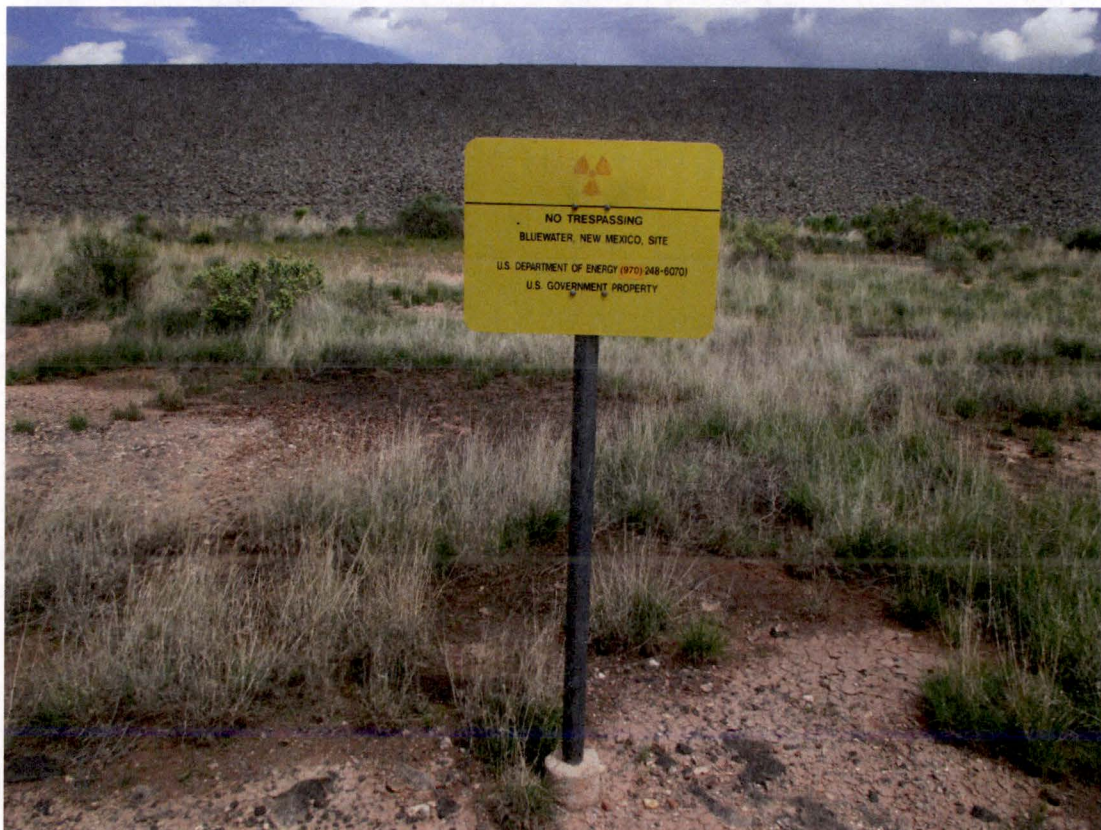
Fifty-five perimeter signs (warning and no-trespassing signs) are mounted on steel posts along the site boundary and around the main and carbonate tailings disposal cells (PL-2). Perimeter signs P3 and P10 have gunshot damage but are still legible. No maintenance needs were identified.

PL-2. Perimeter Sign P51

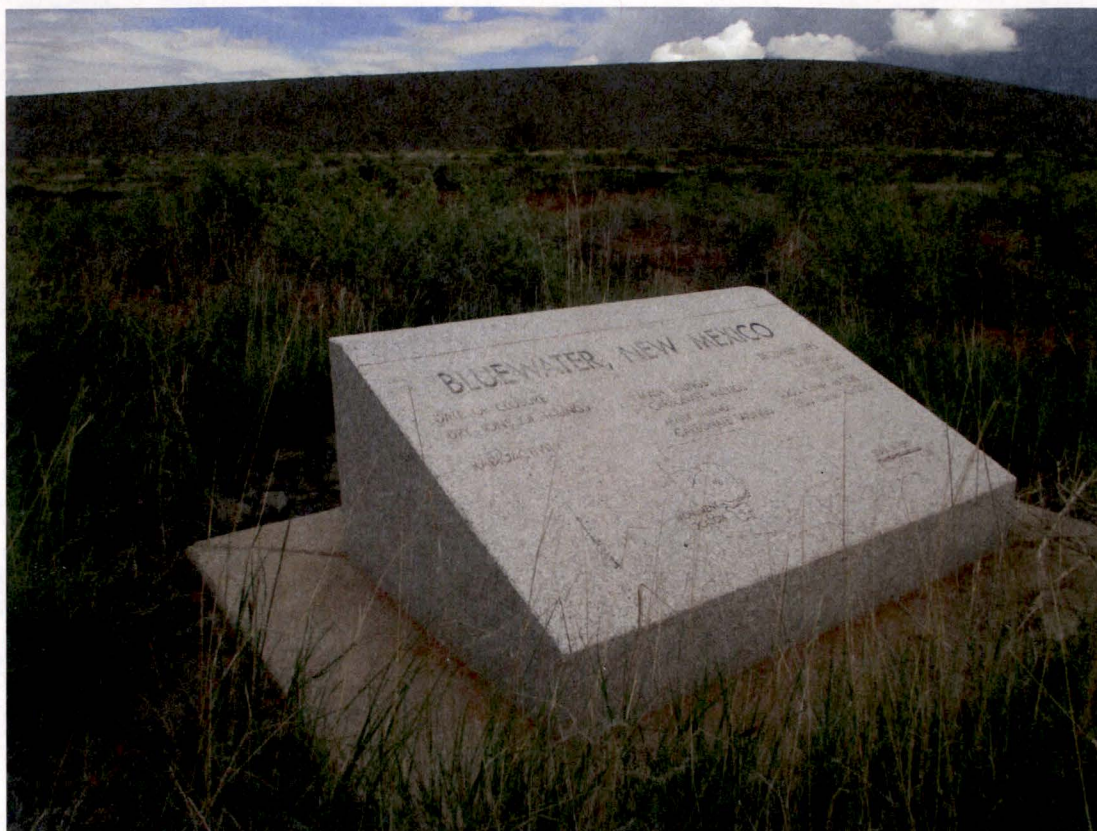
A granite site marker is between the southwest corner of the main tailings disposal cell and the northwest corner of the carbonate tailings disposal cell (PL-3). No maintenance needs were identified.

PL-3. Site Marker and South End of Main Tailings Disposal Cell

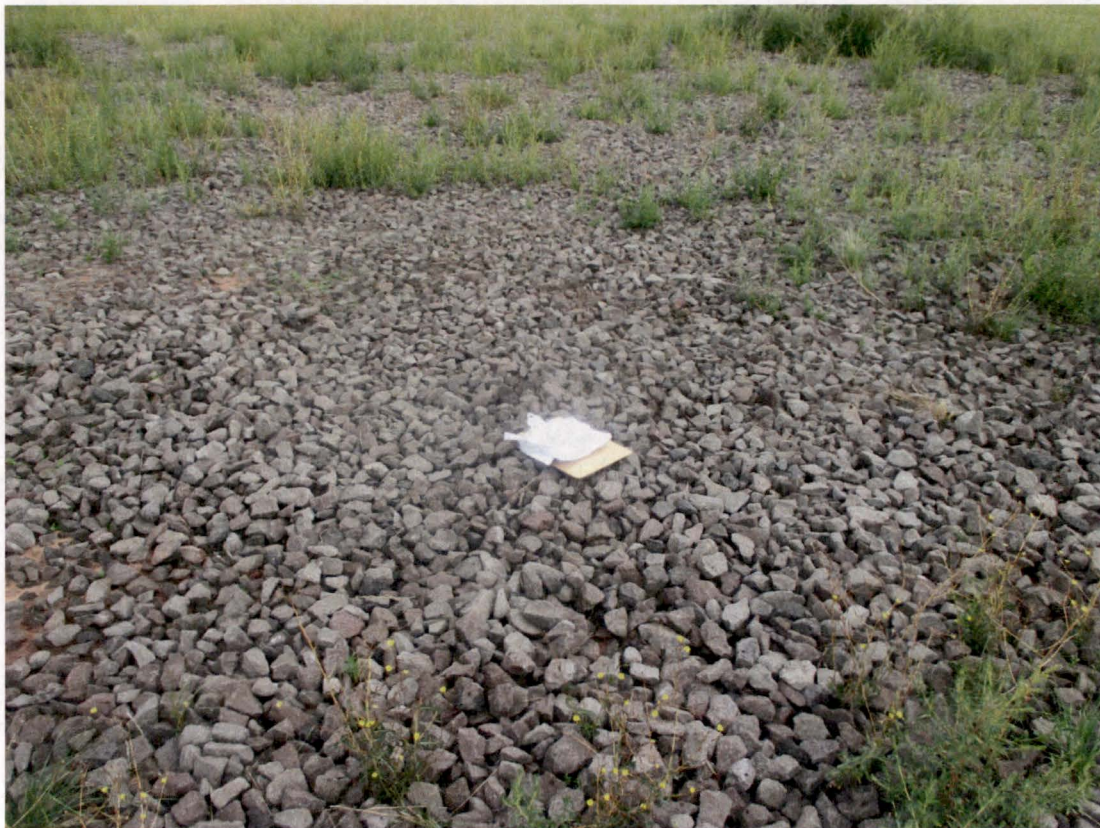
Two test pits were dug and sampled on the top slope of the carbonate tailings disposal cell as part of the NRC/DOE radon study. The test pits were reclaimed after completion of field investigations, and the locations were observed and photographed during the annual inspection. Reclamation appeared to be successful at both test pit locations; no settlement or erosion was visible (PL-14).

PL-9. Reclaimed Test Pit 6

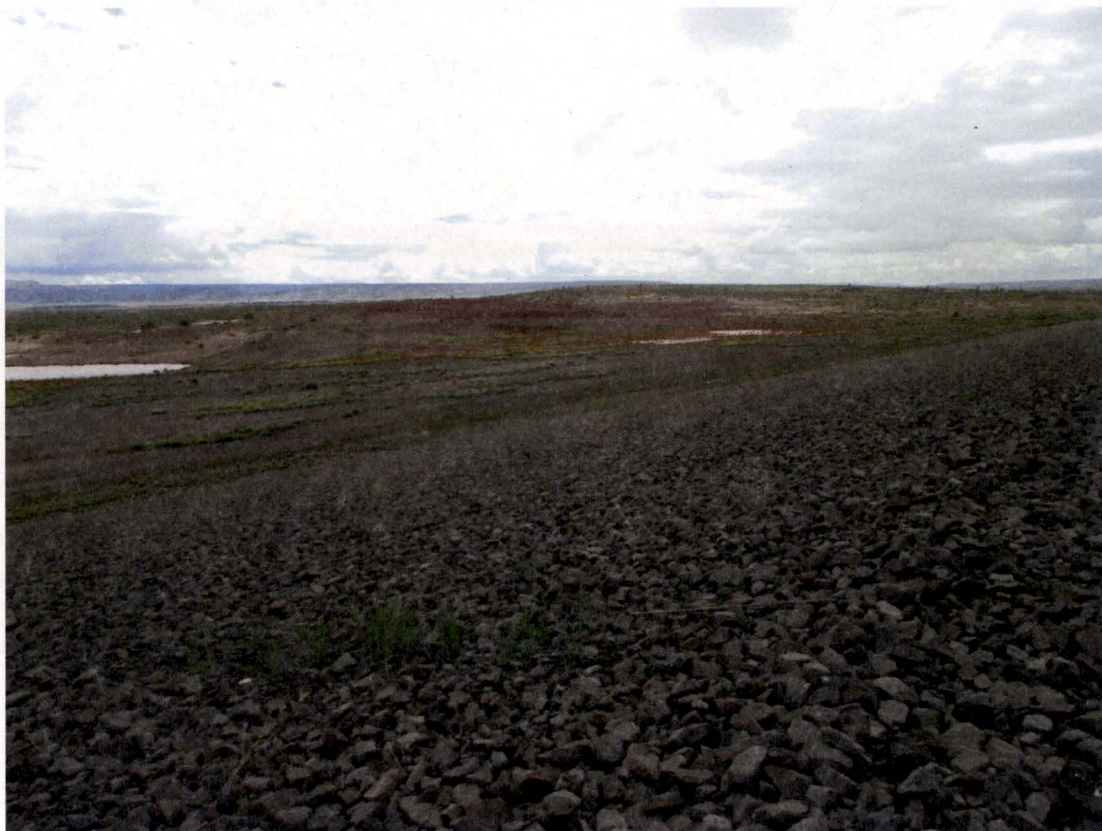
PL-17. Ephemeral Ponds Near East Side of Main Tailings Disposal Cell

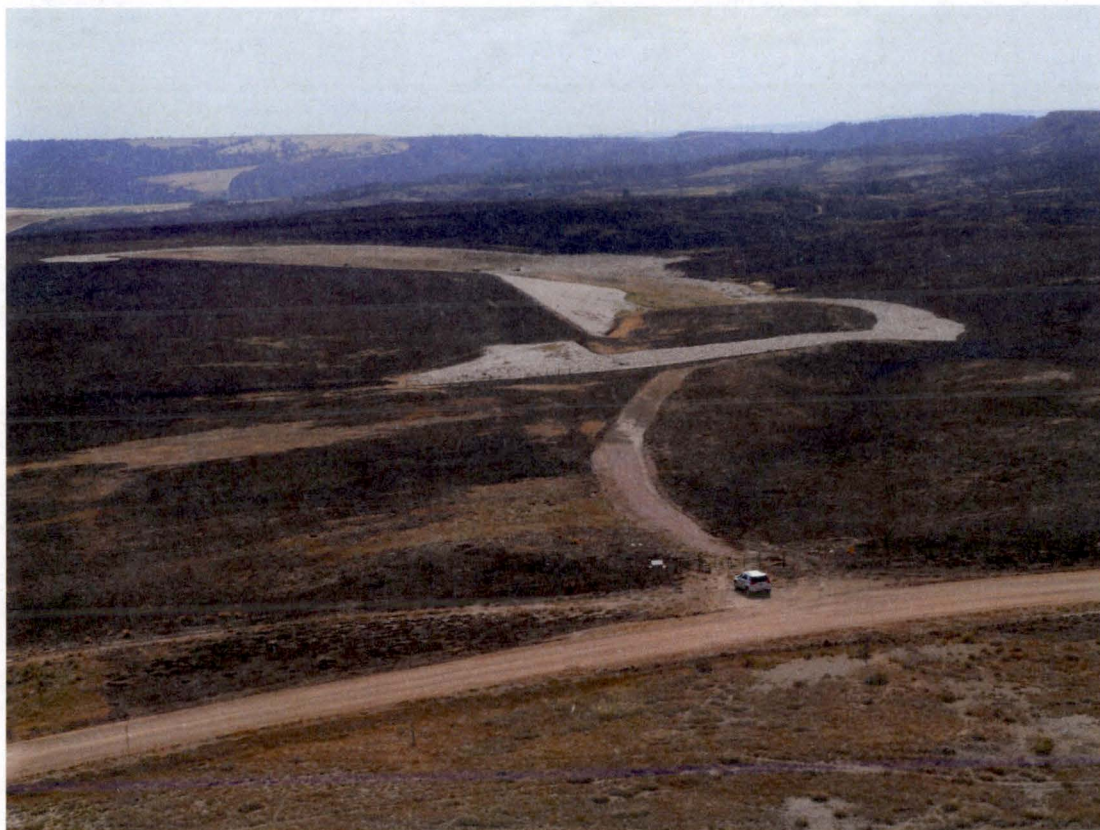
After the wildfire, which burned most of the vegetation except for the areas within the riprap diversion channels (PL-4), the ground was examined to determine the depth of fire damage. In all areas examined, the roots appeared healthy, indicating the fire had moved very rapidly. The rancher agreed with this observation, stating that it was a very fast-moving fire due to the wind.

PL-4. Tailings Embankment and Diversion Channels, Looking East, July 22, 2016

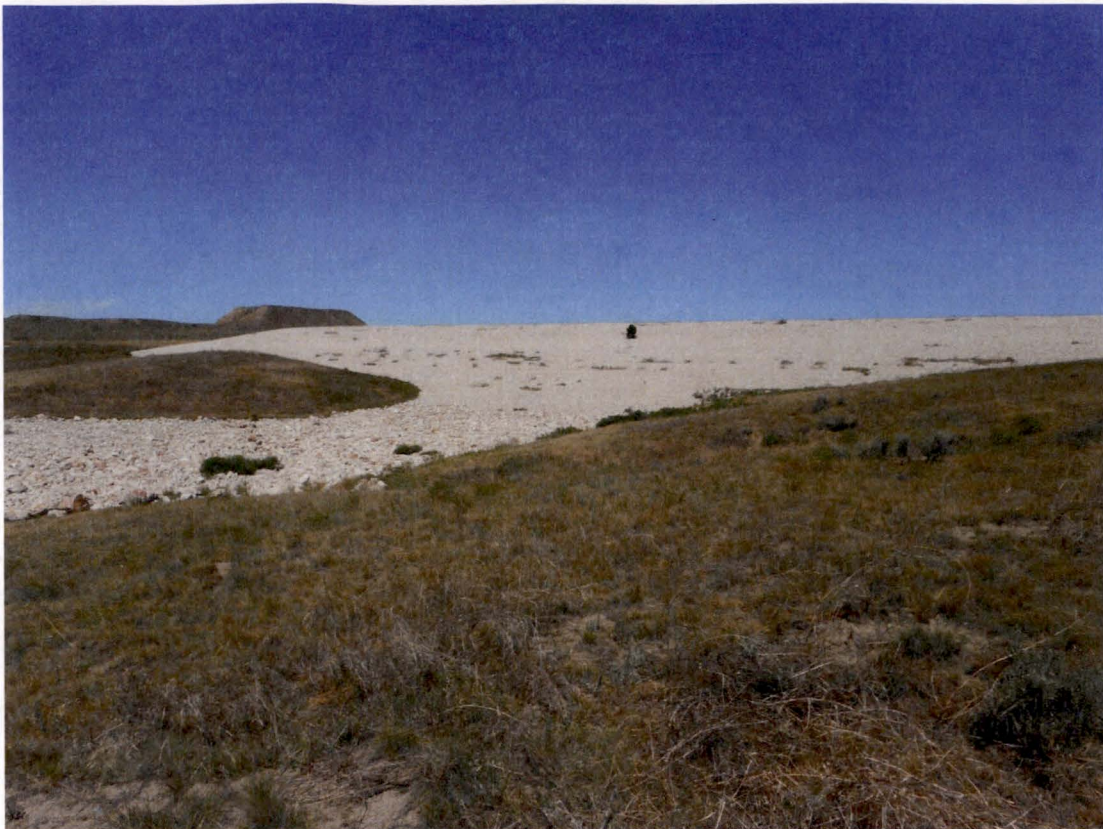
The tailings embankment face, the steepest man-made slope onsite, is covered with riprap and was intact and stable (PL-5). The riprap showed no signs of degradation. Scattered plants, mostly grass and annual weeds, grow in the riprap. These plants do not threaten the stability or function of the embankment face.

PL-5. Drainage Channel and Embankment, July 12, 2016

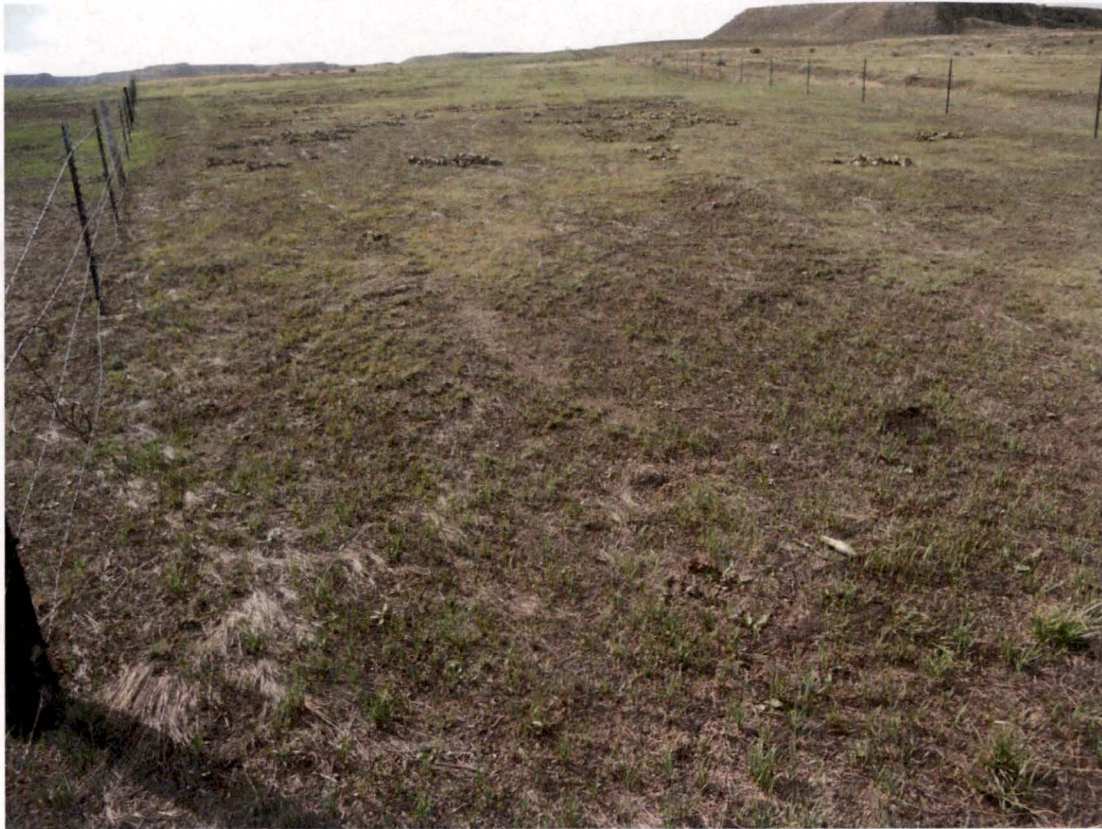
PL-7. Vegetation Regrowth Observed on September 6, 2016

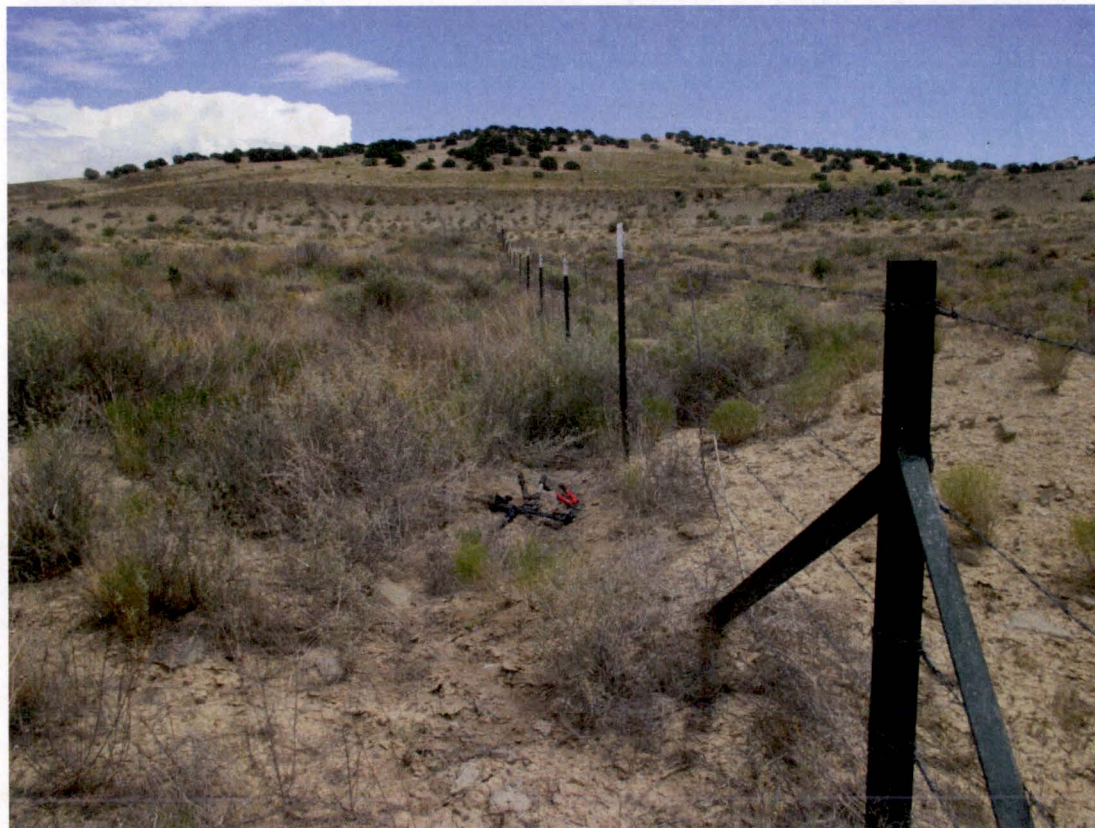
PL-2. Repaired Fence

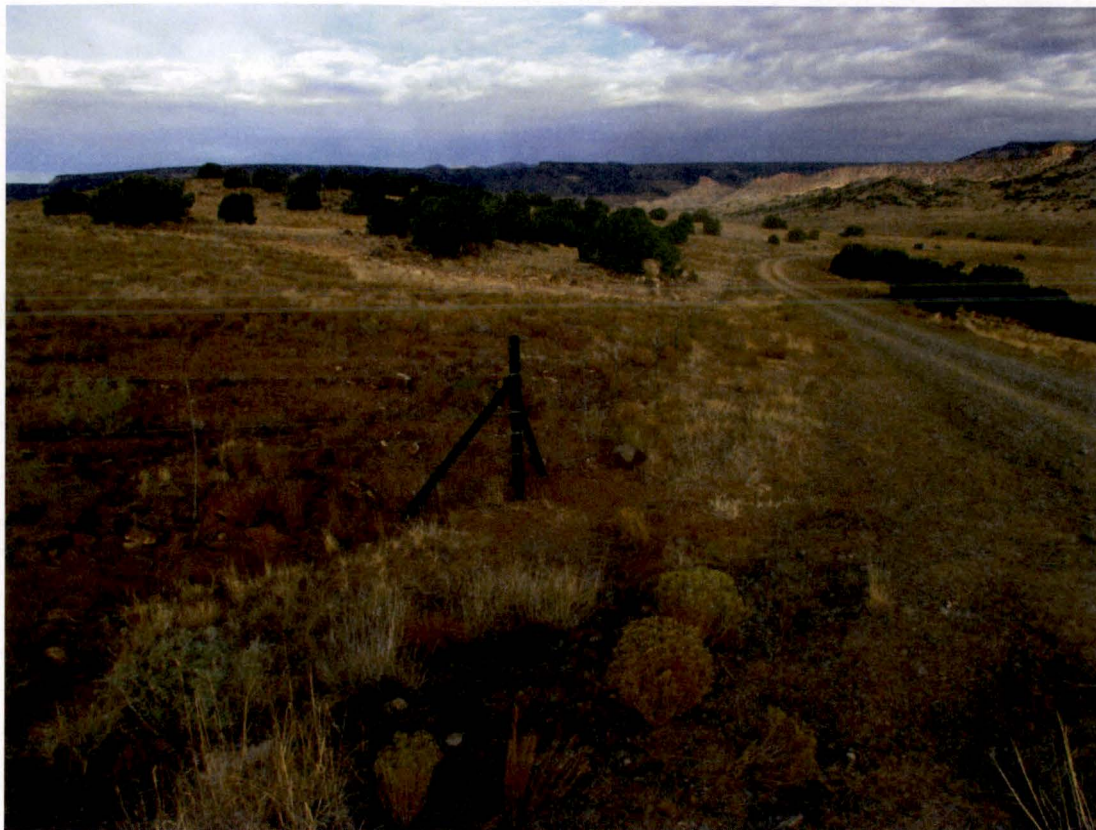
PL-3. New Fence Along East Site Access Road

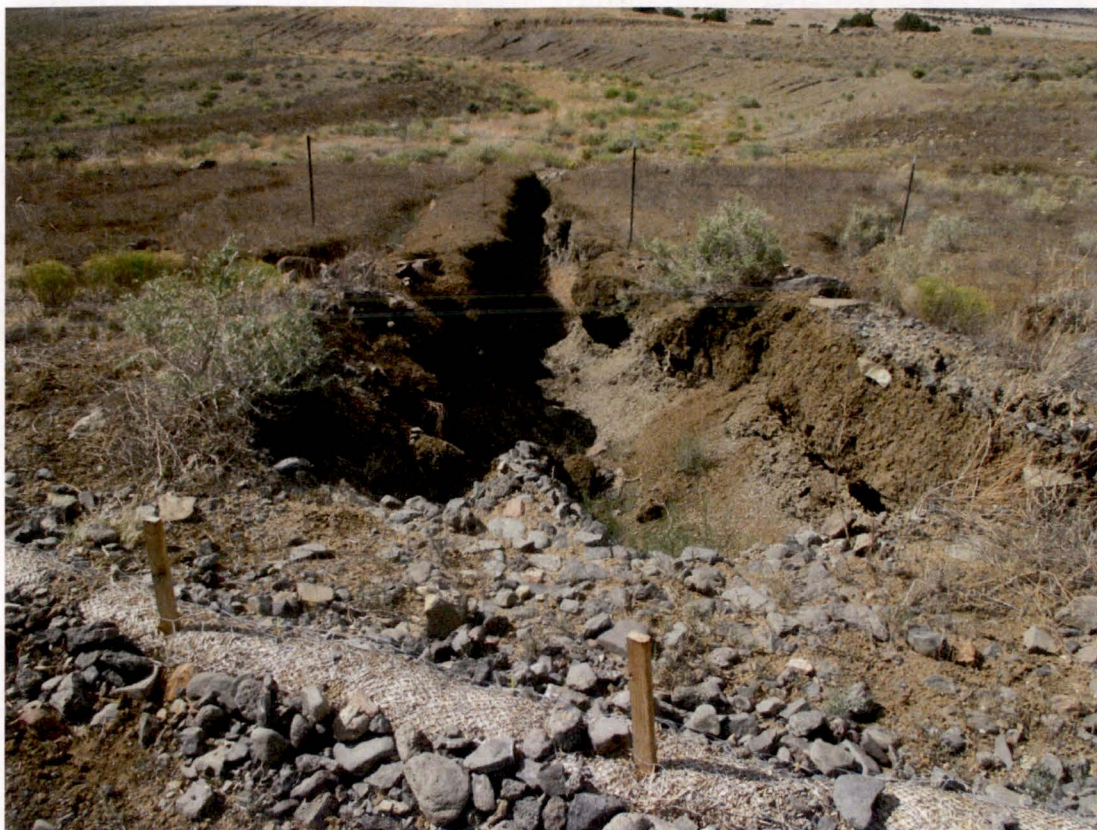
PL-11. Encroaching Gully Along East Access Road

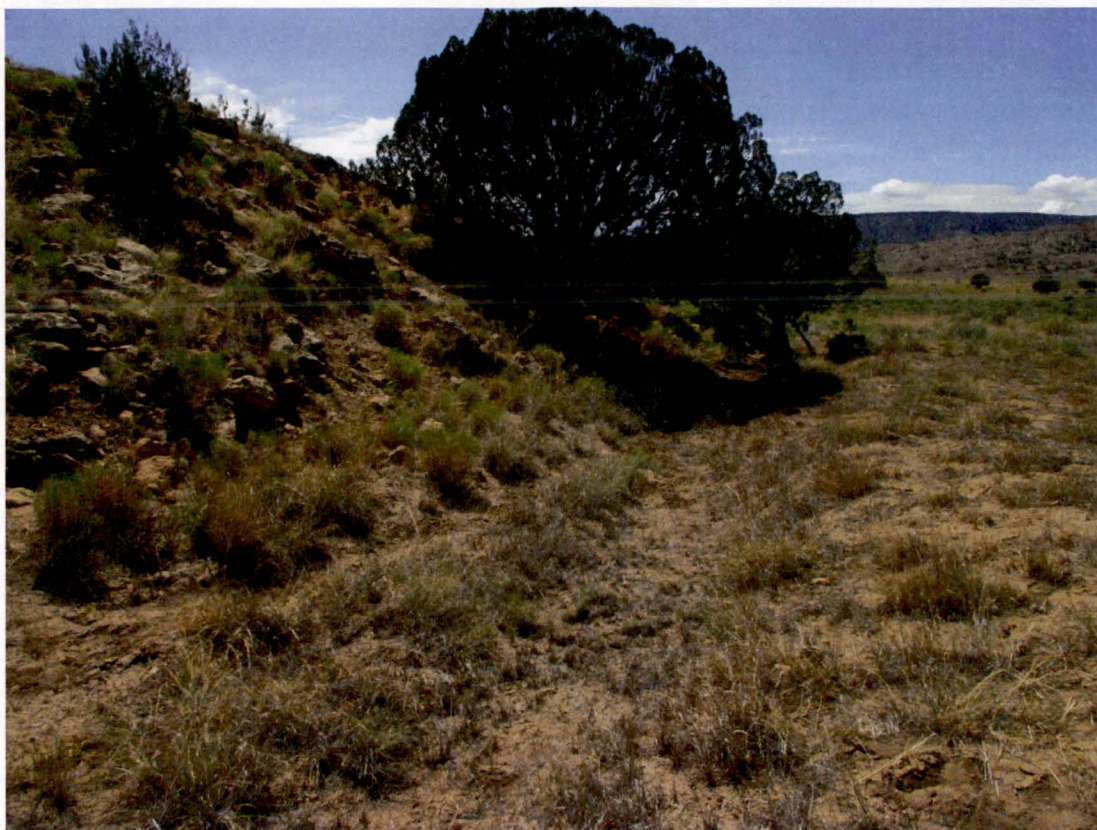
PL-15. Potential Seep Area at Tres Hermanos Sandstone Outcrop

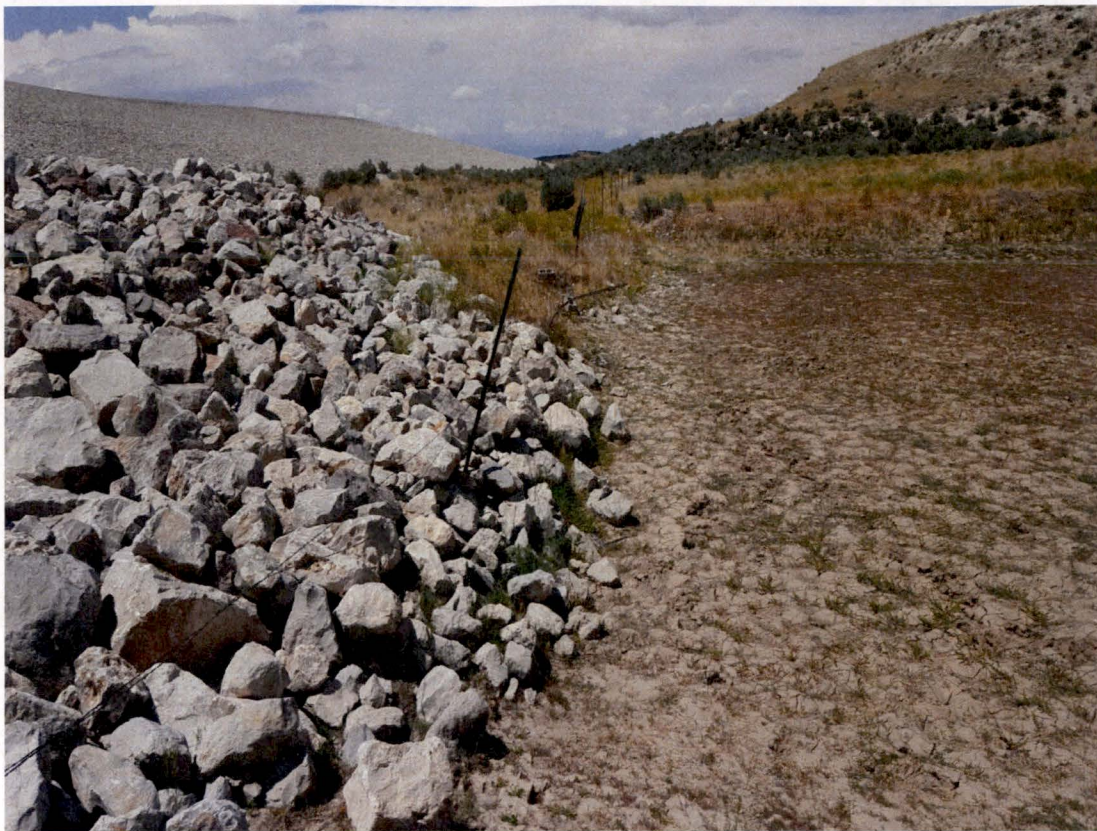
PL-1. Fence Damage East of Disposal Cell

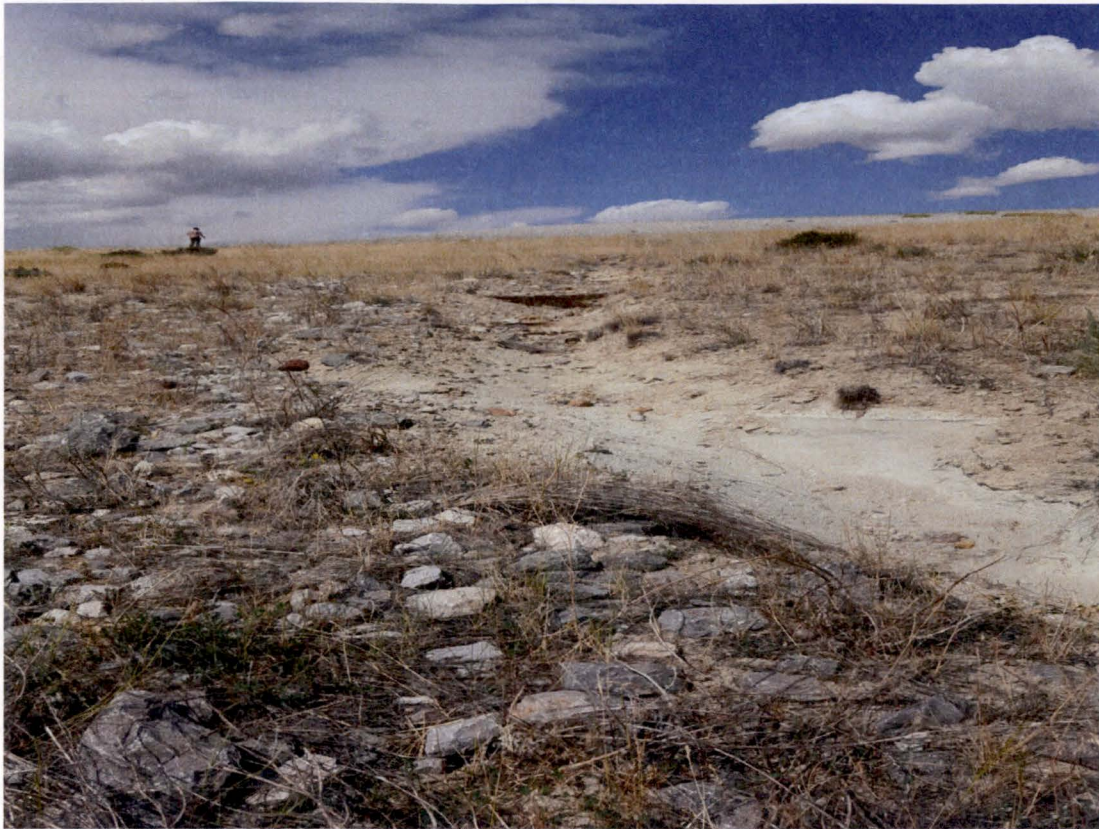
PL-13. Gully Southwest of Disposal Cell; Looking Upslope

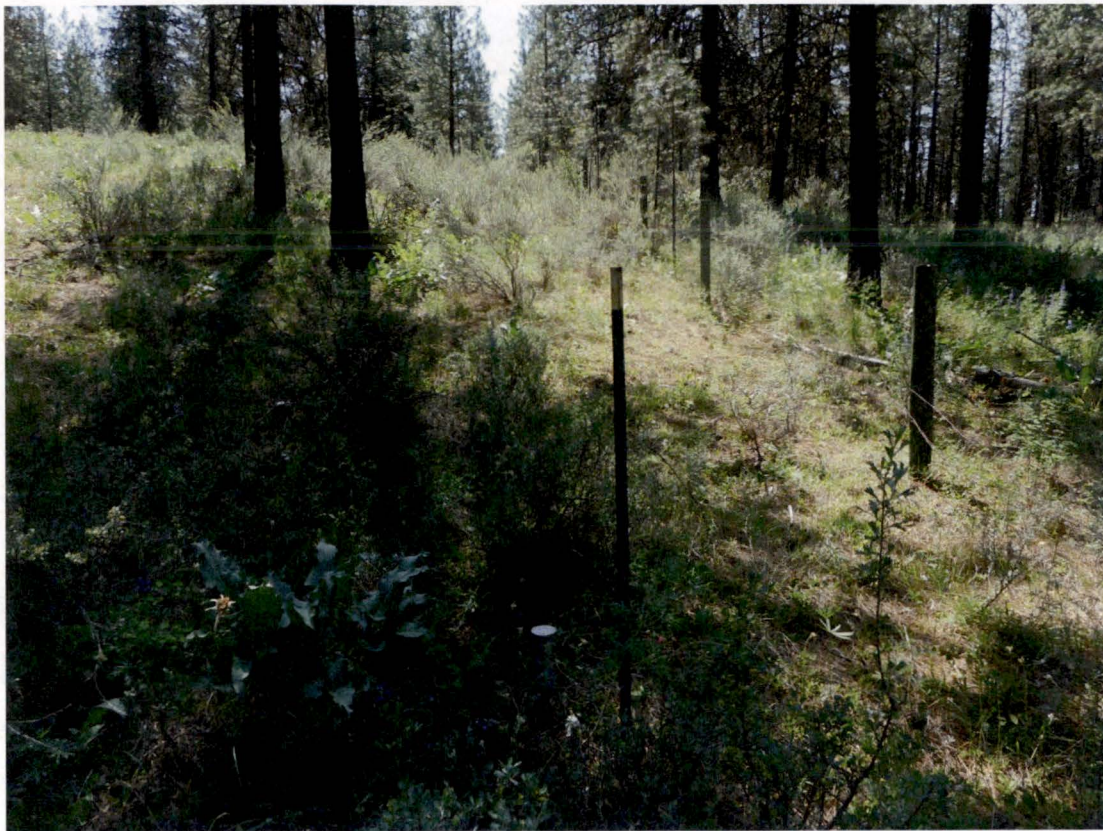
Six boundary monuments set in concrete define the site boundary (PL-3). Boundary monument BM-3A, near the granite site marker, is bent but does not need to be repaired. Because surrounding vegetation had made it difficult to locate some of the monuments, metal t-posts were installed at each monument location. All boundary monuments were verified to be present and stable during the 2016 inspection (PL-3).

PL-3. Boundary Monument BM-1

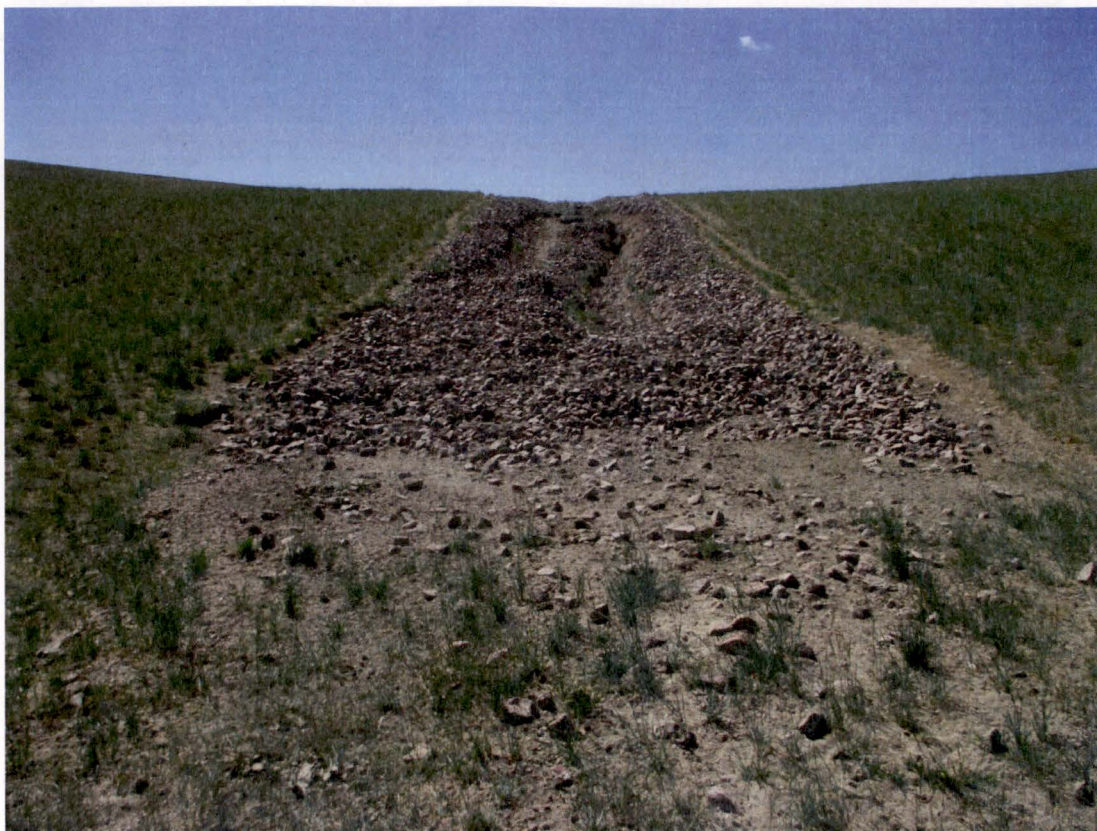
PL-13. Outlet of Eroded Riprap-Armored Drainage near Bottom of Pit 4
