PLANT WIDE INCIDENT ANALYSIS REPORT

Monsanto, Soda Springs, Idaho Plant

Subject: Nuclear Source Exposure

Report Date: 10/27/2016

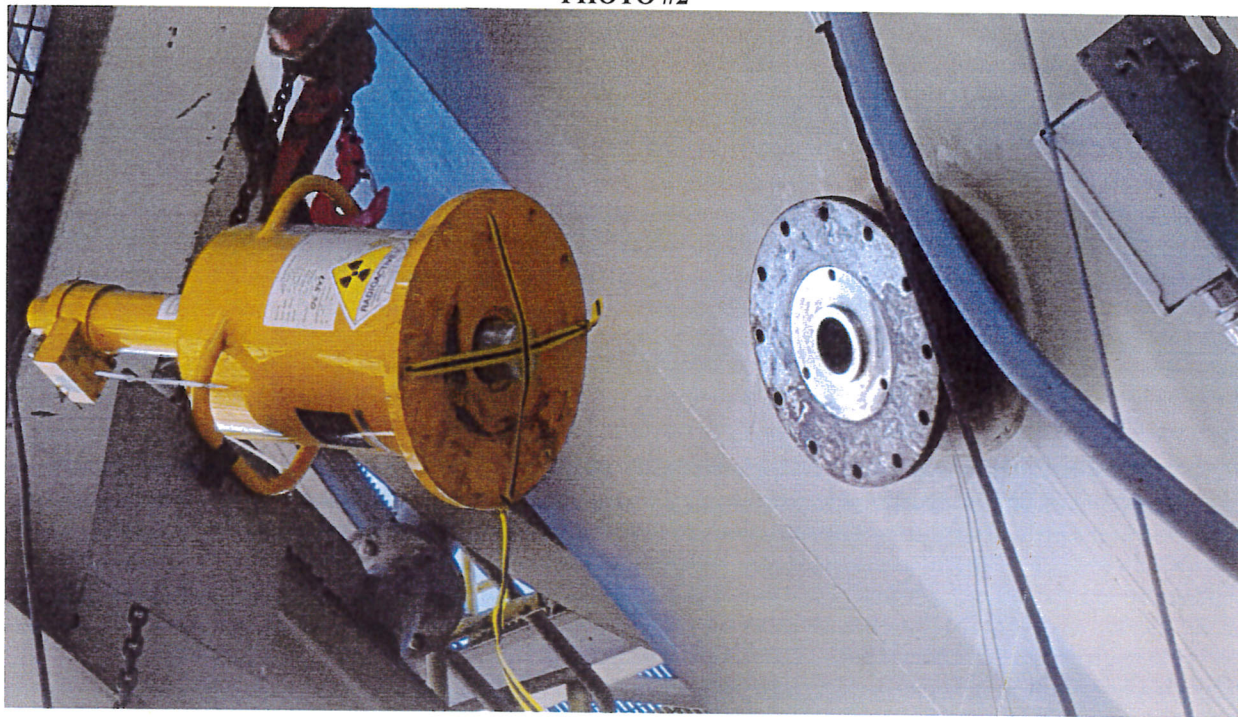
PHOTO #2

device. He tried to pull it back with the cord but it would not move so he pushed it back into the device with a wrench and secured it with some barricade tape (see photo #2). He then contacted the project engineer who came and took pictures of the device and sent them to Berthold.
