Subject: VIRGIL C. SUMMER NUCLEAR STATION (VCSNS) UNIT 1  
DOCKET NO. 50-395  
OPERATING LICENSE NO. NPF-12  
RELIEF REQUEST RR-4-11, TEMPORARY NON-CODE CONDITION OF  
CLASS 3 SERVICE WATER SYSTEM FLANGE

**South Carolina Electric & Gas Co. (SCE&G)  
Virgil C. Summer Nuclear Station Unit 1 (VCSNS)  
Relief Request RR-4-11**

**DESIGN CALCULATION SW050/02 REVISION 0 "THROUGH WALL LEAK  
EVALUATION"**

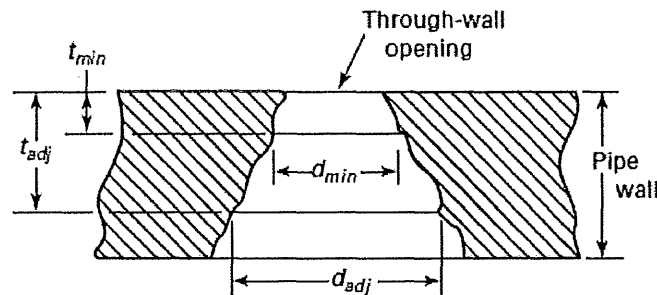
**Figure 6**  
**Illustration of Adjusted Wall Thickness and Equivalent Hole Diameter**

Within section 3.2, the evaluation moves to portion (c) because there is a through wall leak within a portion of the thinned wall. The evaluation then utilizes the branch reinforcement method, where the hole becomes a circular penetration (see Figure 6 from Ref. 2 below).

Using this method a value of T<sub>adj</sub> of 0.14" was selected (a value greater than T<sub>min</sub> and less than the pipe wall nominal thickness). Placing this value into equation (8) of Ref. 2 yields 1.532; Where T<sub>min</sub> = 0.0625" and R = 9.6875"/2 (conservative)

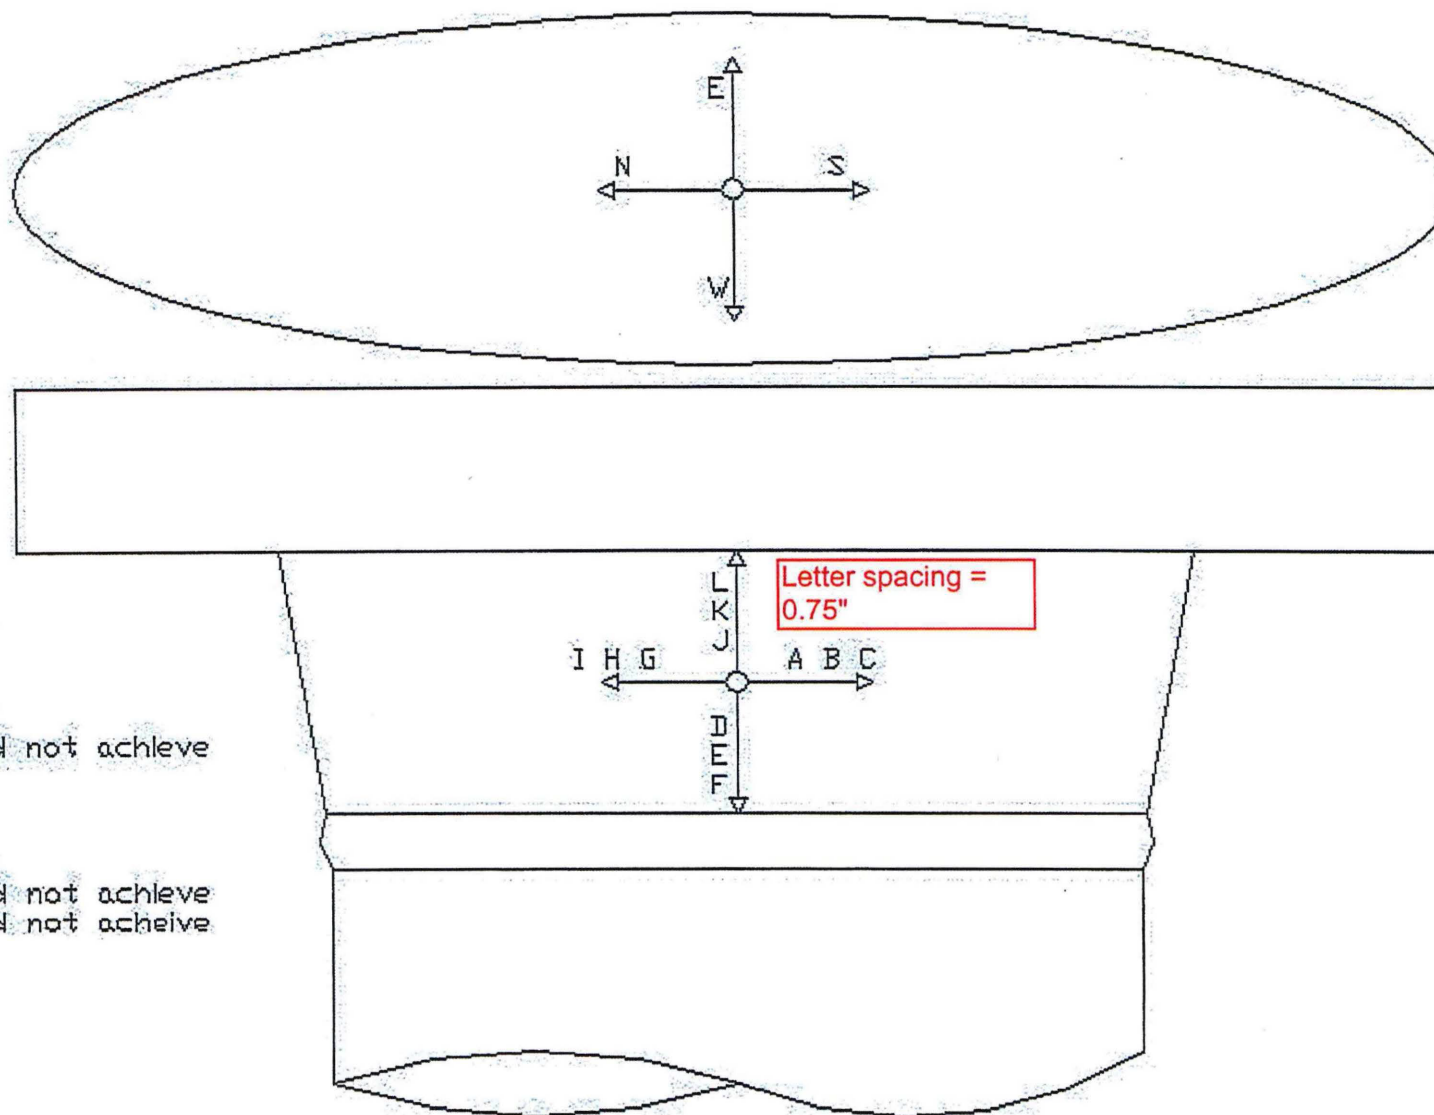
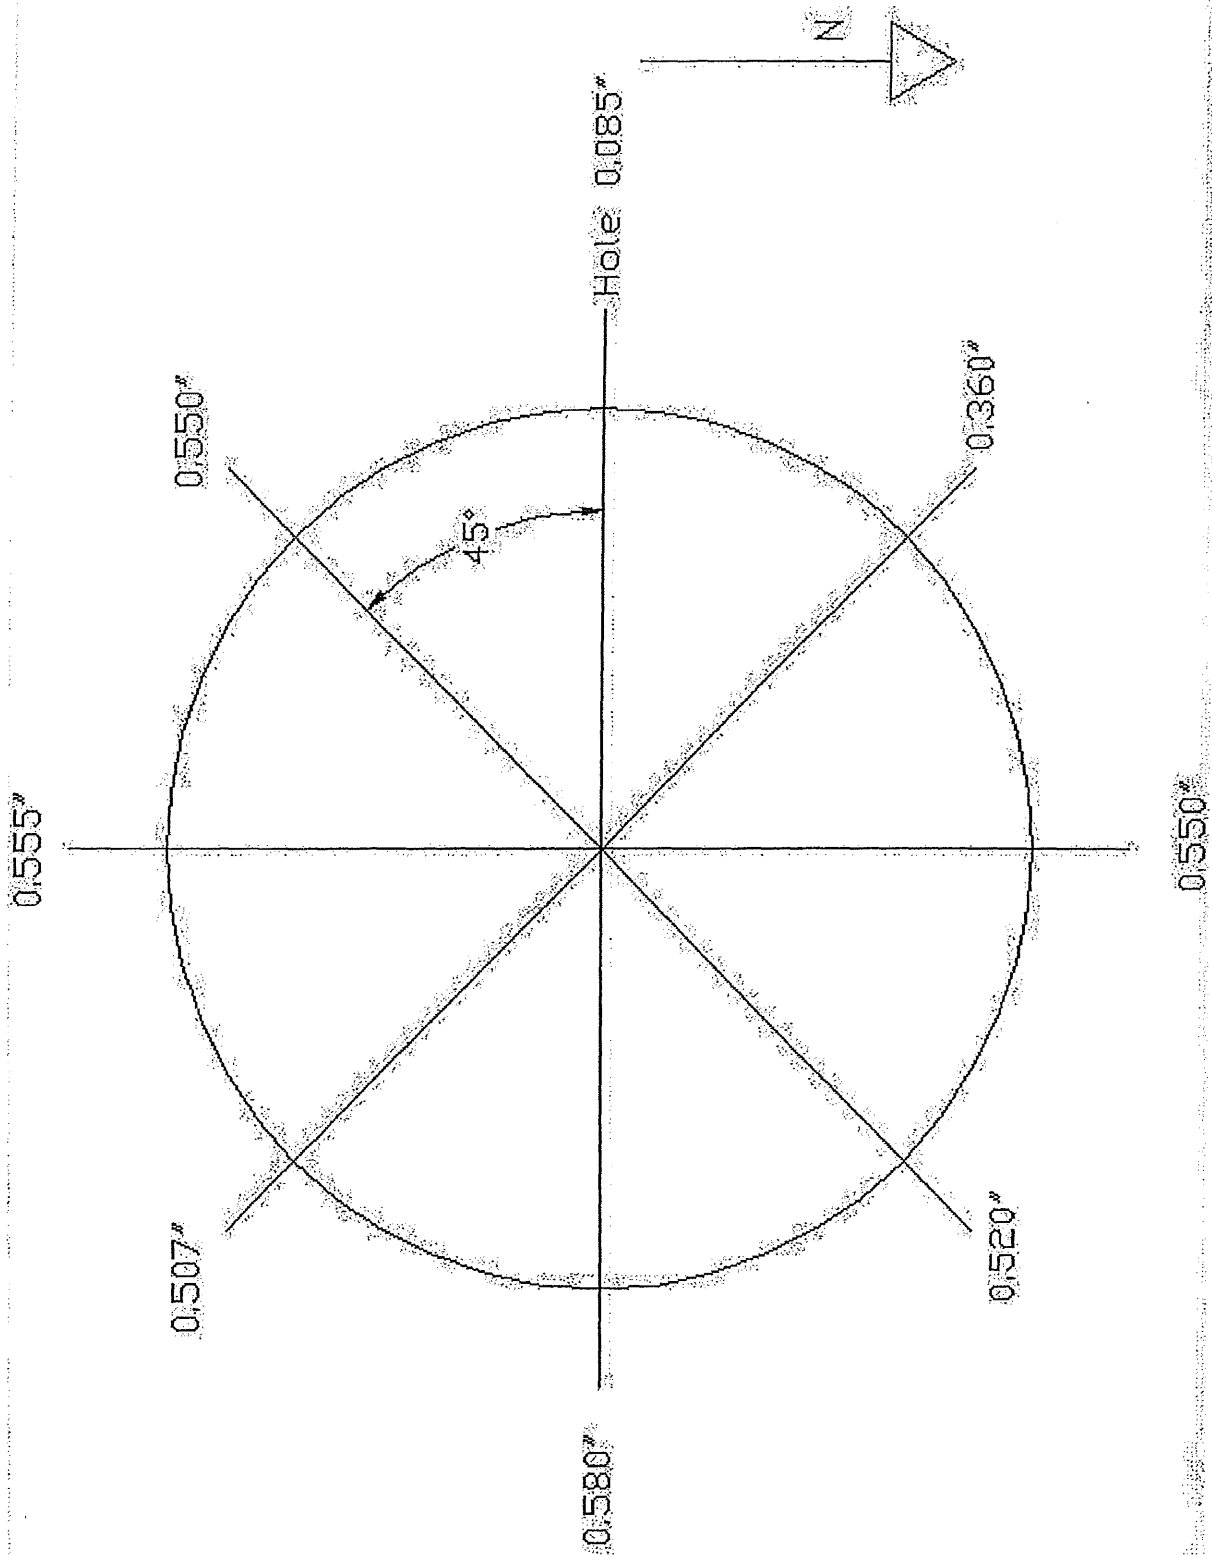
Taking the average of data points A, D, G, J, and including the measurement over the pin hole, yields an average of 0.217", with a minimum value of 0.085".

LOCATION NUMBER	ACTUAL THICKNESS	SKETCH
<u>Min. @ Leak</u>	<u>.095"</u>	<u>See attached drawings.</u>
<u>Max. 180° From Leak</u>	<u>.580"</u>

A=0.241"  
B=0.338"  
C=0.358"  
D=0.310"  
E=0.293"  
F= could not achieve  
G=0.099"  
H=0.240"  
I=0.317"  
J=0.348"  
K= Could not achieve  
L= Could not achieve
