RE: Event Notice #52453

RE: Nuclear Gauge incident s/n 38373

SEALED RADIOACTIVE SOURCE LEAK TEST REPORT

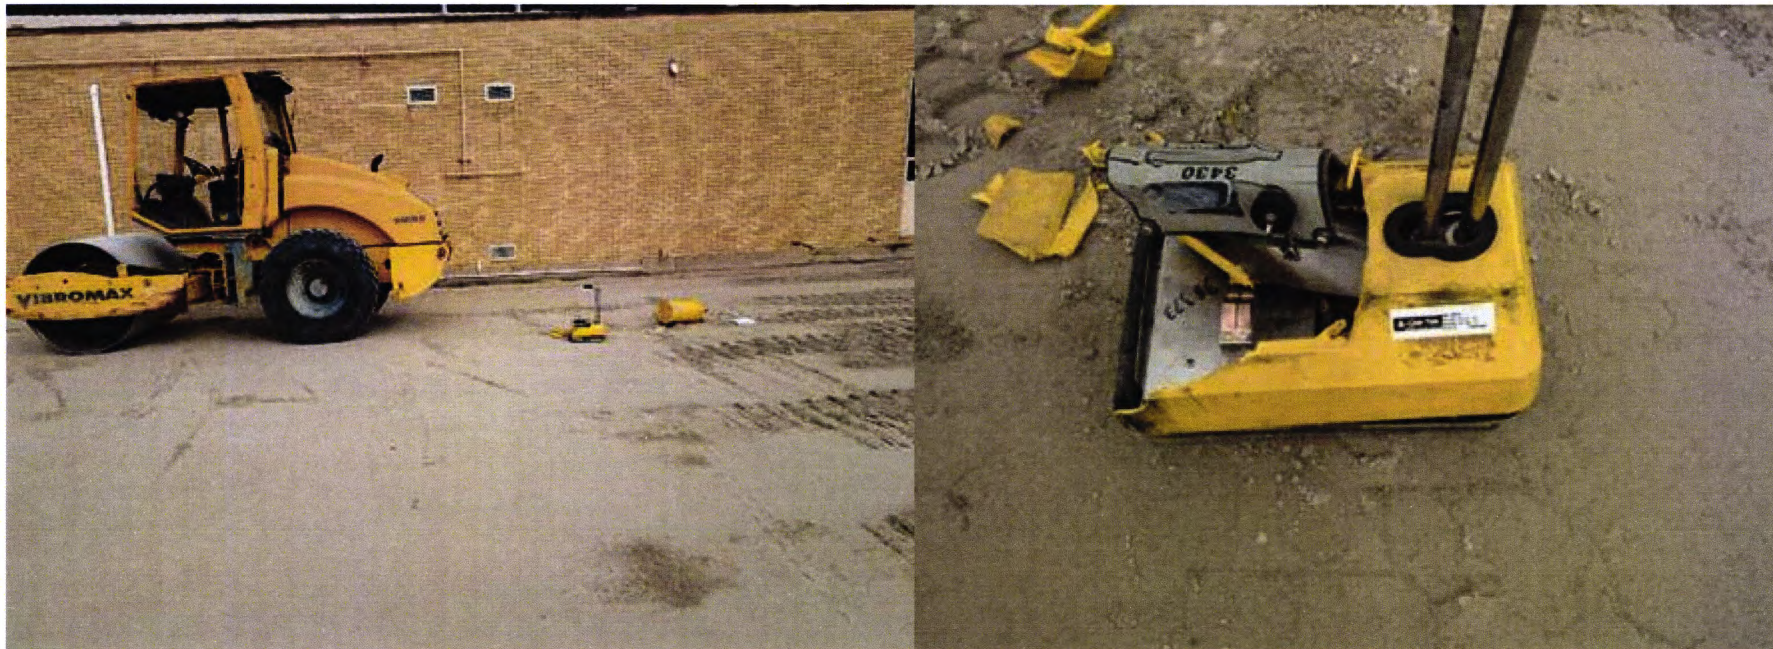
PROJECT: Gauge Incident Reading Page 1 of 1
 JOB NO. _____ Date 12/21/16 Comp. By MD CHECKED BY: _____

Upon my arrival, the gauge and equipment were as expected from the picture. I proceeded to survey the area outside the paint to find the readings were 0 mR/hr. Once I had determined it was as safe as could be, I approached the source from the west, using the roller as a barrier. Once near the gauge, I determined that the source rod appeared intact, with no damage and proceeded to take several readings around the gauge and roller. The readings at one meter were as expected (no higher than 0.5 mR/hr) and contact readings were also normal with the highest reading being 10 mR/hr. I also surveyed the path that the roller took after coming off the gauge, and the tire, to check for radiation, and none was present.

I contacted Katie Gilchrist via text and voice, and waited for a response. In this time, the contractor inquired if they could have their roller, which I allowed. I also had the technician retrieve the shipping case from his truck to place the gauge and pieces into while I maintained surveillance of the gauge. The technician and I then loaded the gauge into the case, and secured it with locks. The gauge was taken to my Terracon darkroom truck, and chained securely in place with chains and locks, and the back door locked. I then dismissed the technician to go back to the office while I awaited further instructions. Once cleared, I returned to the office and secured the gauge into the storage area and performed another survey, again getting no higher reading at one meter than 0.5 mR/hr. The source was secured in storage at 1350 and a "Do Not Use" notice posted at the damaged gauge.
