**UNITED STATES
NUCLEAR REGULATORY COMMISSION**
REGION IV
1600 E. LAMAR BLVD.
ARLINGTON, TX 76011-4511

**SUBJECT: ARKANSAS NUCLEAR ONE – NRC INSPECTION REPORT 05000368/2016011
AND PRELIMINARY WHITE FINDING**

.1 Unit 2 Emergency Diesel Generator A Bearing Failure

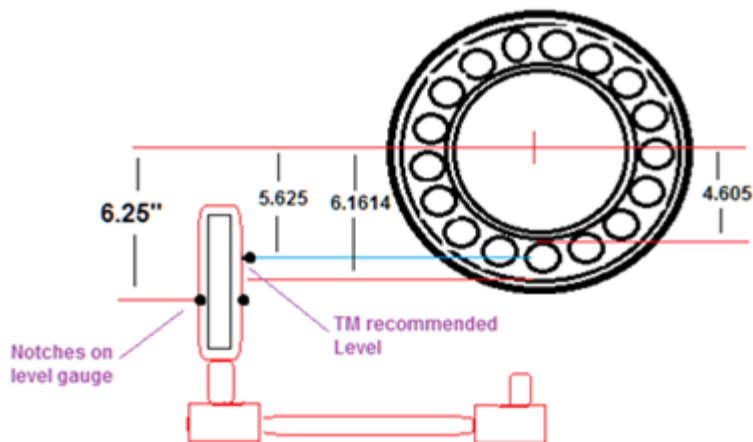
During a causal investigation for the lack of lubrication, the licensee identified that the oil level scribe mark on the sight glass was below the minimum level necessary to provide proper oil lubrication to the bearing. The licensee concluded that on November 11, 2014, while performing Work Order 356569, maintenance personnel had removed and inadvertently inverted the sight glass, which caused the scribe mark to be below the bottom of the bearing rollers (see diagram below). With the sight glass inverted, the scribe mark was 3/8-inch lower than if it was in the correct orientation. Post-failure measurements identified that the scribe mark was 5/8-inch below the correct position. The licensee concluded that adequate oil was initially provided following the sight glass reinstallation. Evidence to support this included multiple successful surveillance tests with no increase in vibrations, including a 24-hour surveillance on January 12, 2015, and having an oil sample from the bearing on June 22, 2016, with no indications of abnormal wear.

On June 22, 2016, maintenance personnel changed the oil in the inboard generator bearing after taking an oil sample in accordance with Work Order 52656389. Maintenance personnel documented leaving the oil level within the procedural limits relative to the scribe mark. Vibrations and system performance were normal during the post-maintenance runs and surveillance tests on June 26, 2016. The licensee determined that the inboard generator bearing had not been leaking oil between the oil change on June 22, 2016, and the September 16, 2016, surveillance failure.

The licensee concluded that the oil in the inboard generator bearing heated up slowly during the 24-hour surveillance. After 14 hours, enough oil had vaporized within the bearing casing that the liquid oil level became inadequate to lubricate the bearing, resulting in bearing failure. Therefore, the inspectors concluded that the emergency diesel generator could have failed approximately 14 hours after the start of a postulated event between June 26, 2016, and September 16, 2016.

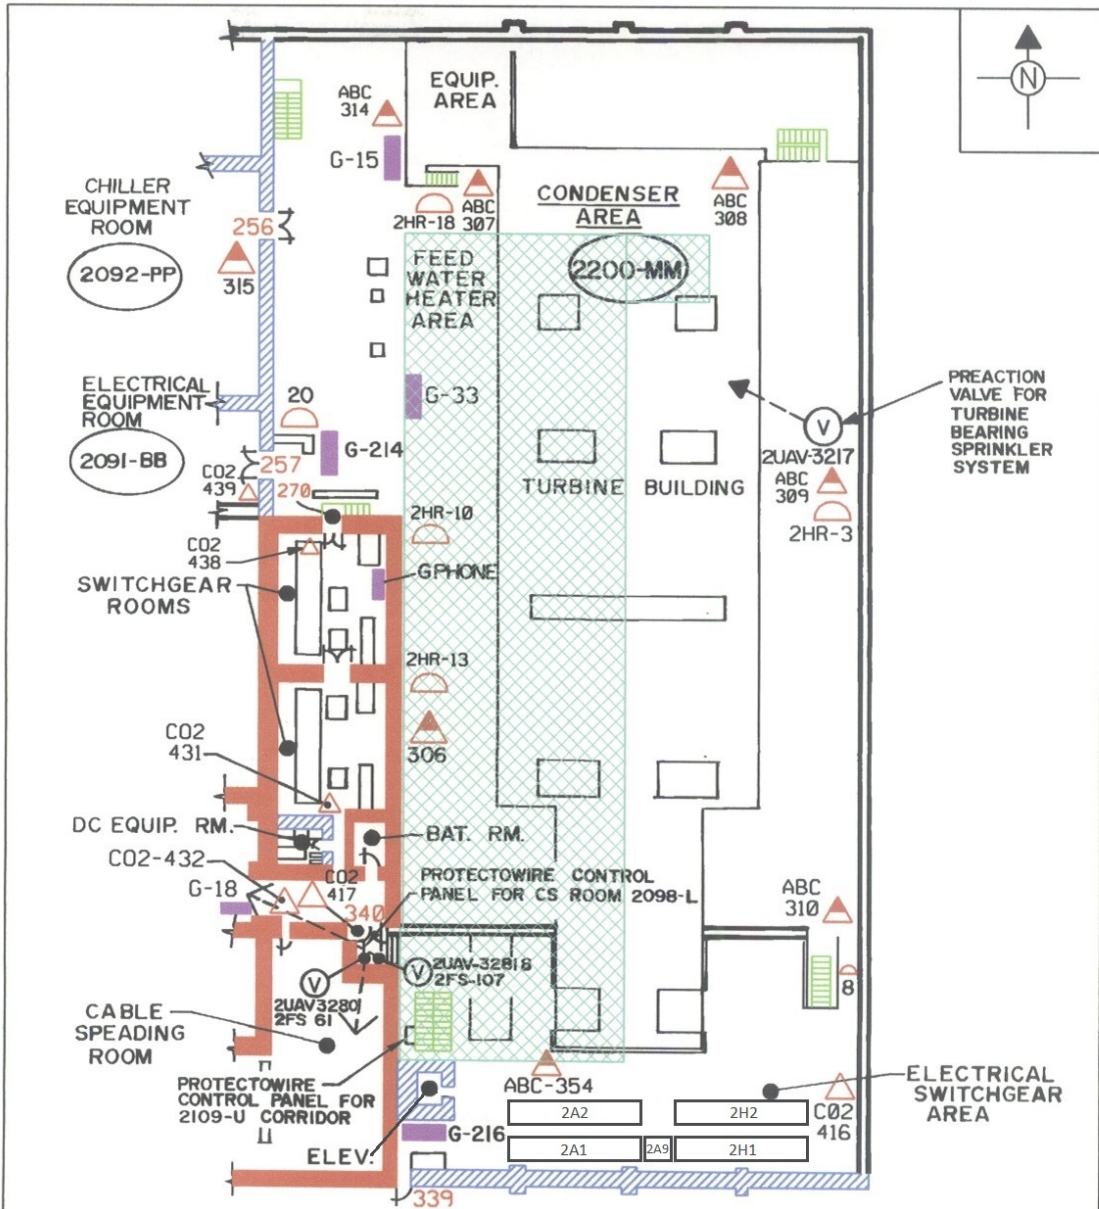
A fire that impacted more than one of the three buses of concern had a significant impact on the results. Therefore, the analyst evaluated the fire spread probabilities. The severity factors were assumed to be 1.0 for the licensee's NFPA 805 analyses for the fire scenarios of interest. The analyst then adjusted the severity factors to model more realistic fire scenarios and to remove some of the conservatism inherent in the NRC and industry approved methodologies. These methodologies included treatment that a fire started in one electrical switchgear would always spread and render the other redundant electrical switchgear unavailable (e.g., a fire in switchgear 2A-1 would always render switchgears 2A-2 and 2A-9 unavailable). This simplification was made during the NFPA 805 licensing process because of the close proximity of the cabinets and the low importance of such a fire scenario with all other equipment fully functional.

As shown in the following figure (taken from the ANO Unit 2 pre-fire plans and enhanced for emphasis), the simplified modelling assumed a fire in switchgear 2A1 would always affect switchgear 2A2 because of their close proximity to each other (6 feet apart). Likewise a fire in switchgear 2A2 would always affect switchgear 2A1. The same spatial relationship and fire

Walkway between 2A1/2A2 and 2H1/2H2 is 6 feet wide.
Space between 2A9 and 2A1/2H1 is 6 inches wide.
