Subject: 10CFR21 Reporting of Defects and Non-Compliance -
Engine Systems, Inc. Report No. 10CFR21-0114, Rev. 0

Subcover Assembly, P/N 1A-7846

10CFR21 REPORTING OF DEFECTS AND NON-COMPLIANCE

SYSTEM: Emergency Diesel Generator

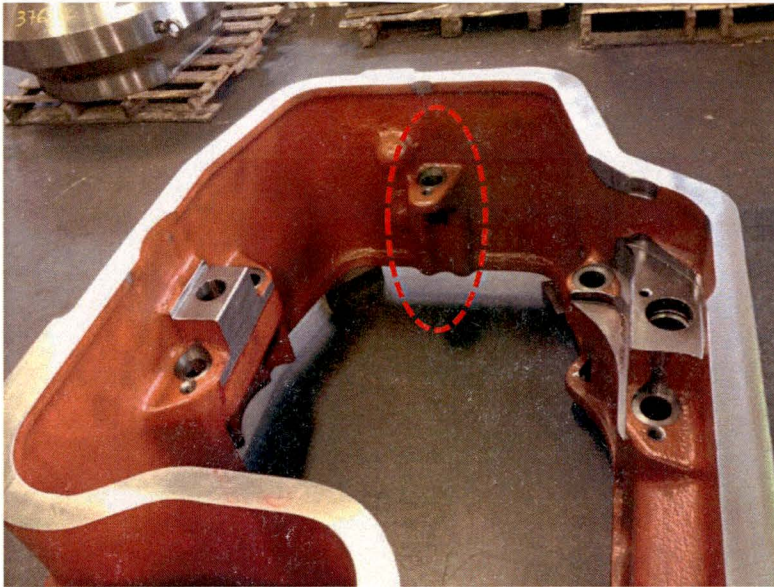
Item #1:

Photo 1: Visual Depiction of Inadequately Drilled Bolt Hole

The issue regarding the inadequately drilled bolt hole would be detected during installation since it would prevent the bolt from passing through the hole. Therefore, it is determined this issue would have no impact on operability since the cover could not be installed with an incompletely drilled bolt hole.

- Inspect for the bolt hole (item #1). If rework is necessary, drill through to a diameter of 13/16".
- For the incomplete machining of the rocker arm pedestal (item #2), first remove the installed dowel which has 0.000" to 0.001" clearance. Then machine a 2" radius relief at the affected area. All other dimensions such as pedestal height shall remain unchanged.

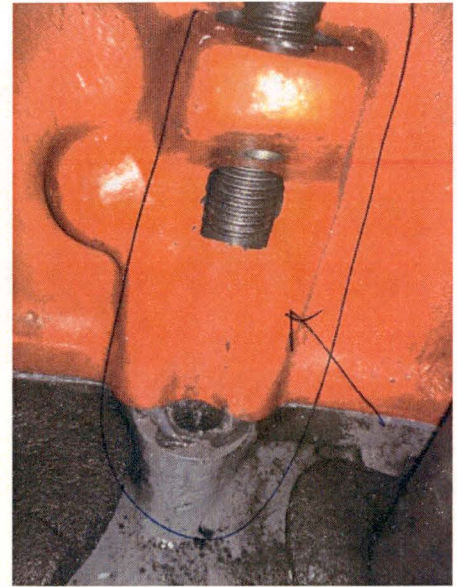
Photo 2: Attempted Bolt Install

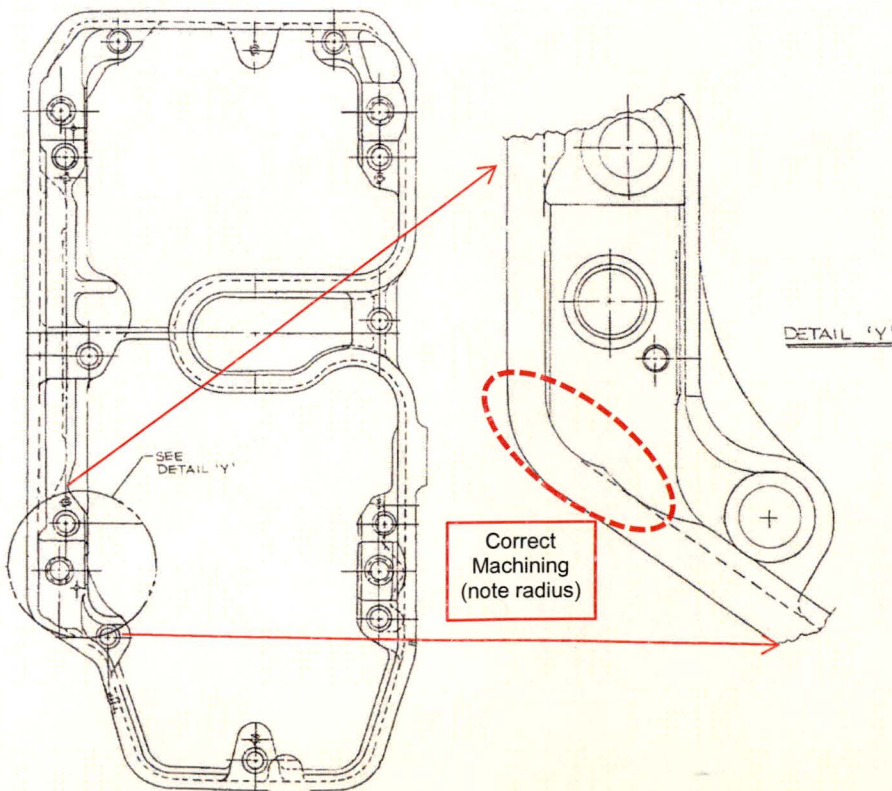
Item #2:

Figure 2: Ideal Pedestal Machining

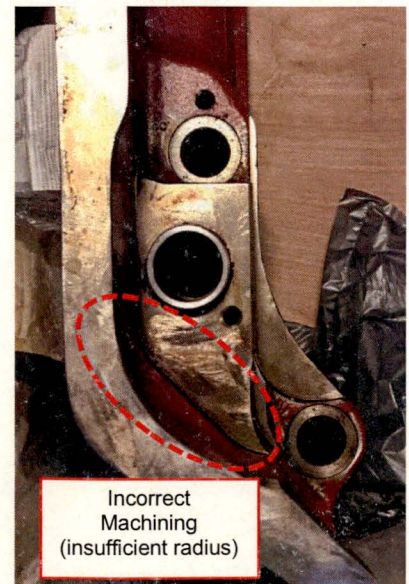
Photo 3: Actual Machining

With regard to the incompletely machined pedestal, there is the potential that a customer could install the rocker arm shaft without detecting this issue. In this situation, the shaft will partially fit on the pedestal and the bolt will thread into subcover; however, the shaft will not seat fully on the pedestal. This prevents full contact with the pedestal and inhibits adequate preload throughout the bolted joint. If a customer were to install the rocker arm shaft (with mating rocker arms, pushrods, etc) onto the engine without realizing this issue, operability and durability of the engine would be compromised. This could present a substantial safety hazard.
