Re: St. Lucie Unit 1
Docket No. 50-335
Renewed Facility Operating Licenses DPR-67
Inservice Inspection Plan
Fourth Ten-Year Interval Unit 1 Relief Request No. 14, Revision 0

Proposed Alternative
in Accordance with 10 CFR 50.55a(z)(2)
--Hardship without a compensating increase in quality and safety--

Florida Power & Light (FPL) is proposing an alternative repair to the St. Lucie Unit 1, 1B2 Reactor Coolant Pump (RCP) seal heat exchanger cooling line tube base material.

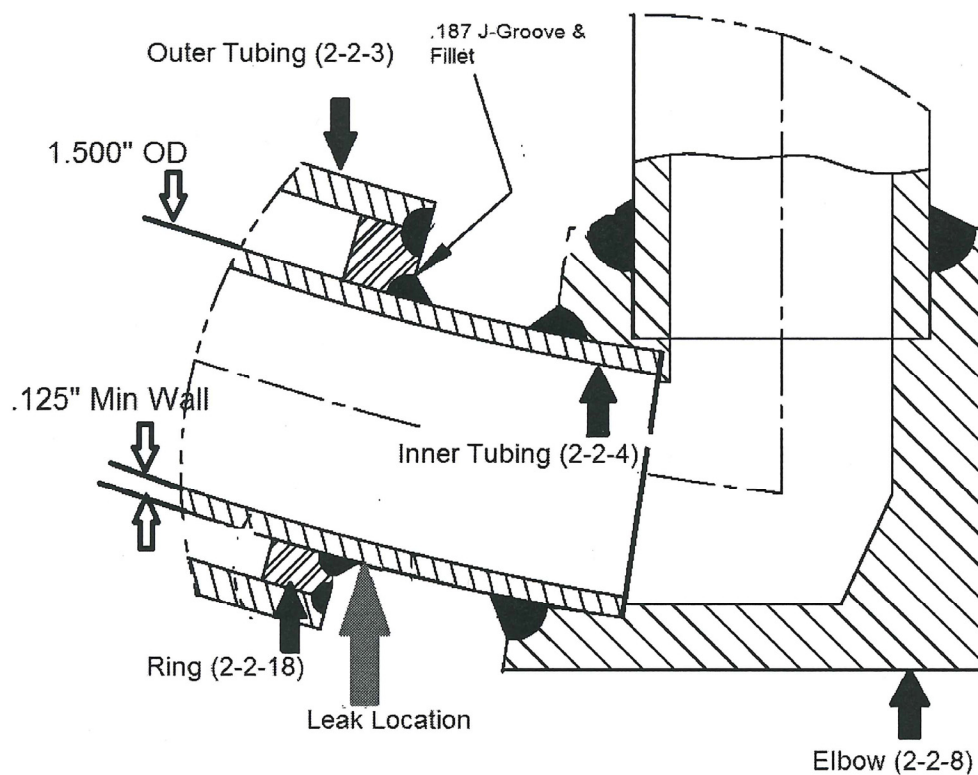
FIGURE 1

The seal heat exchanger is a tube in tube type. The inner tube material is 1.5 inch outside diameter (OD) ASME Class 1, SA-213 Type 316 tubing. The minimum wall thickness is 0.125 inches. The location of the flaw is where the inner reactor coolant pressure boundary tube (2-2-4 in Figure 1 below) exits the outer tube of the heat exchanger (Item 2-2-3 in Figure 1 below) before returning to the pump cover.

ST LUCIE 1B2 RCP HEAT EXCHANGER FLAW

On January 31, 2017, St. Lucie Unit 1 was shut down to investigate leakage in the 1B2 RCP shroud. The investigation revealed that the 1B2 RCP seal cooler heat exchanger tubing was leaking. The leak is located in the tube material near the toe of the fillet weld that joins the seal cooler tube (Figure 1, Item 2-2-4) and the heat exchanger ring (Figure 1 Item 2-2-18). Based on the location and apparent orientation of the leak/defect the likely cause is OD initiated fatigue. The flaw orientation and size will be further characterized as part of the initial surface visual and dye penetrant examinations prior to defect excavation to assure defect removal and will validate the initial cause. The cause and extent of condition will be determined by the station's corrective action program.

The geometry of the RCP seal cooling line and heat exchanger assembly as shown in Figure 1, does not allow for in-situ radiographic examination. Specifically, the design of the assembly in this location does not use full penetration welds, has various diameters/thicknesses and has multiple access obstructions which does not allow for a radiographic examination of the repair weld in the tube material.

FPL proposes to fully remove the flaw and perform a weld repair to restore the tube wall in accordance with the applicable ASME Code. An alternative is requested to the ASME Code nondestructive examination requirements as described below.

As an alternative to performing radiographic examination of the repair weld to the seal cooler tube material (NB-2539), FPL proposes that progressive dye penetrant examinations be performed.

The defect will be completely removed by mechanical means. The repair area will be excavated and prepared suitable for welding. The prepared excavation will be cleaned as complete as possible. As the repair is an open root weld, the back side of the joint (tube ID) will be purged to eliminate moisture and provide a backing gas for the root pass. The root pass will be dye penetrant examined to assure weld quality. Subsequent weld layers, until the minimum tube wall is restored, will also be dye penetrant examined to assure the weld quality. As an added level of assurance, additional weld metal overlay layer(s) will be applied to the repair area and incorporated into the existing fillet weld to provide a smooth transition between the fillet weld and the tube. This transition will resemble a 2:1 fillet weld configuration as much as physical access to the repair region permits. The final weld repair area will receive a dye penetrant examination to assure the quality of the completed repair. Since the flaw will be completely removed, and the Code compliant repair restores the full thickness of the tube, the original design requirements will be met and the repair will be a life time repair. The progressive dye penetrant examinations are expected to provide a comparable level of quality as the partial penetration and fillet welds used in the RCP seal cooler tube connection welds which are not volumetrically examined.
