TRIP REPORT
by
W. R. Rutherford

ELECTRICAL CONNECTOR ASSEMBLIES

IE Bulletin 77-05A

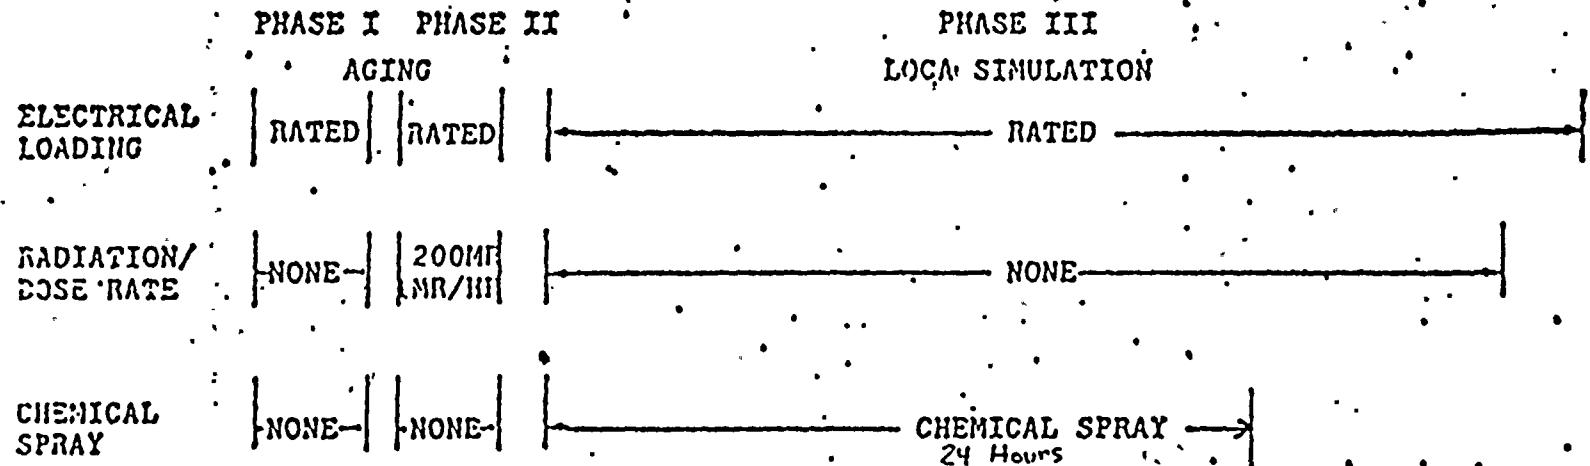
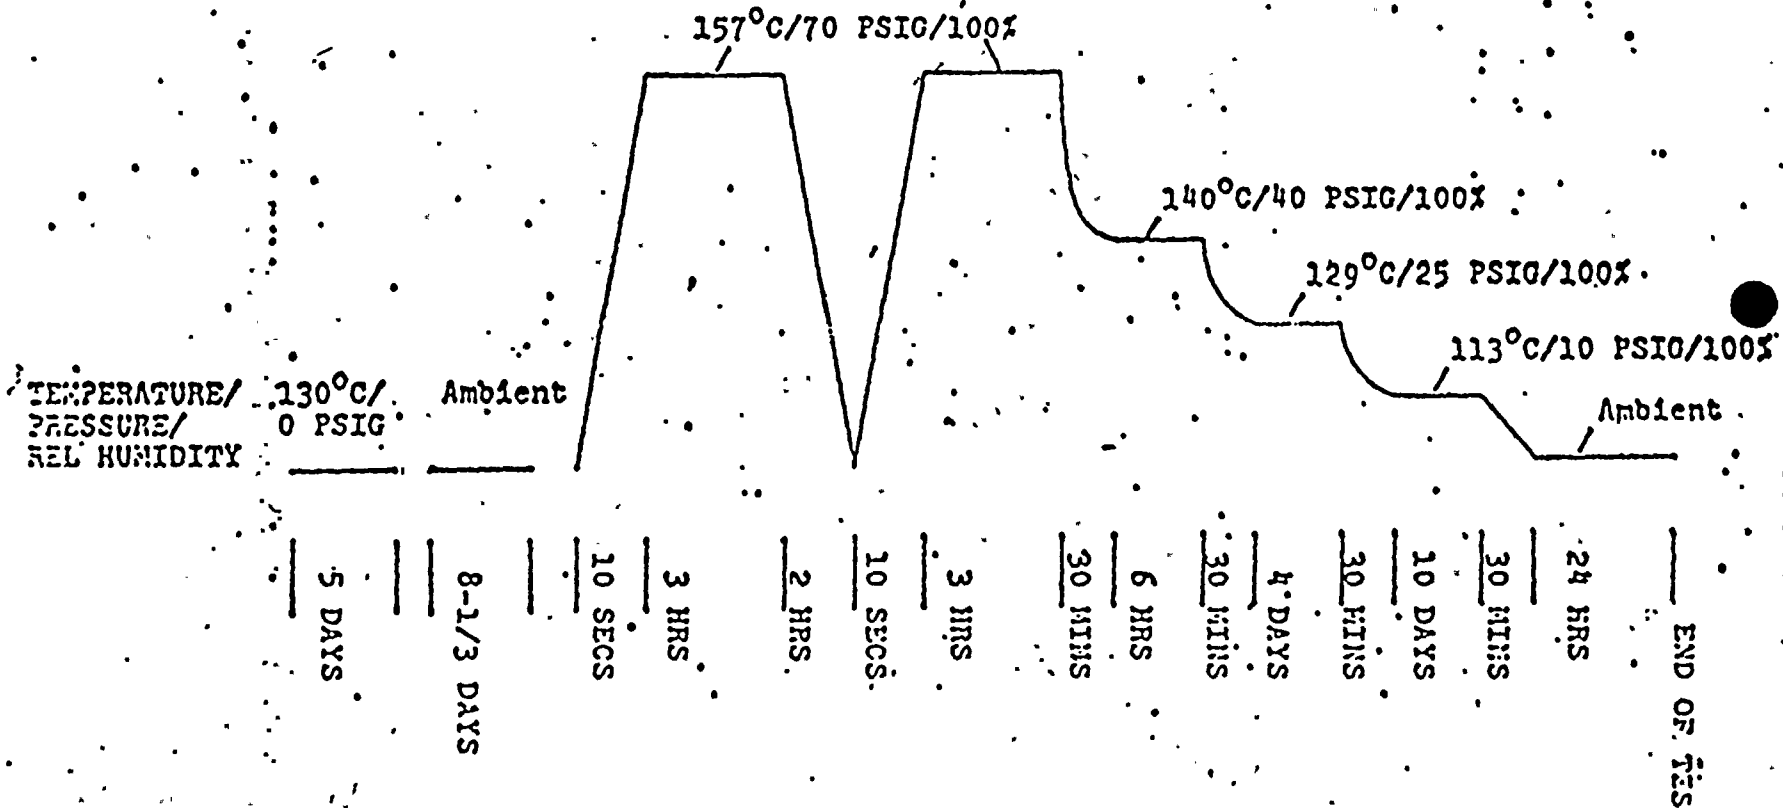
Figure 1

The three tests performed by Sandia were composed of two sequential and one simultaneous exposure to LOCA environments. In each case the equipment was exposed to radiation and thermal aging prior to operating under the simulated LOCA conditions. Figures 1 and 2 describe the test profiles for sequential and simultaneous tests respectively (Sandia tests were designed to study synergistic effects). Each of the tests satisfy the intent of IEEE 323-1974. The assemblies were electrically loaded to 20 amperes and 600 volts at the start of the tests. Insulation resistance and capacitance measurements were recorded during the tests to indicate damage.

SEQUENTIAL TEST PROFILE

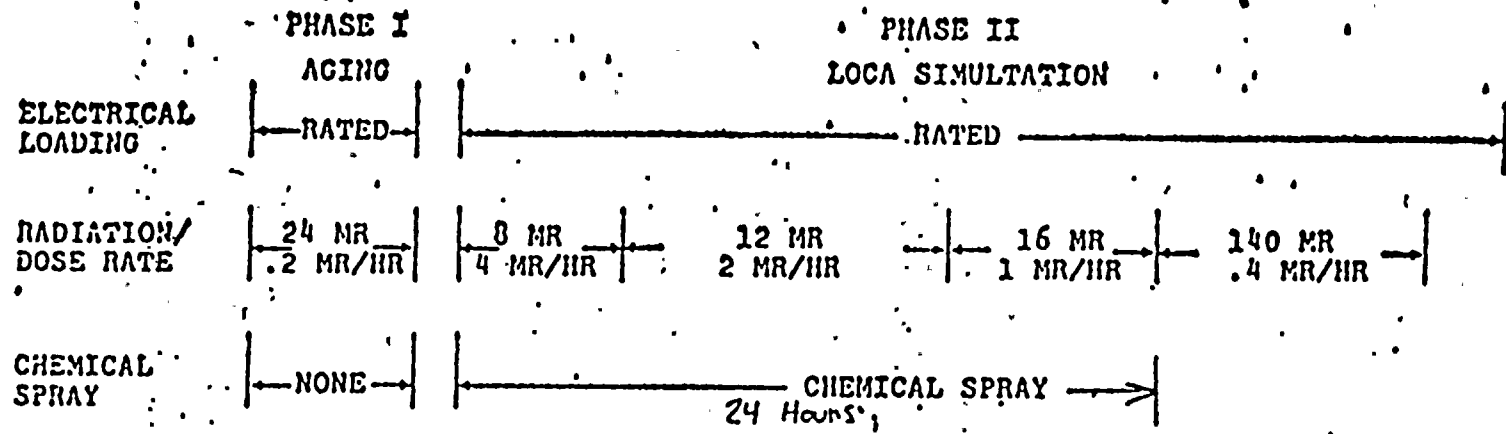
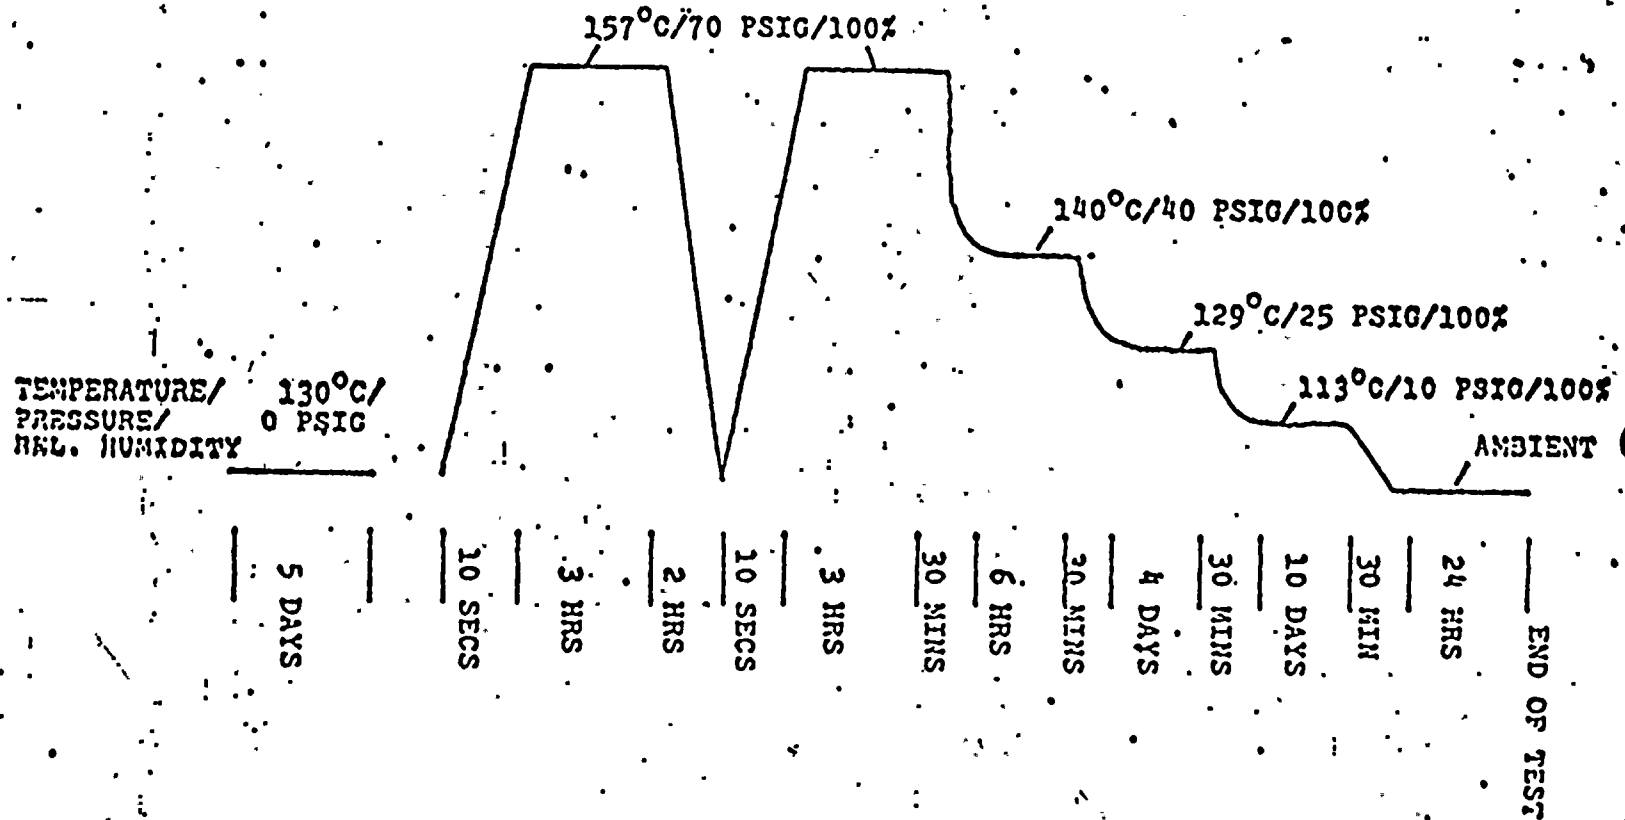
Figure 2

SIMULTANEOUS TEST PROFILE
