DESCRIPTION:  
Ltr reporting an incident on 6-2-72, regarding a problem with the electromatic relief valves & trans the following:

ENCLOSURES:  
Consolidated Electromatic Relief Valve  
6"- Type 1525-VX (Drawing)

PLANT NAMES: Nine Mile Point

Re: Provisional Operating License: DPR-17  
Docket No.: 50-220

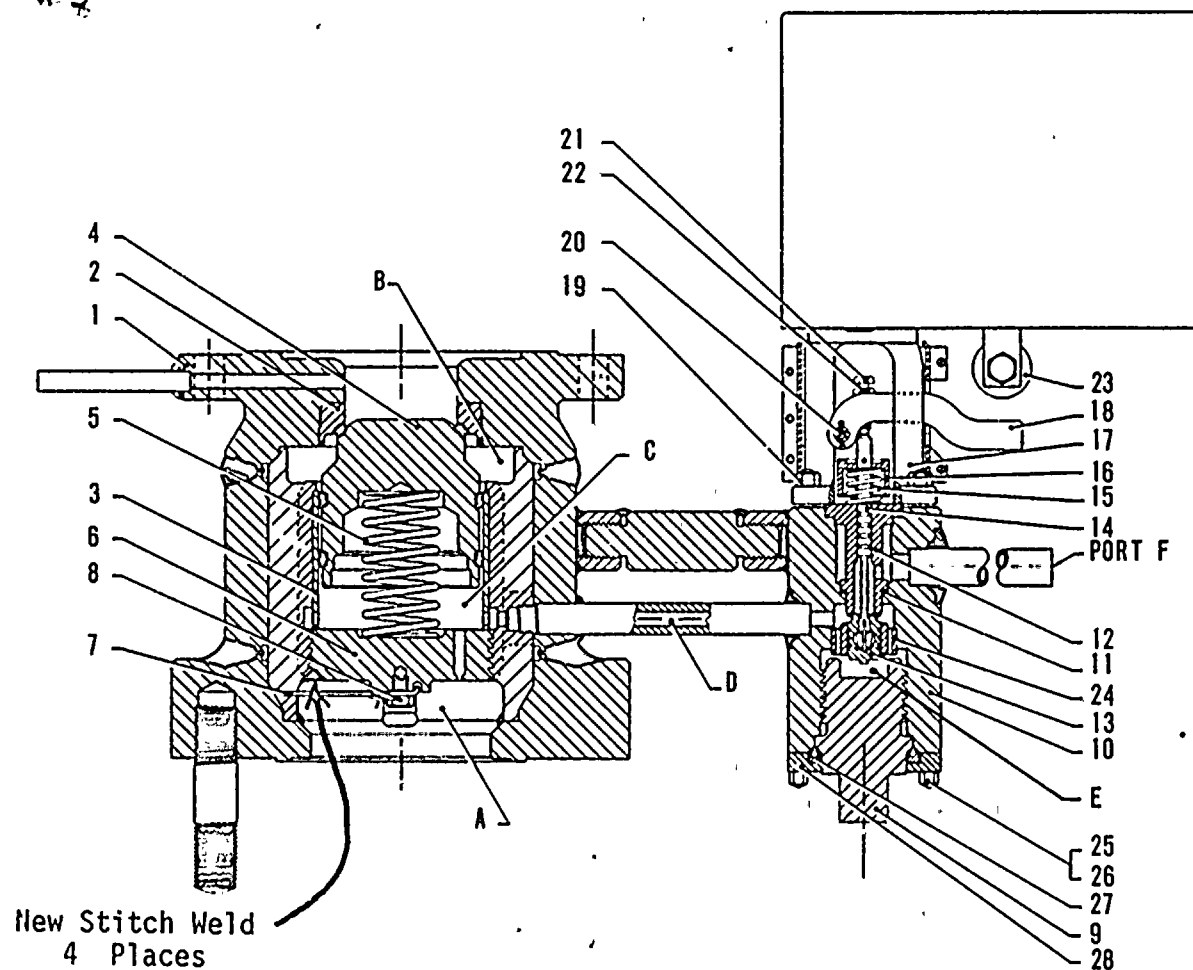
## CONSOLIDATED ELECTROMATIC RELIEF VALVE

On one valve, the locking screw, Part #8 on enclosed drawing, had become unscrewed allowing lock retainer Plate #7 to fall free (both parts were recovered in the turbine stop valve strainer basket). This permitted the disc retainer, Part #6, to completely back-out falling to the bottom of the valve body. In this condition, it would be impossible to bleed enough steam from Chamber "C" to open the valve as it would be wide open to Chamber "A" and would not have the benefit of the restricting orifice in the retainer plate.

One other valve was found with the locking screw, Part #8, backed out 1/16" but the lock retainer plate and disc retainer had not moved, therefore the valve was operable. Tie-wires holding the locking screws were broken on all six valves.

- #4 Valve Disc.
- #6 Disc Retainer
- #7 Lock Retainer Plate
- #8 Locking Screw

Repair was effected to all six valves by removing the locking screw, Part #8, and lock retainer plate, Part #7. In their place, four 1/4" V grooves, 1" long, were cut in the joint between the disc retainer and the valve body insert. These were stitch welded together. Future maintenance may be accomplished by grinding out the stitch weld. In this manner, there can be no loose parts on the valves to drop into the steam lines and dependability of valve operation is increased.
