DOMINION NUCLEAR CONNECTICUT, INC.
MILLSTONE POWER STATION UNITS 2 AND 3
RESPONSE TO REQUEST FOR ADDITIONAL INFORMATION REGARDING END OF
CYCLE 23 AND END OF CYCLE 17 STEAM GENERATOR TUBE INSPECTION
REPORTS (CAC NOS. MF8507 & MF8506)

**RESPONSE TO REQUEST FOR ADDITIONAL INFORMATION REGARDING MPS2
END OF CYCLE 23 STEAM GENERATOR TUBE INSPECTION REPORT**

**RESPONSE TO REQUEST FOR ADDITIONAL INFORMATION REGARDING MPS3
END OF CYCLE 17 STEAM GENERATOR TUBE INSPECTION REPORT**

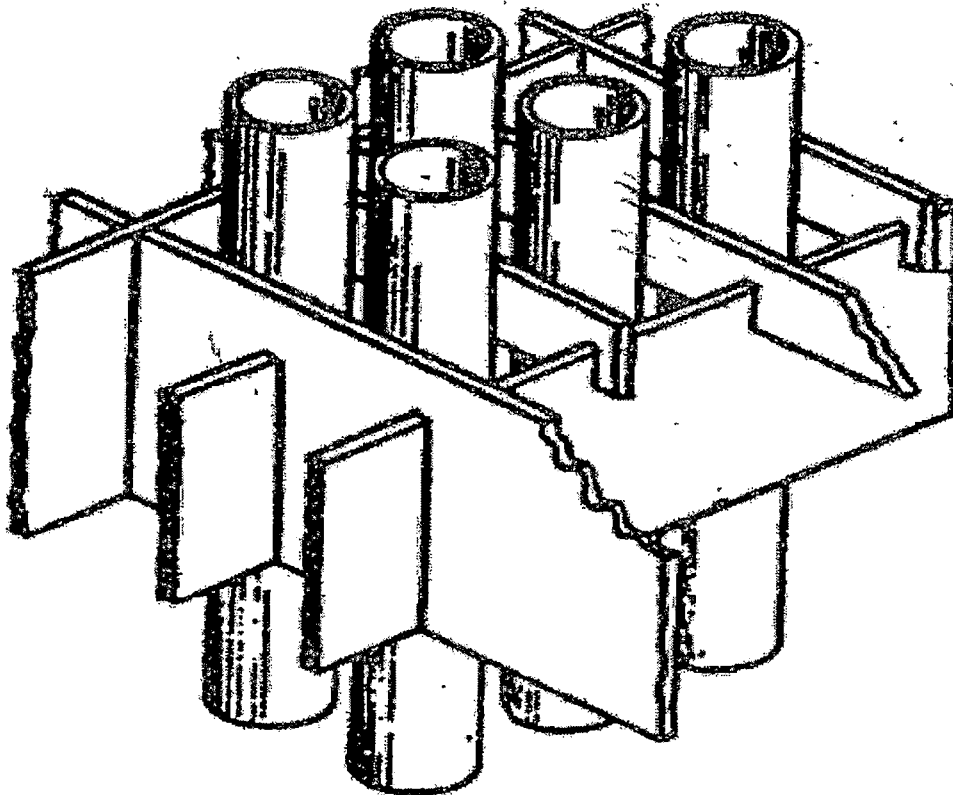
**Figure-1
Typical Lattice Grid Configuration**

The tubes are supported by a number of lattice grids in the vertical (straight) section of the tube bundles as depicted in Figure 1. The configuration of the support/anti-vibration structures in the U-bend section of the tube bundle are illustrated in Figure 2.

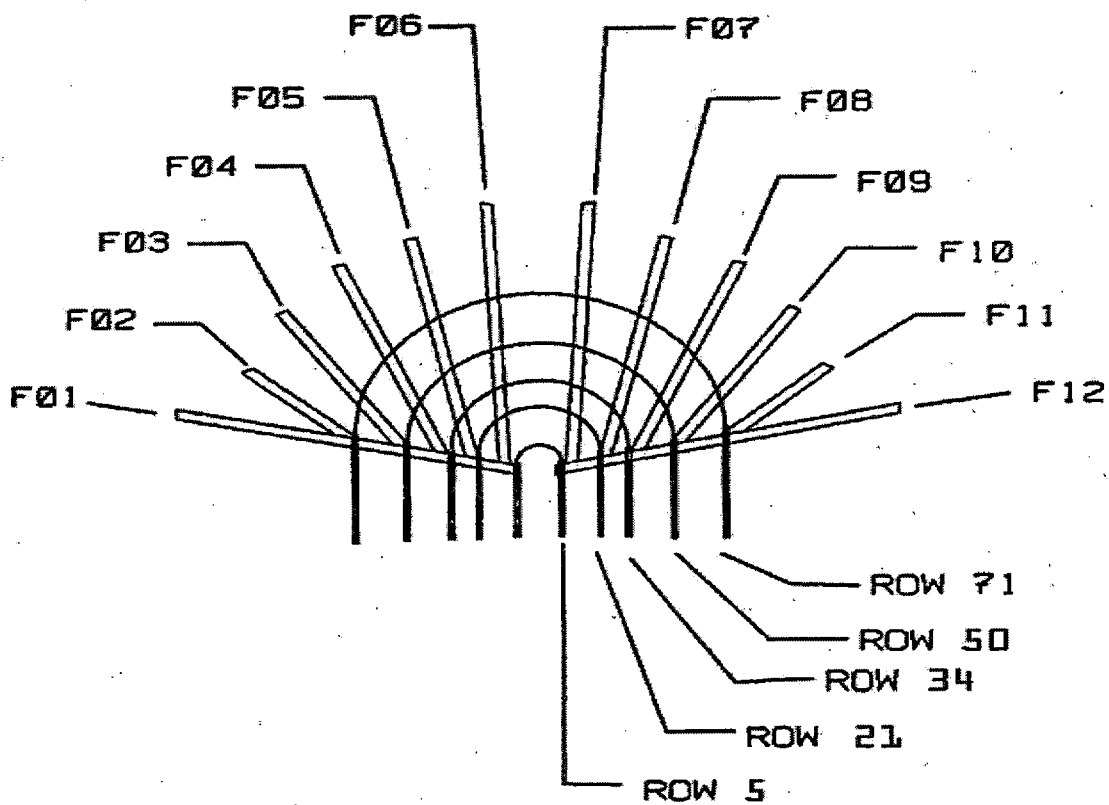
Figure 3
Fan Bar Arrangement

The fan bars are of various widths and the two fan bars at a given tube/fan bar intersection are offset from one another. This offset distance varies from one fan bar to another.

As shown in Figure-3, the contact area where a tube is crossed by a particular fan bar depends on the position of the tube within the tube bundle, U-bend radius, and the angle of the fan bar.

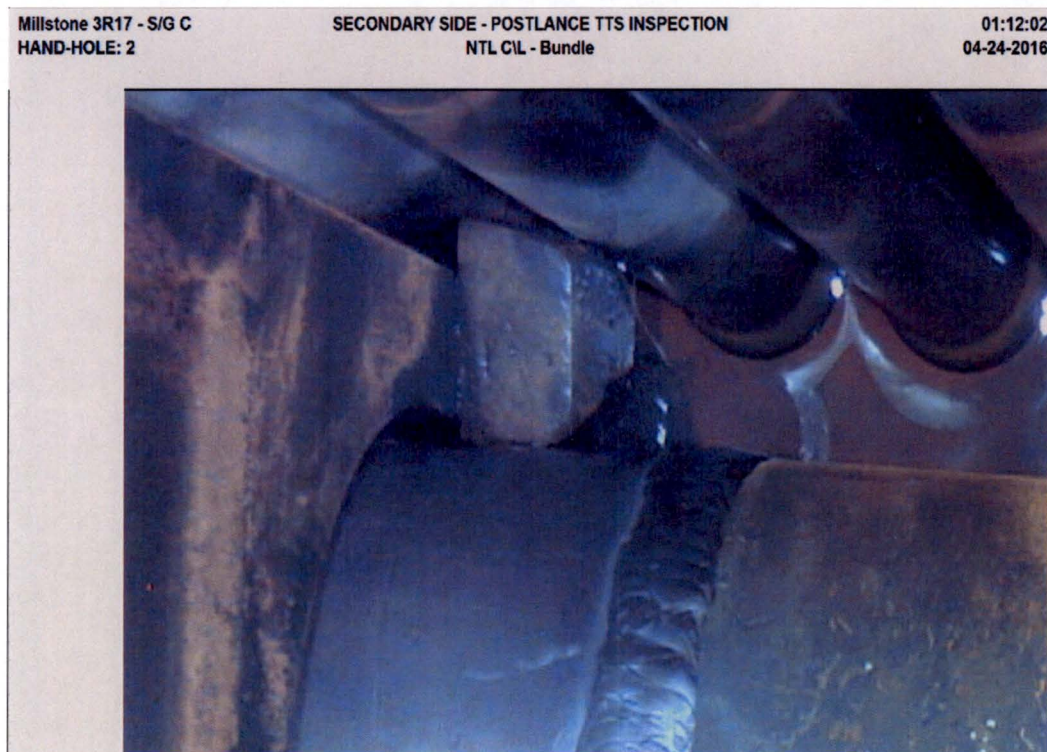
Figure-1
Foreign Object Between Blowdown Piping and Tube R1C4

In the four MPS3 SGs, only one foreign object, which was first observed and evaluated during 3R8 (2002), remains in steam generator C. The foreign object is a block of metal lodged between the blowdown piping and tube R1C4 on the cold leg side (Figure-1). Tube R1C4 was plugged and stabilized during 3R8. The existence of this foreign object is confirmed to be confined at this location during every secondary-side visual examination.

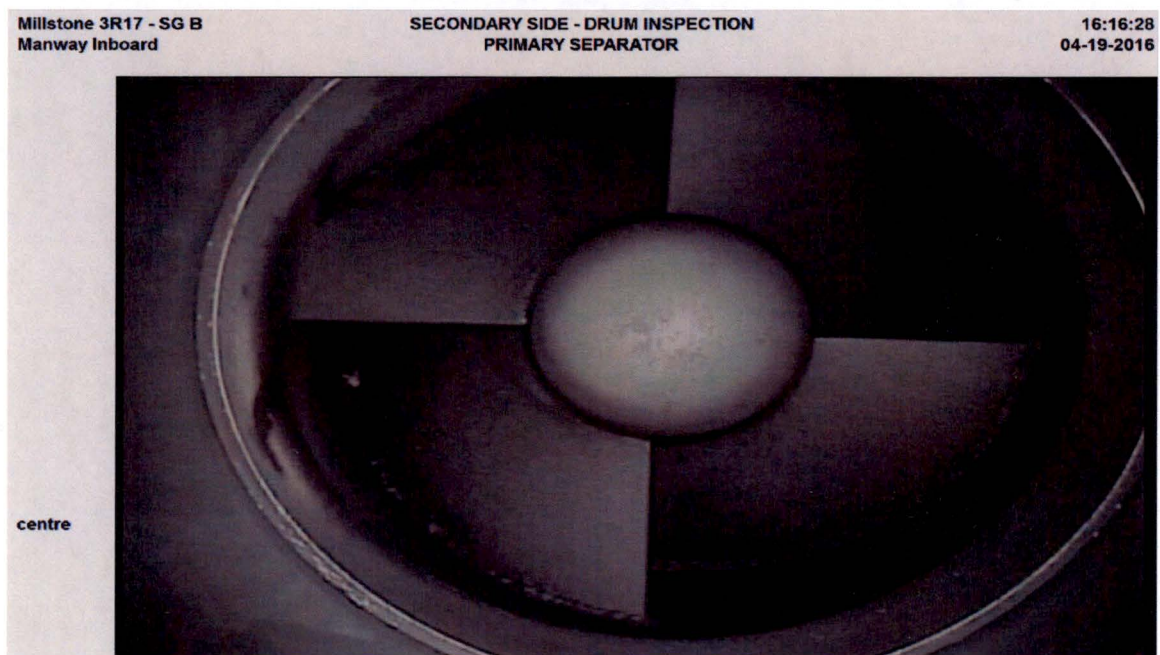
Figure-2
Primary Moisture Separator

- b. During 3R17, no visually identified foreign objects associated with eddy current indications were left in service.
- c. Upper internals inspections were performed in SG-B only. The upper internals inspection included examinations of the steam drum and upper bundle region. The secondary moisture separator chevrons were found to be in good condition. The perforated holes of the outer plate showed minor buildup of sludge in the bore of the hole. No holes were observed to be plugged. The chevrons were straight and showed a light coating of sludge deposit. The primary moisture separator swirl vanes appeared to be in good condition (Figure 2). The vanes

had a slight deposit on them but the edges were sharp, with no indication of erosion. Ladders, drains, wedges, supports and associated welds throughout the upper internals were acceptable.

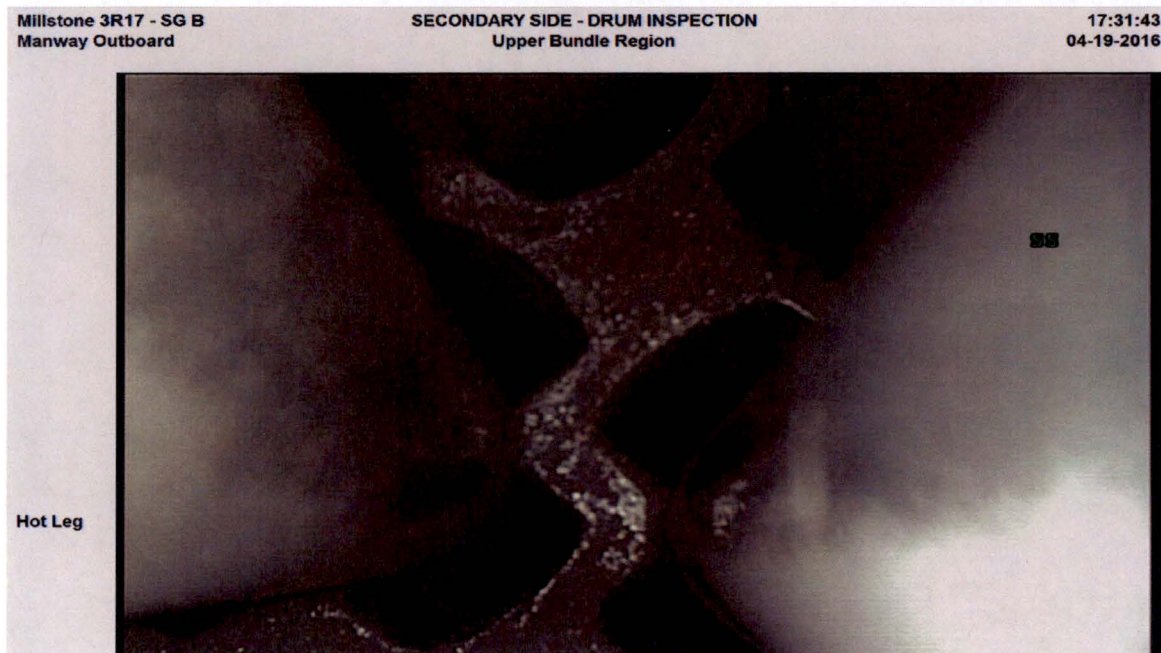
Figure-3
7th Support Plate: Broached Holes Free of Deposits

Internal visual inspections of the steam drum and upper bundle inspections above the 7th tube support plate found SG B to be in good structural condition. The majority of the loose sludge deposits in the upper tube bundle region were removed by the chemical cleaning. The views obtained of the broached holes at the periphery revealed no occlusion of the 7th tube support plate (Figure 3).
