LR-N17-0036

Hope Creek Generating Station
Renewed Facility Operating License No. NPF-57
Docket No. 50-354

Subject: License Renewal Commitment Implementation

**Hope Creek Generating Station License Renewal Commitment Implementation
90-Day Report for Refueling Outage 20**

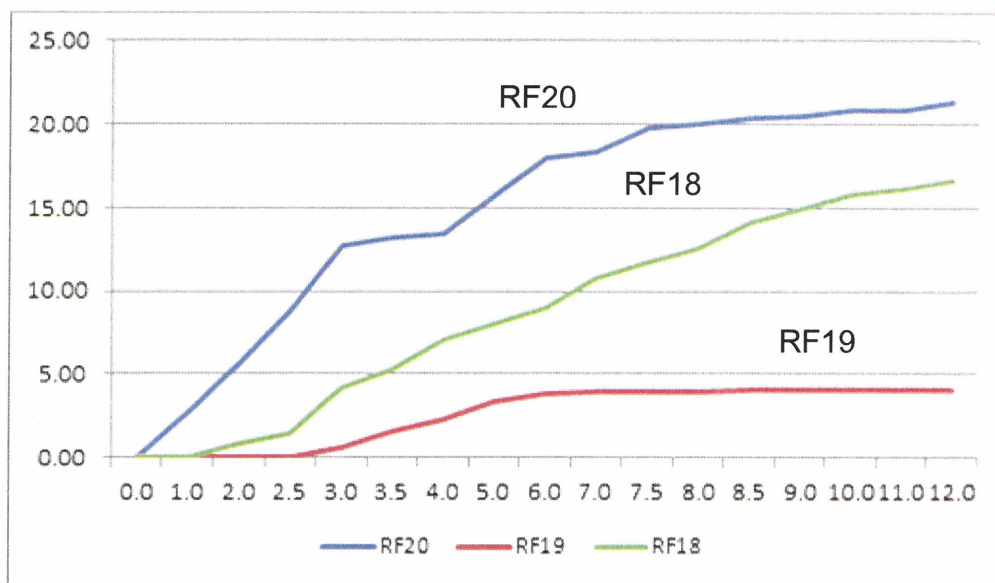
at a rate of approximately 28 dpm. Note that the cavity remained flooded through November 3, 2016. The chart below represents a comparison of the RF20 leakage to that of the RF19 and RF18 leakage, where the X-axis represents days following flood up and the Y-axis represents cumulative gallons leaked.

The data for RF18 and RF20 is similar. Leakage was first observed during RF20 after one day flooded up versus two days for RF18. The durations of the leakage for RF18 and RF20, however, were similar. The RF18 data versus RF20 data indicates a potential increase in leakage. The difference in leakage between RF18 and RF20 is very small (5 gallons total) and, overall, the total leakage continues to remain low.
