Valley Council of Governments

Connecticut Radium Sites Verification Survey

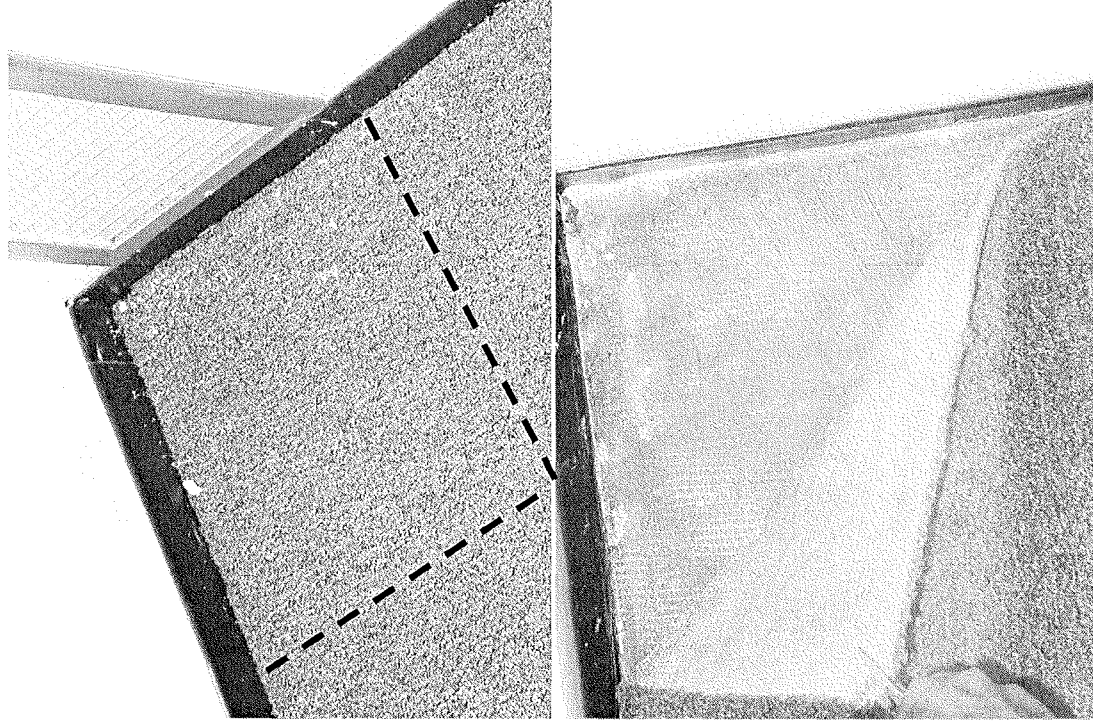
Enterprise Apartments- Apt 507

Contamination found in
living room corner.

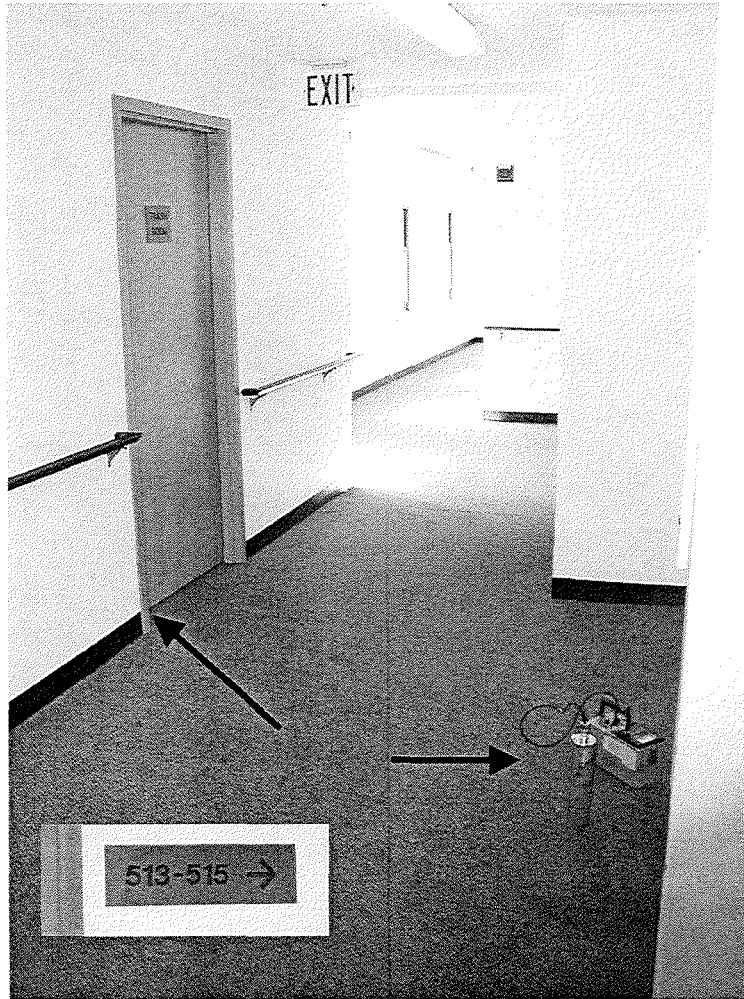
Enterprise Apartments- Hallway 513-515

Contamination found on
floor (as shown by meter)
and tile floor in Waste Room
door.

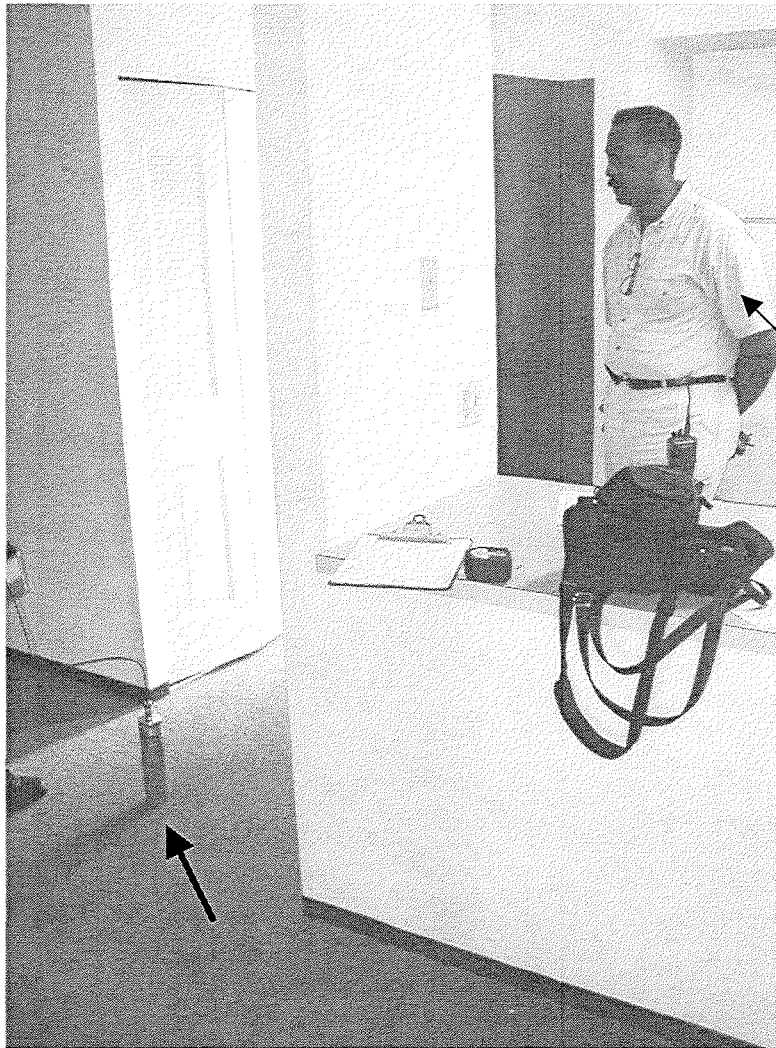
Enterprise Apartments- Apt 514 (Cont)

Contamination
found on Kitchen
Hallway.

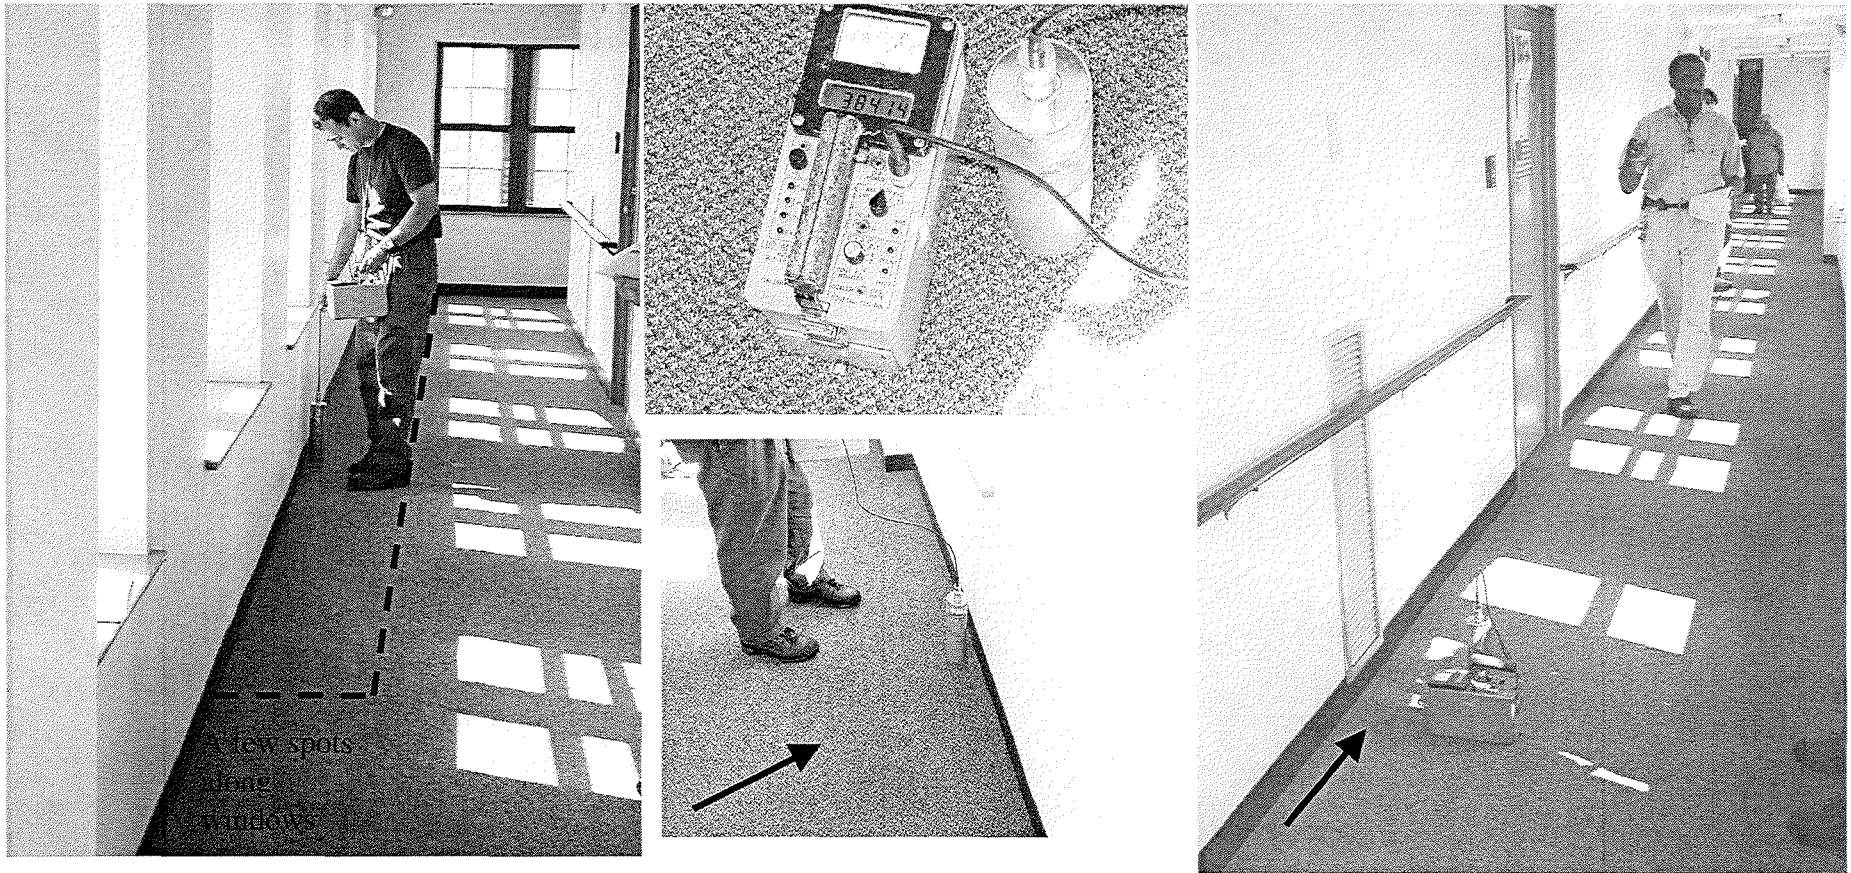
Enterprise Apartments- Hallway Outside of Apt 514

Contamination found on a few floor spots.

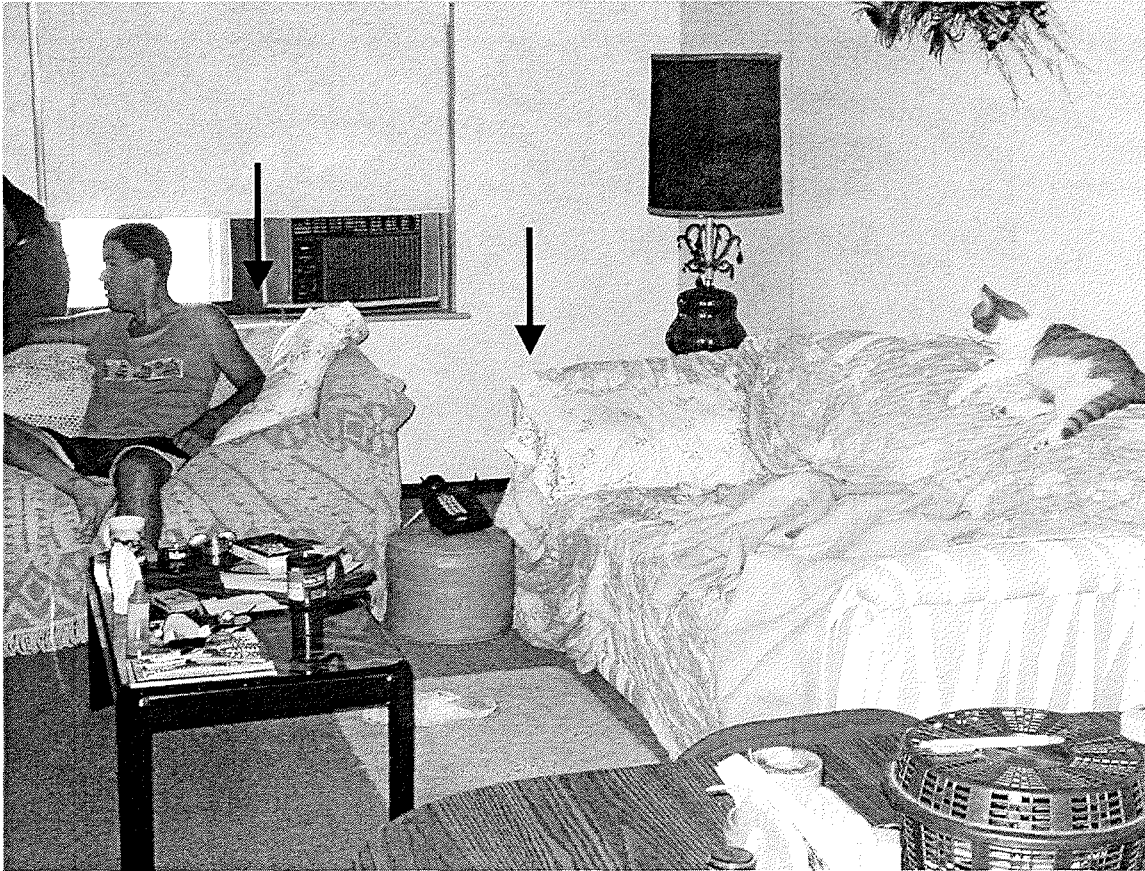
Enterprise Apartments- Apt 515

Contamination found on floor spots in Living Room corner and by window (as shown by meter).

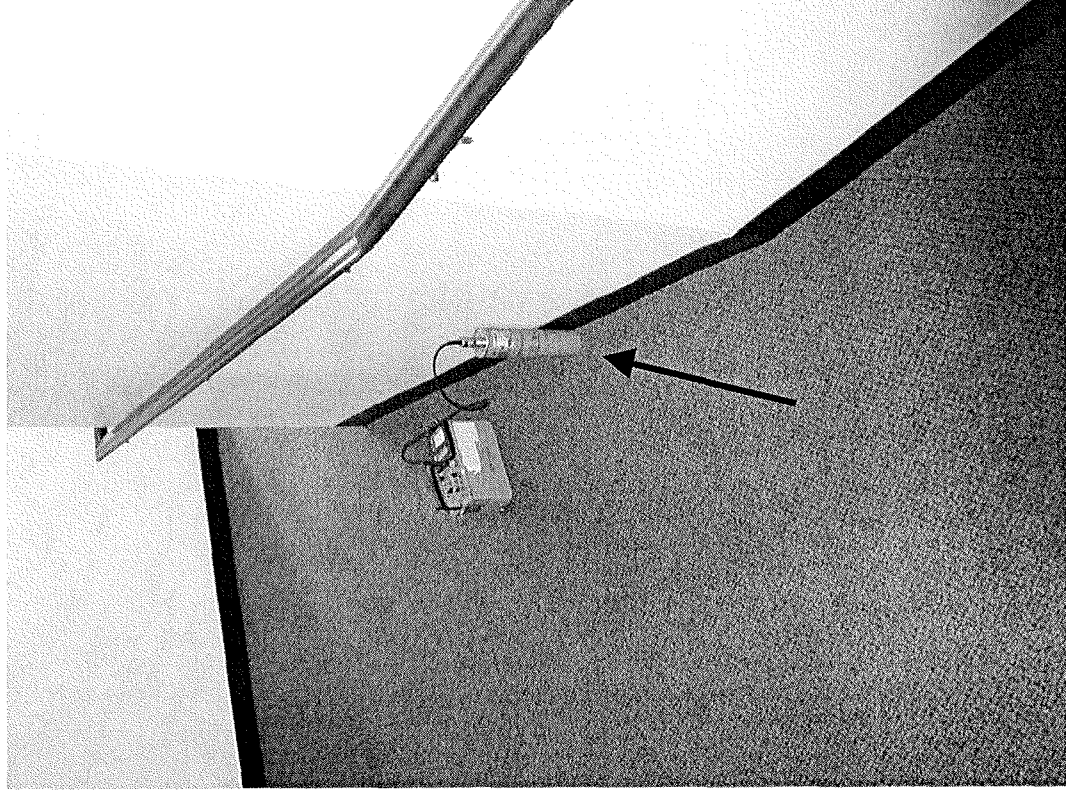
Enterprise Apartments- Hallway

Contamination found on
floor spot.

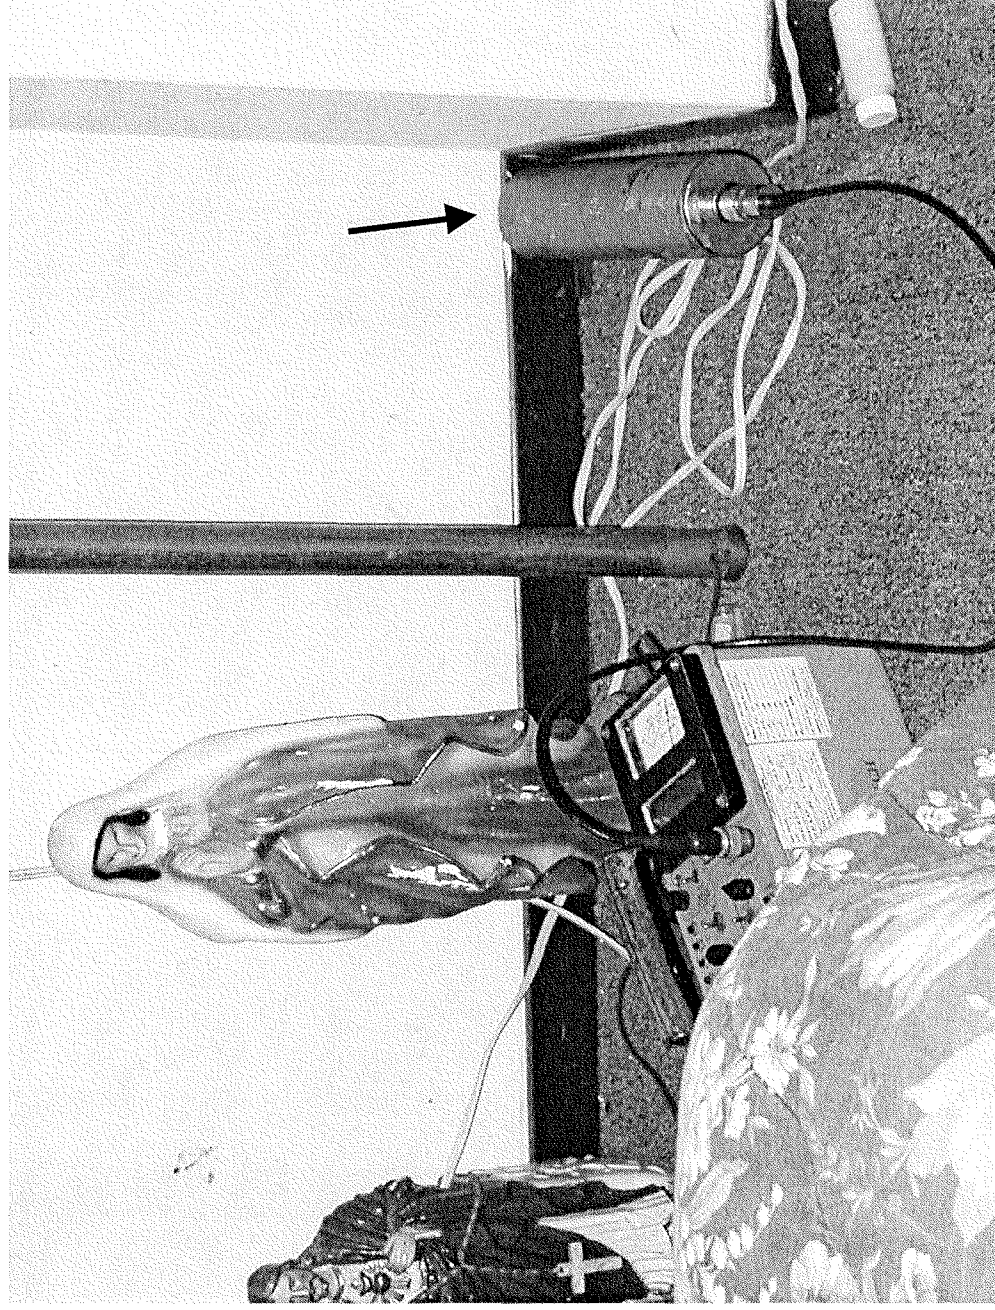
Enterprise Apartments- Apt 520

Contamination found on floor spot.

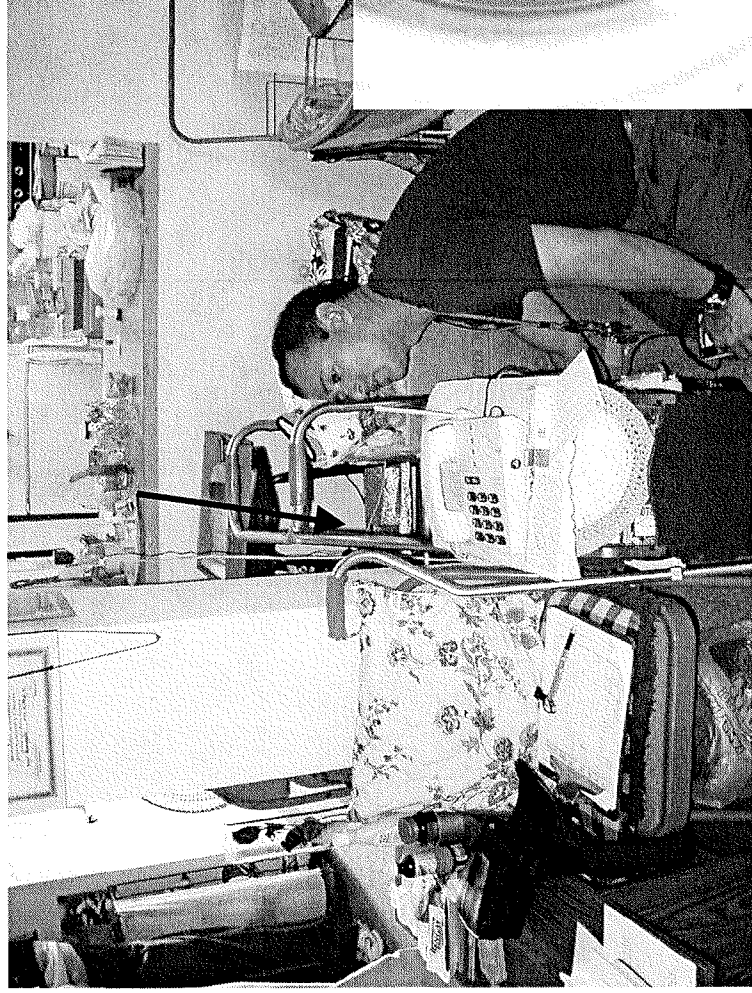
Enterprise Apartments- Apt 417

Contamination found
against base of pillar.

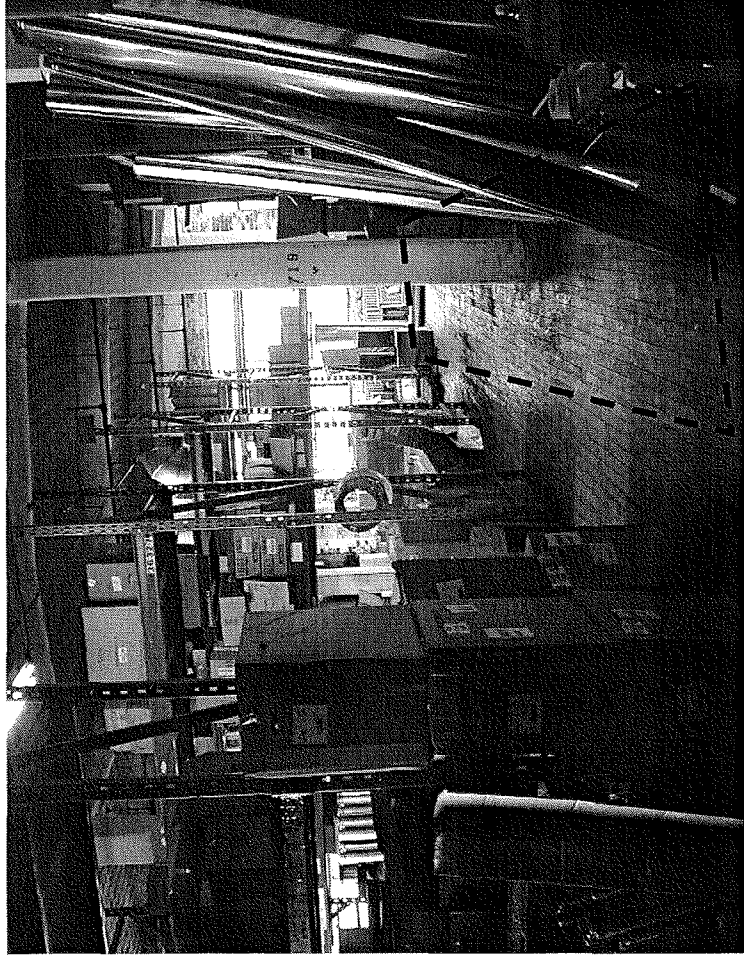
Bender Plumbing- Seventh Floor

Contamination found
throughout the floor.

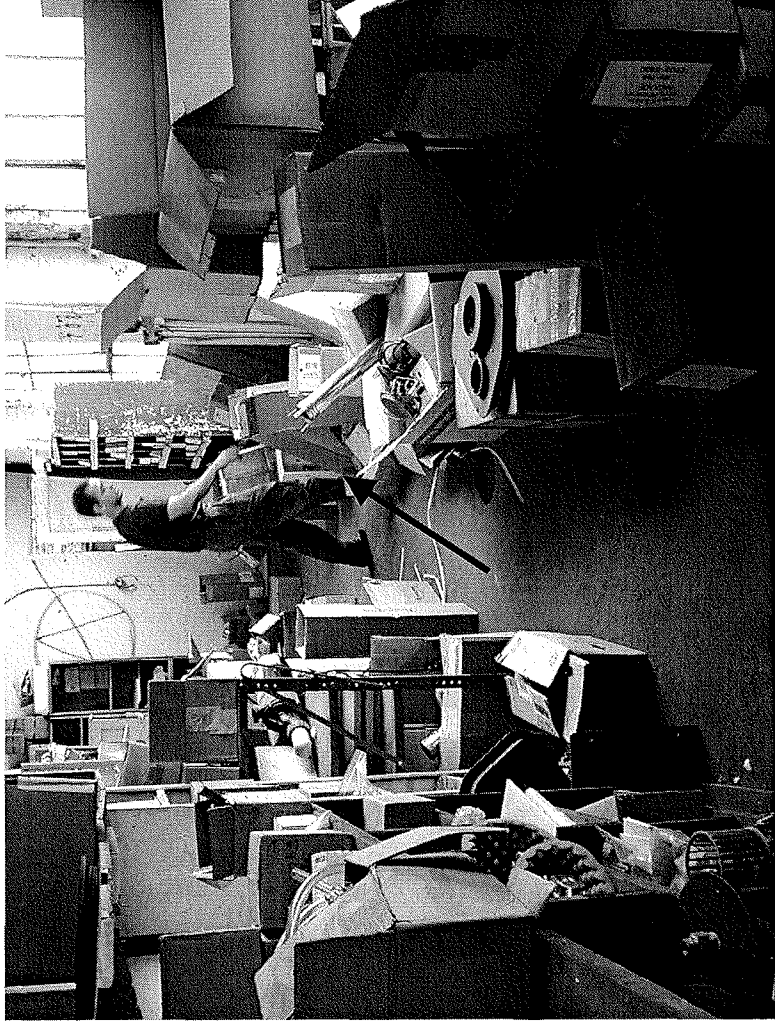
Bender Plumbing- Seventh Floor

Contamination
found along wall
and in hole.

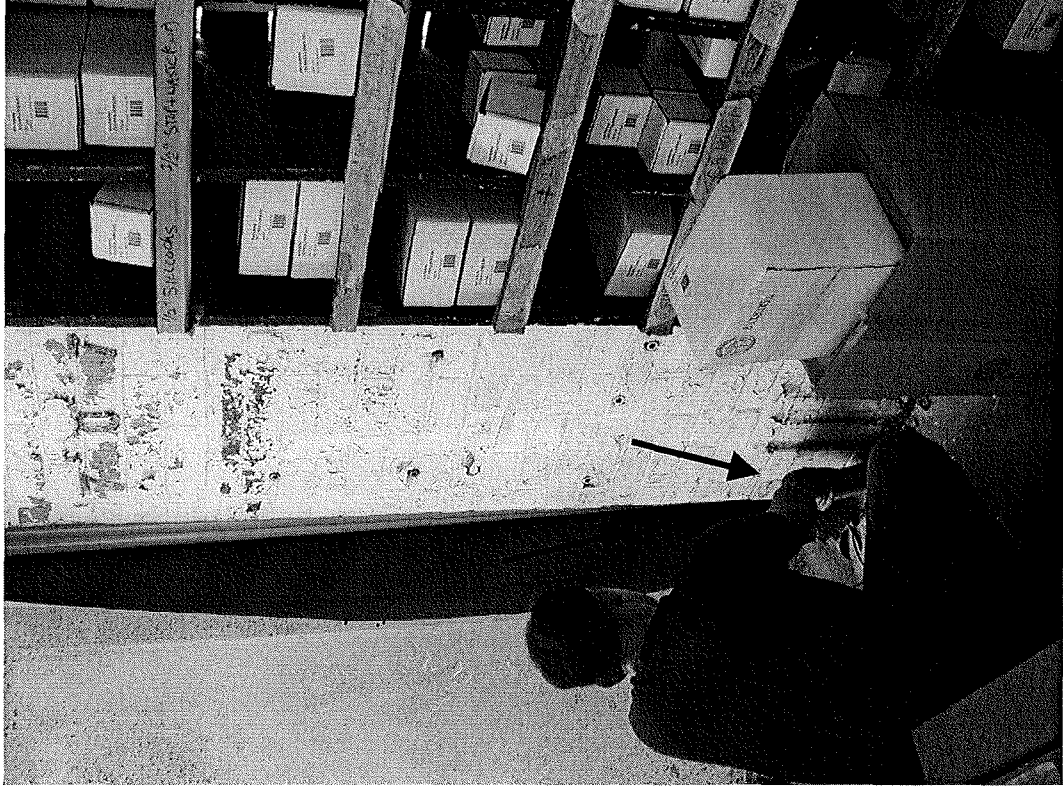
Bender Plumbing- Seventh Floor

Contamination
found in corner
by wall.

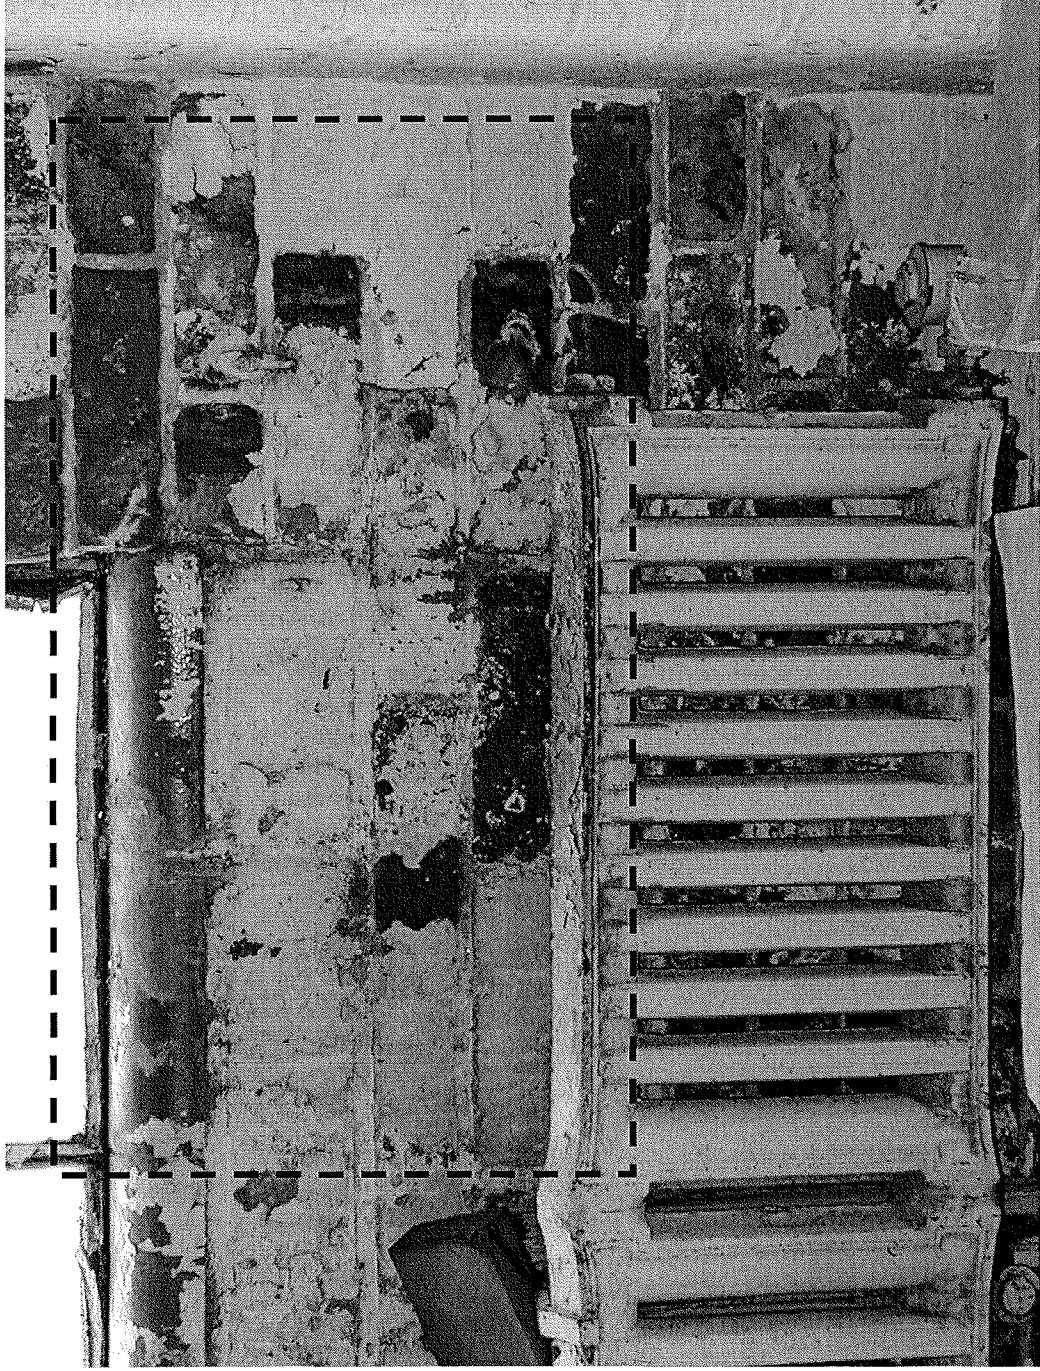
Bender Plumbing- Seventh Floor

Contamination
found along
wall and by
window sill.

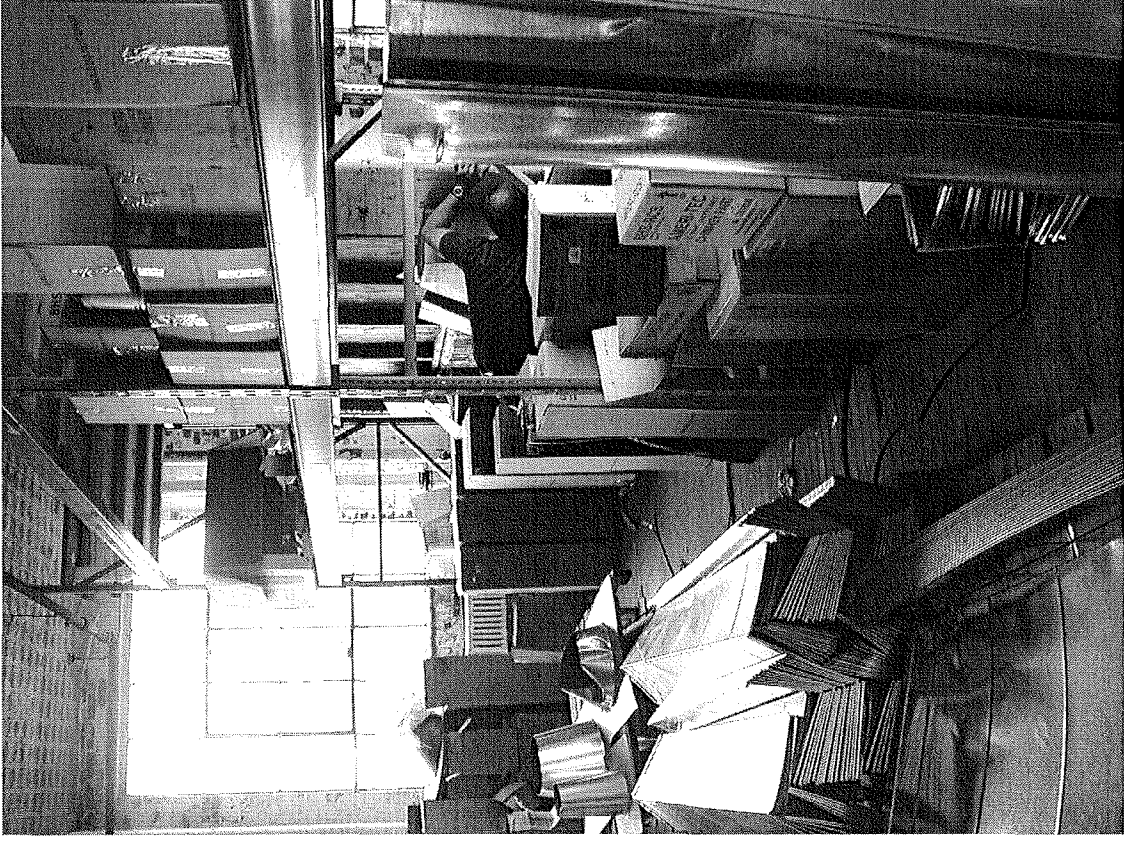
Bender Plumbing- Seventh Floor

Area is elevated.

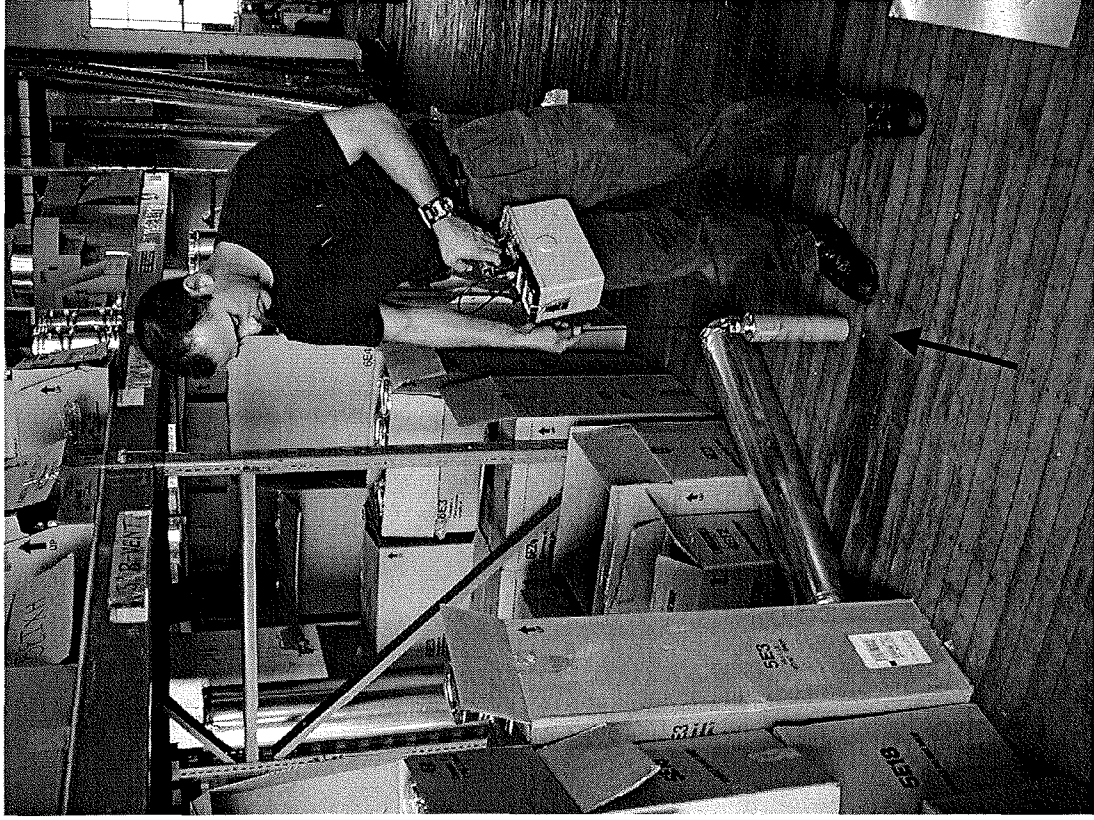
Bender Plumbing- Seventh Floor

Contamination
found on floor in
various spots
and paths.

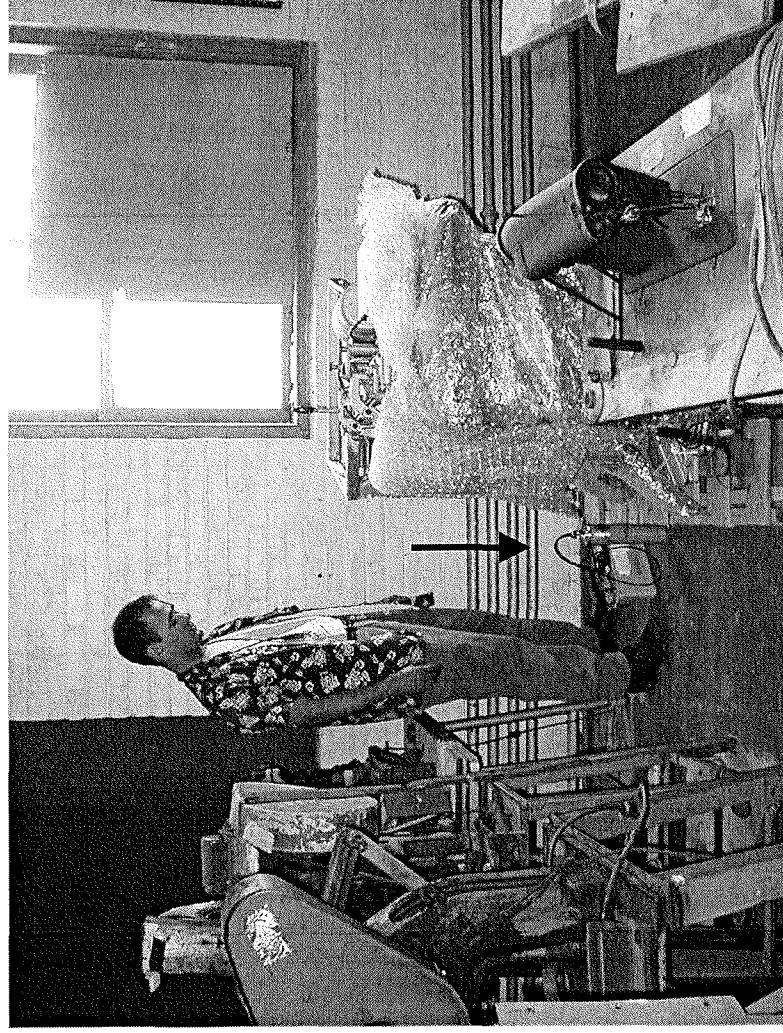
Belco-Sixth Floor

Building 1, Loft
Machines-
contamination
found in 1' x 7'
area by windows

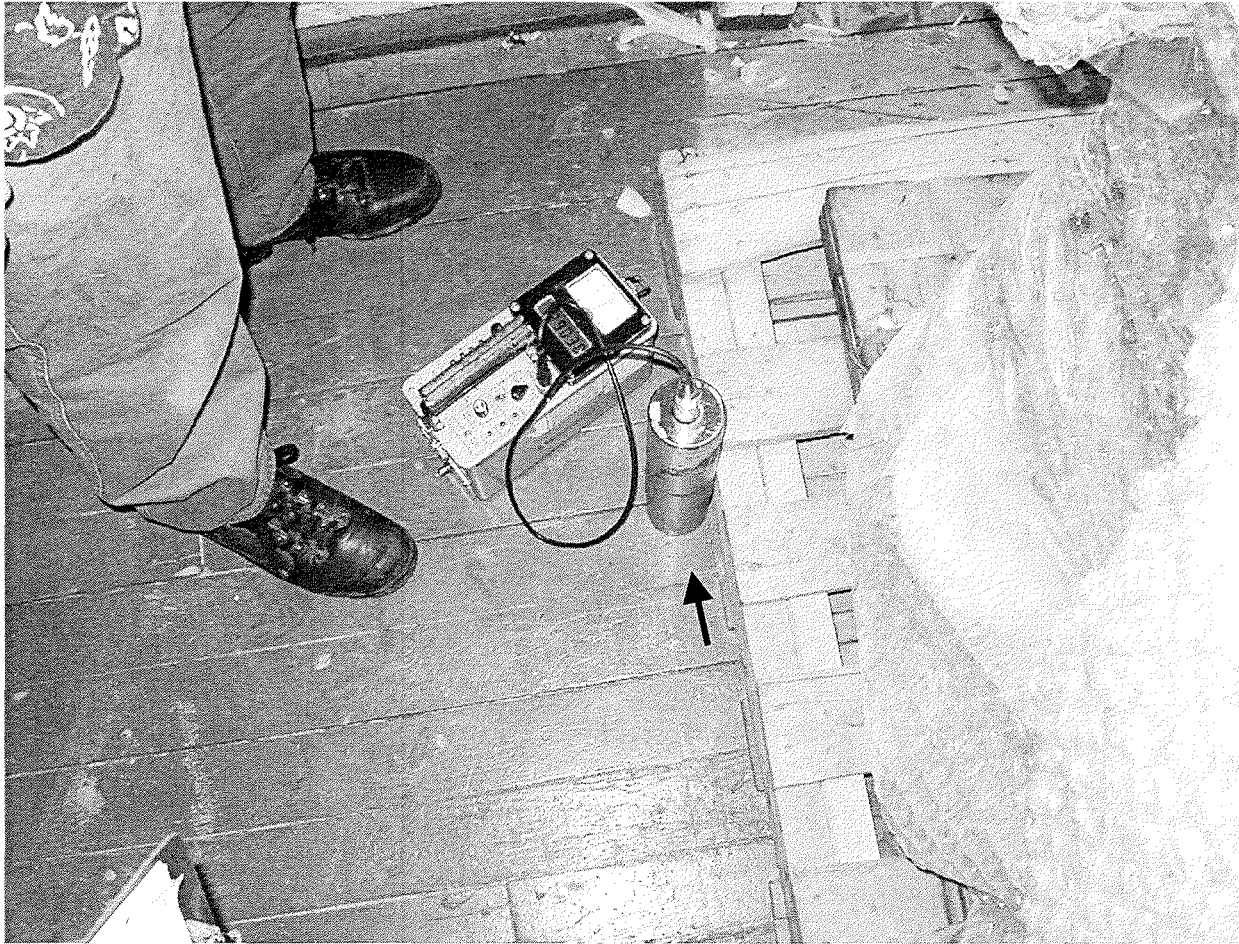
Belco-Sixth Floor

Building 1, Loft Machines- spot contamination (need to move items to find exact area of contamination)

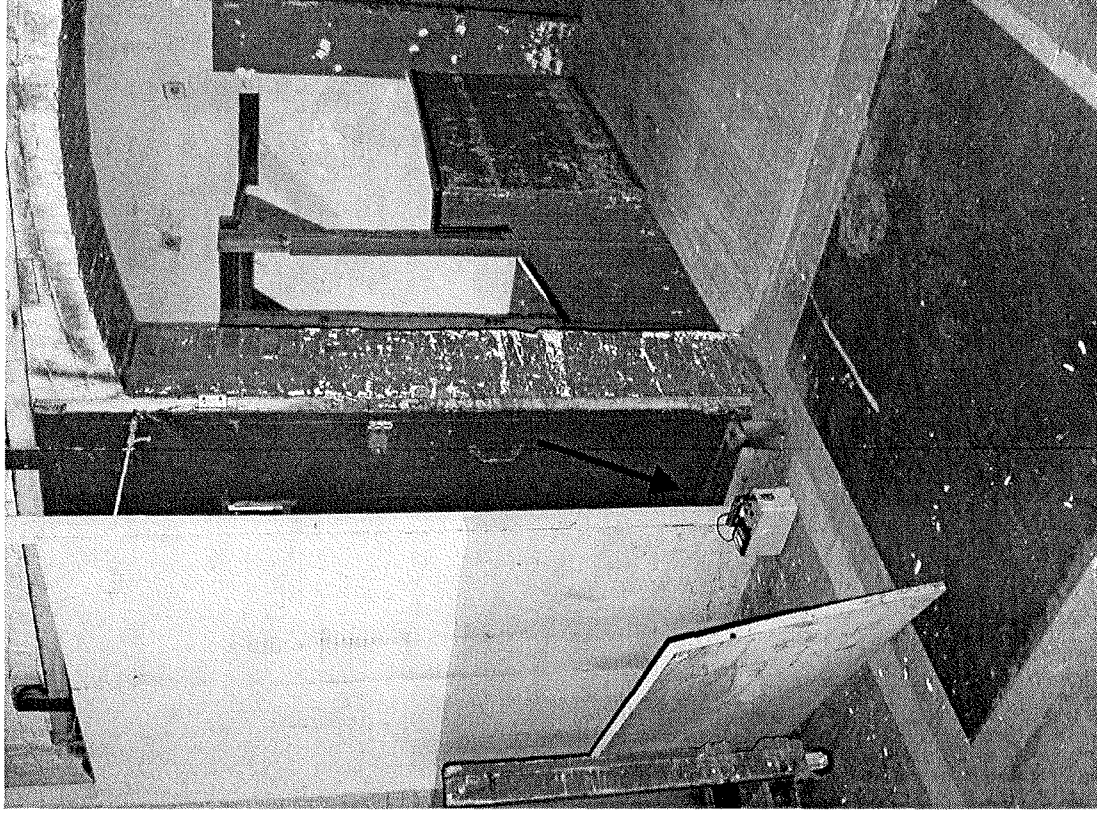
Belco-Sixth Floor

Building 2, NB –
contamination found
behind rolling door

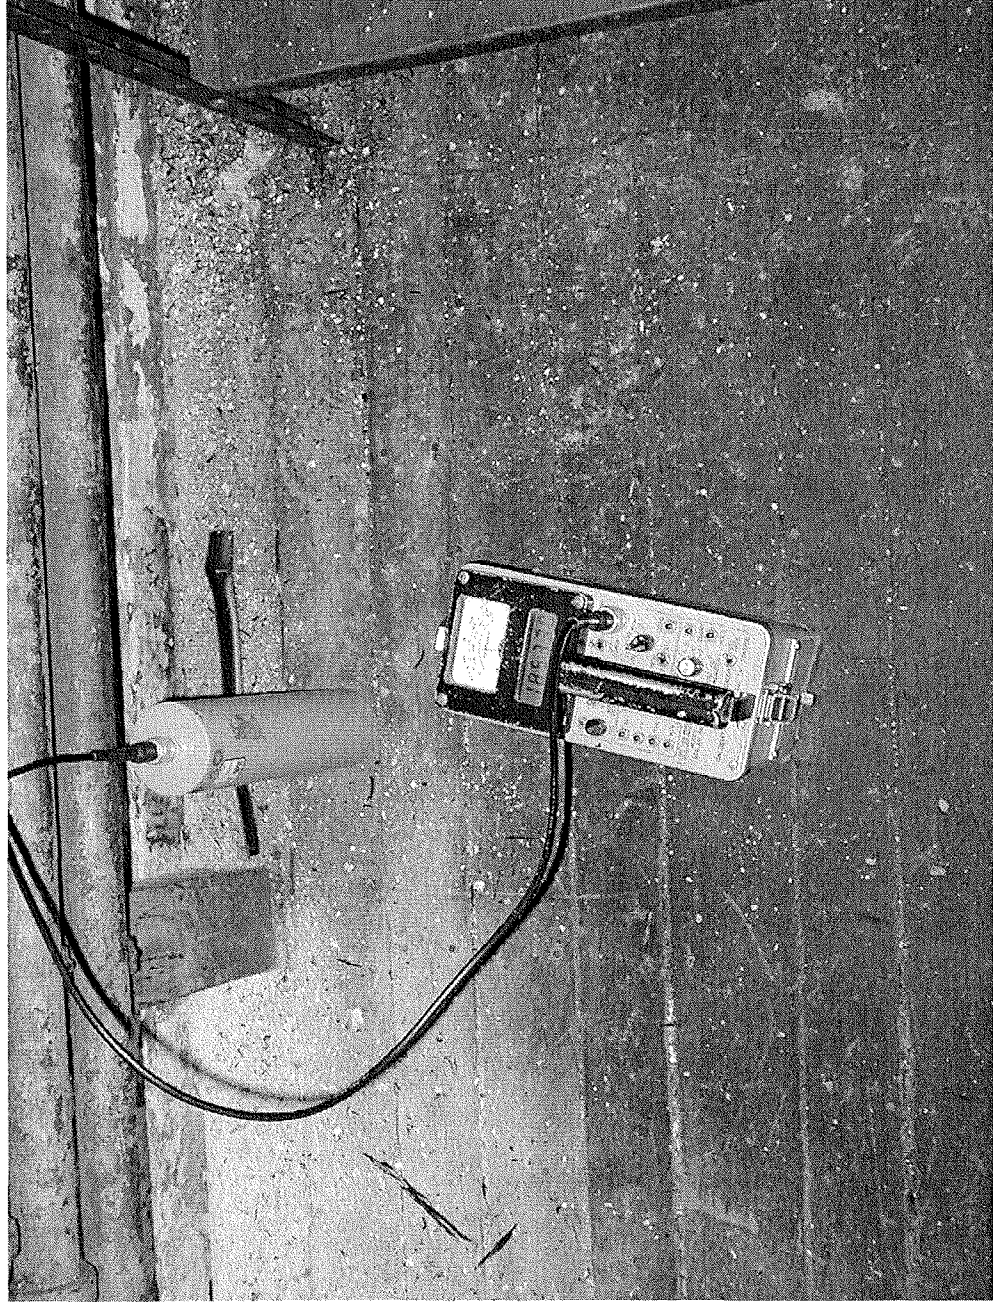
Belco- Sixth Floor

Building 3, Leatherworks- Contamination found on
floor spot by wall.

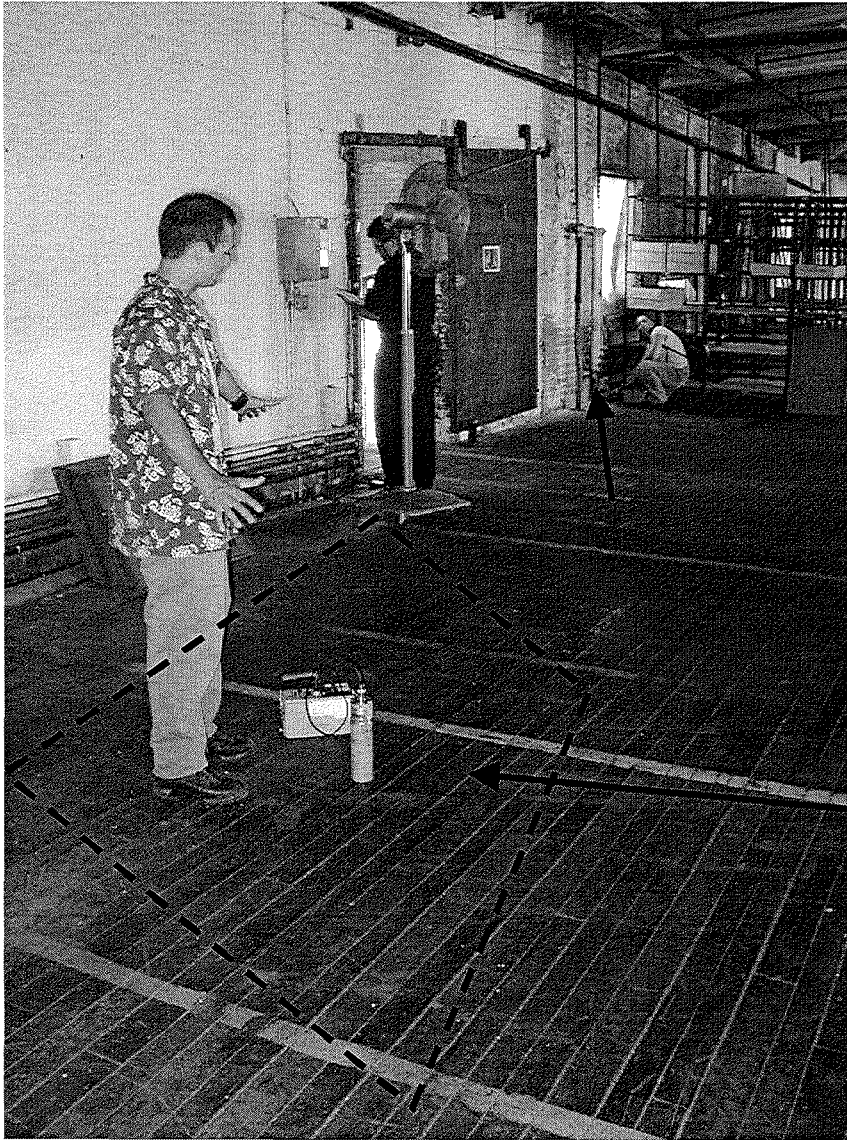
Belco- Sixth Floor

Building 3,
Leatherworks-
Contamination
found on floor
area 5' x 12'.

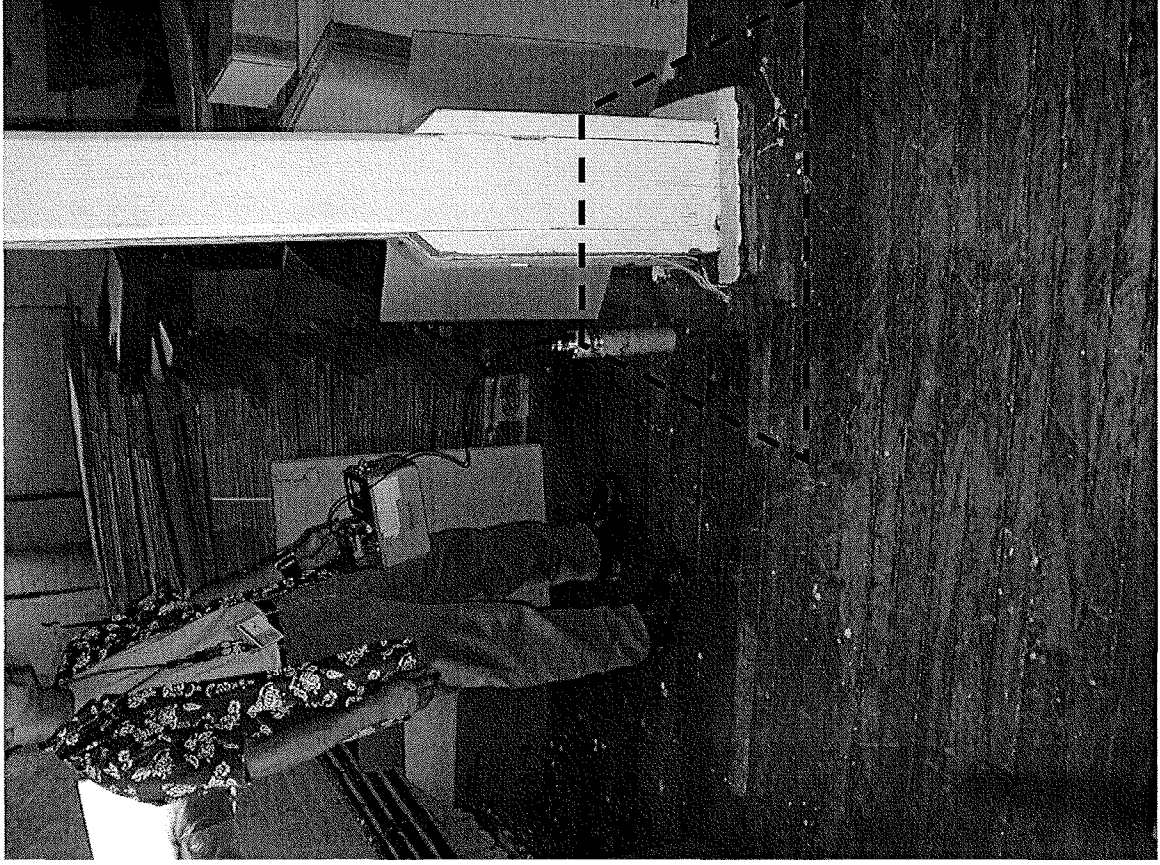
Belco- Sixth Floor

Building 3,
Leatherworks-
Contamination
found on floor
around most
pillars.

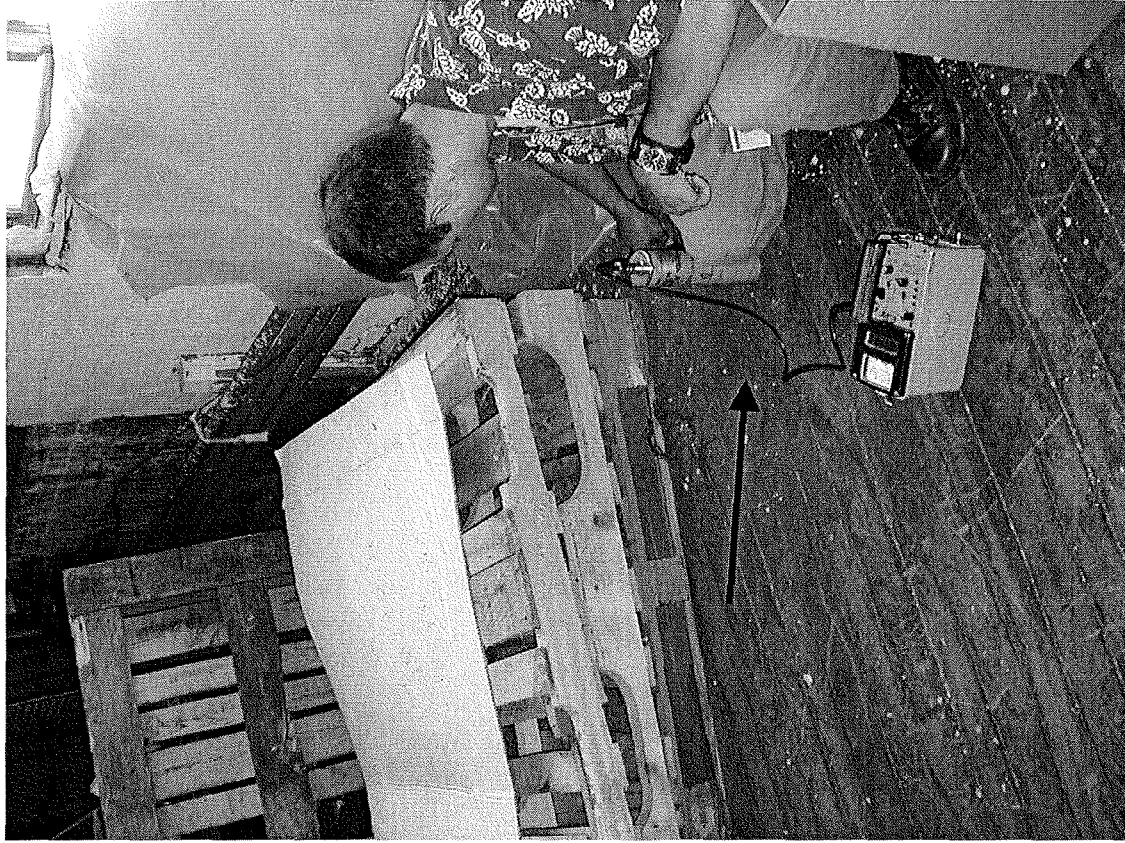
Belco- Sixth Floor

Building 1,
Leatherworks-
contamination
found on floor
spot by
windows.

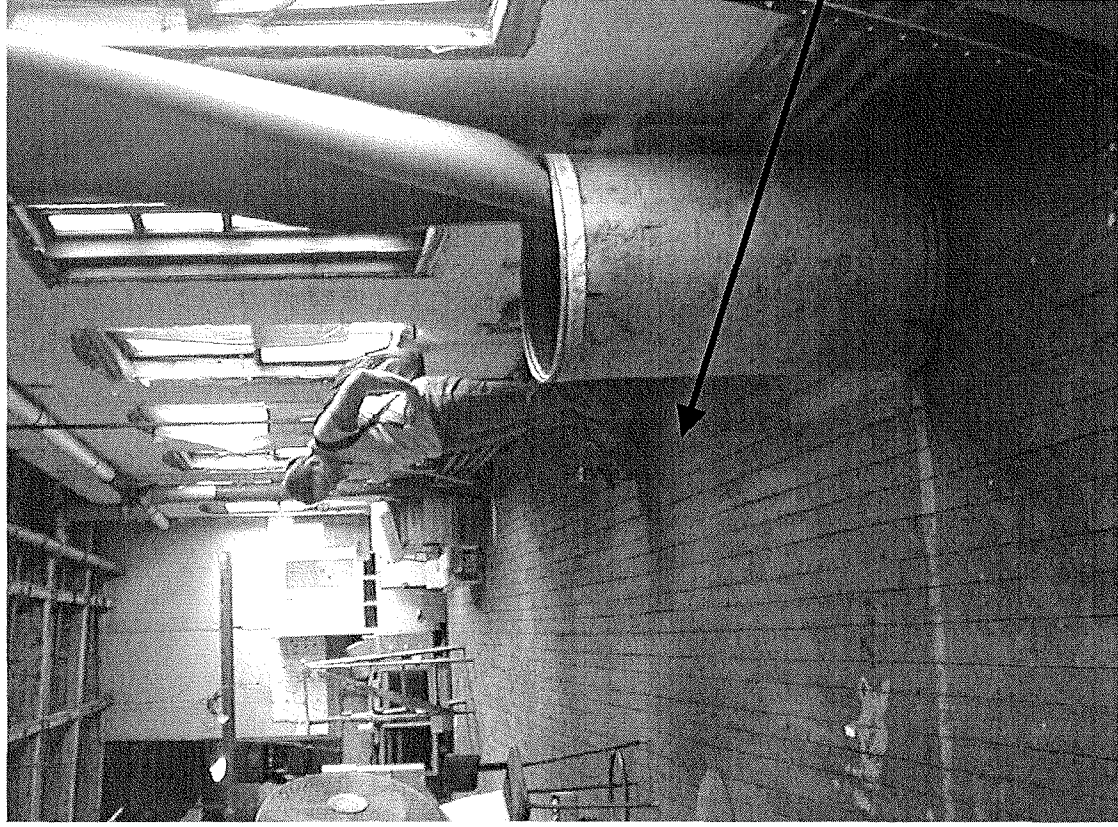
Belco- Sixth Floor

Building 1,
Leatherworks-
contamination
found on floor
spot by windows.

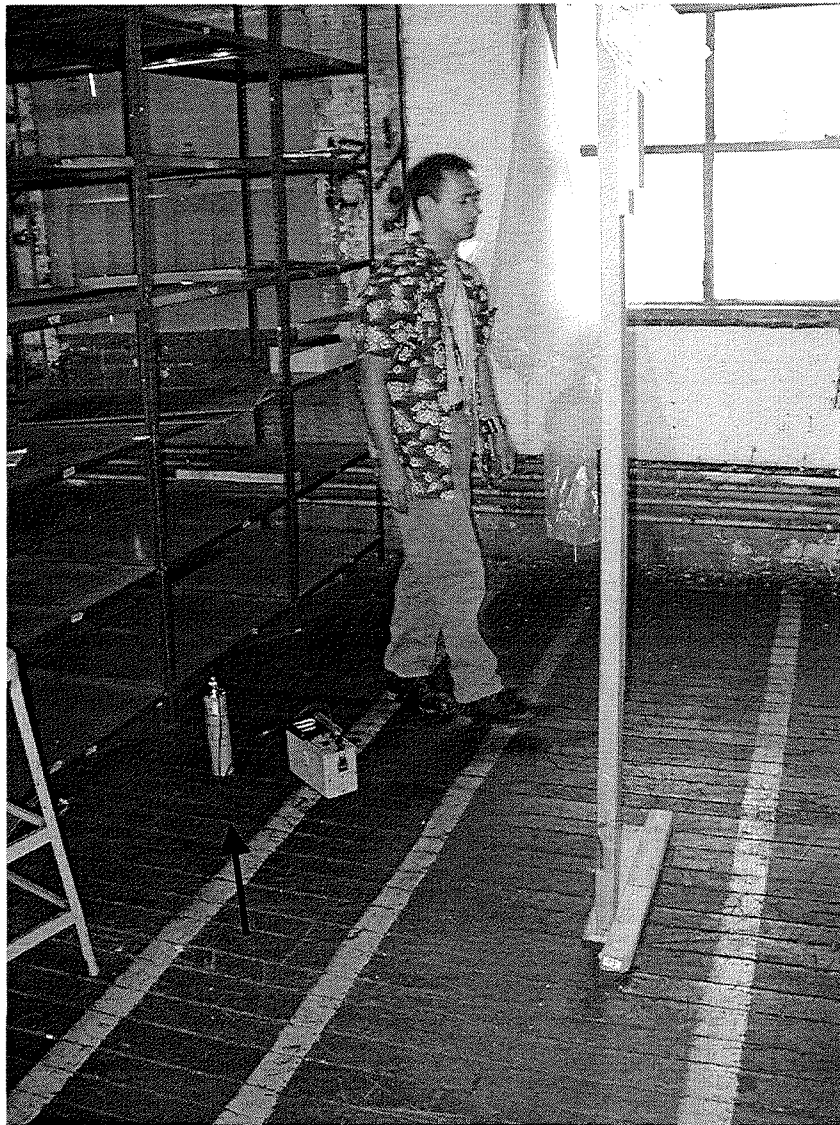
Belco- Sixth Floor

Building 1,
Leatherworks-
contamination
found on floor
spot shelving.
