Valley Council of Governments

Connecticut Radium Sites Verification Survey

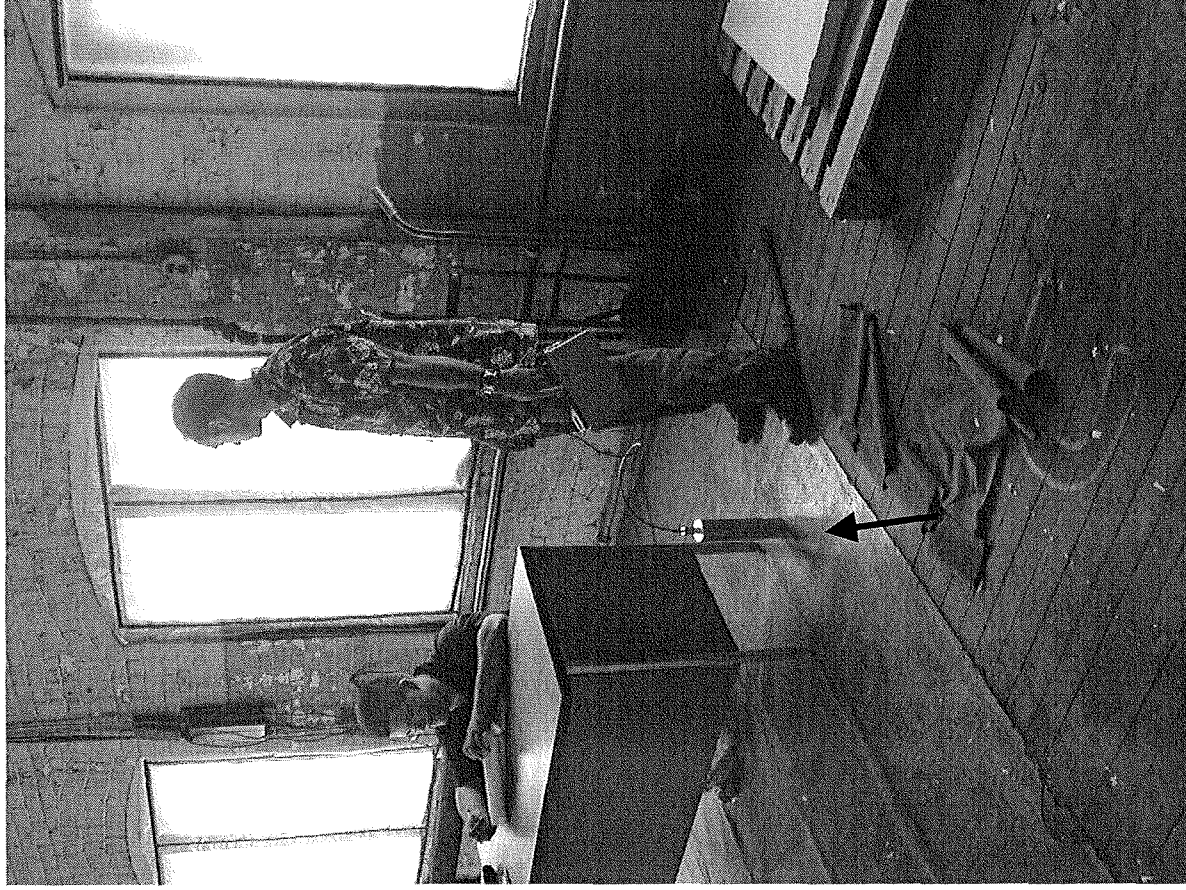
Belco- Fifth Floor

Building 1,
Belt Storage-
contamination
found on floor
spot by desk.

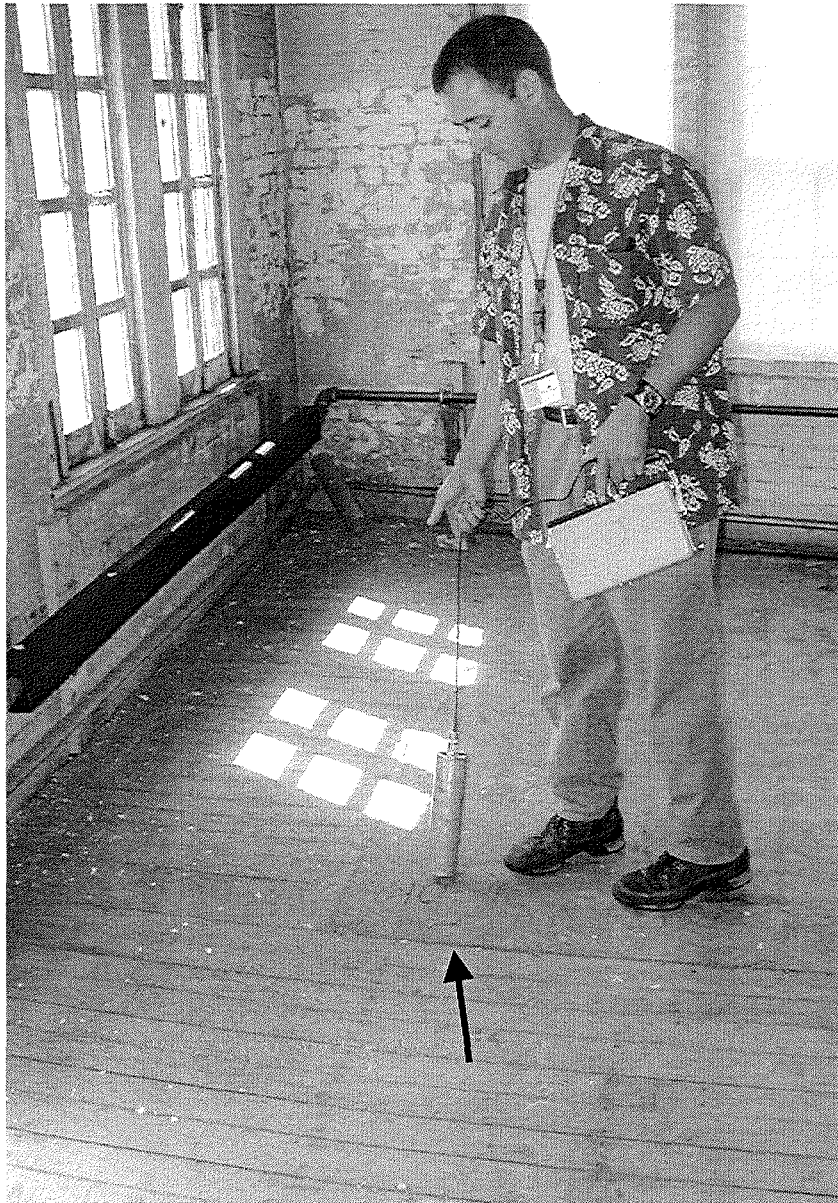
Belco- Fifth Floor

Building 1,
Belt Storage-
contamination
found on floor
spot by
windows.

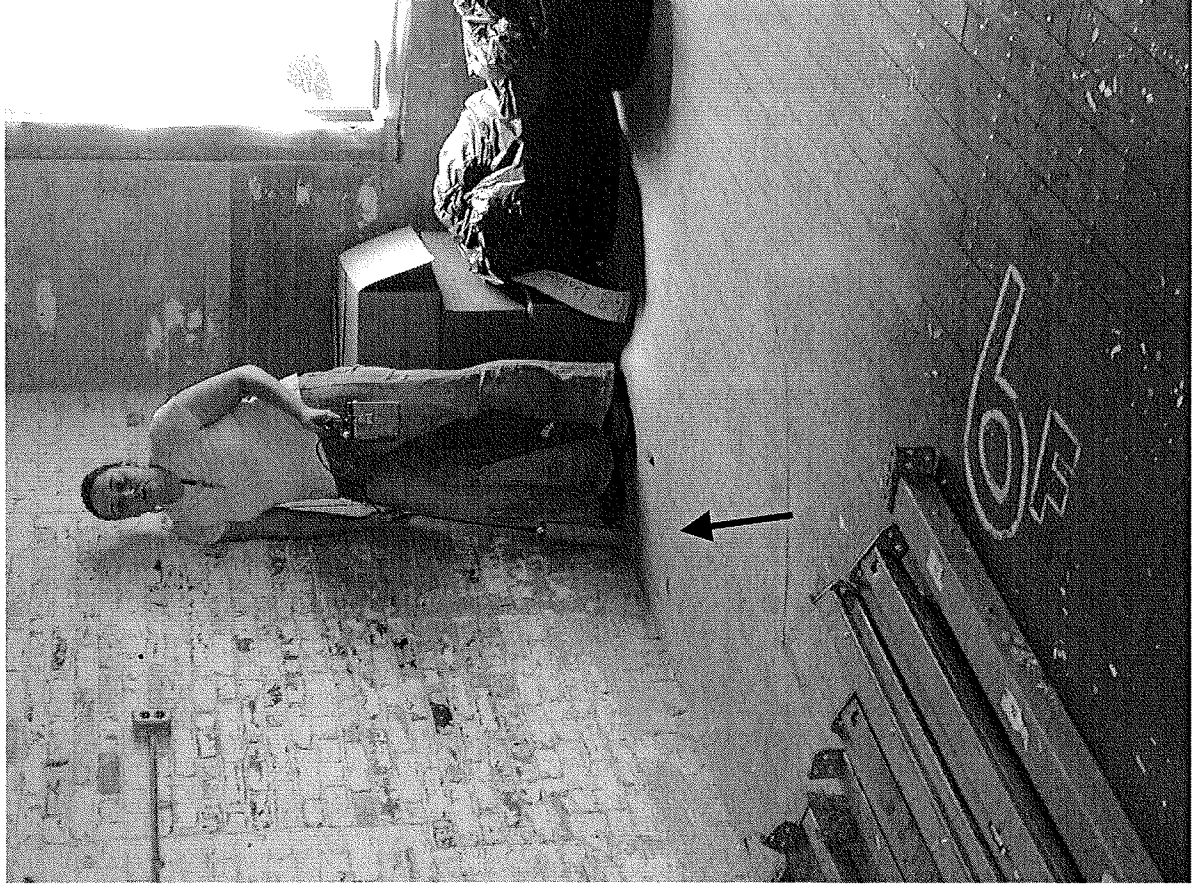
Belco- Fifth Floor

Building 1,
Belt Storage-
contamination
found on floor
spot by wall.

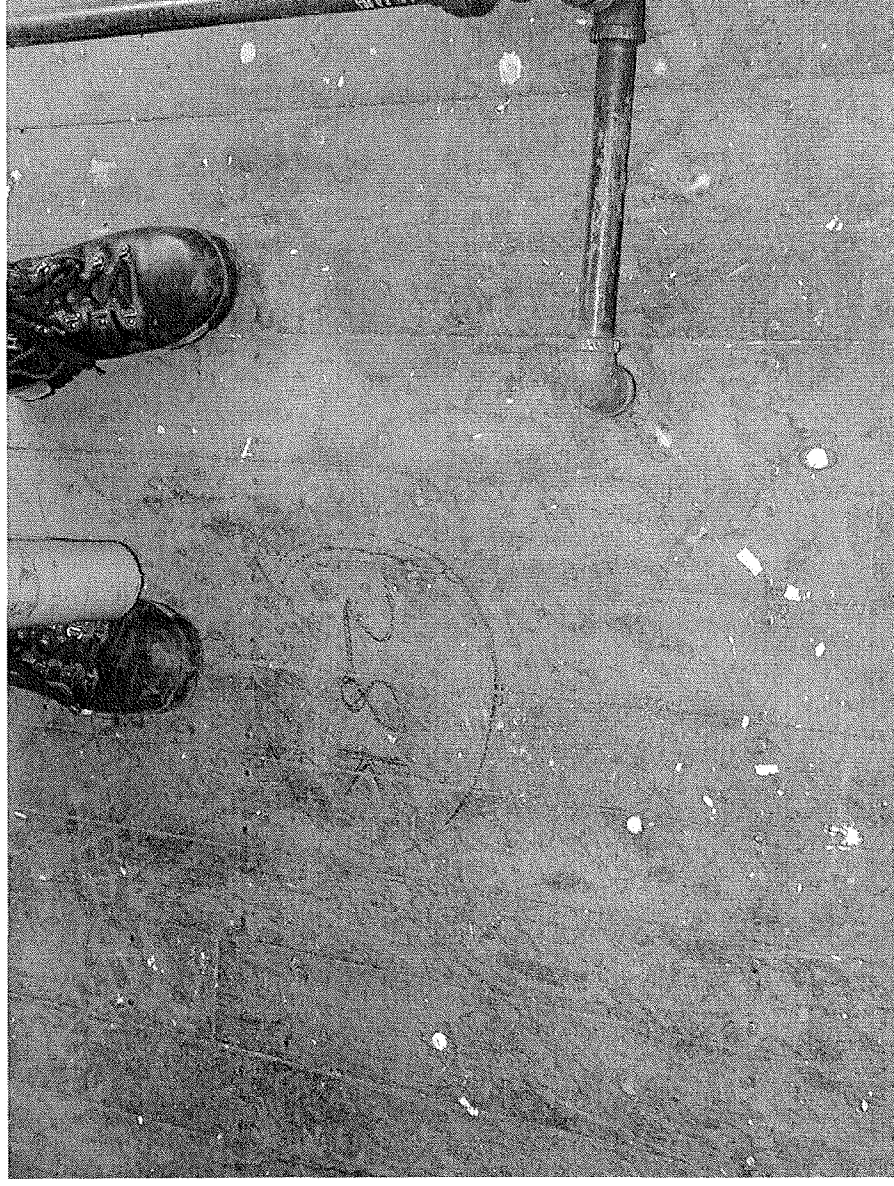
Belco- Fifth Floor

Building 2,
Storage 2-
contamination
found on floor
spot by pipe.

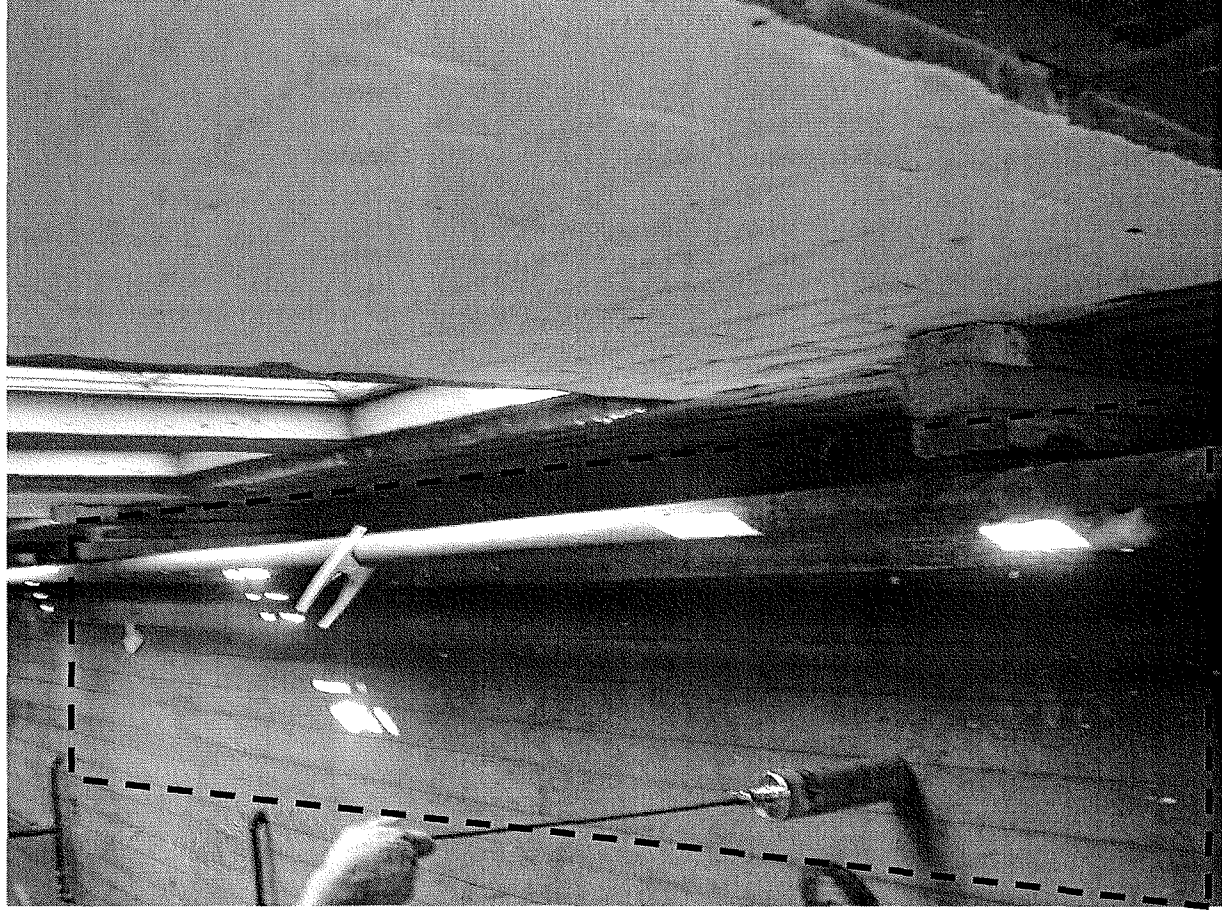
Belco- Fifth Floor

Building 2,
Storage 2-
contamination
found on floor
along
windows.

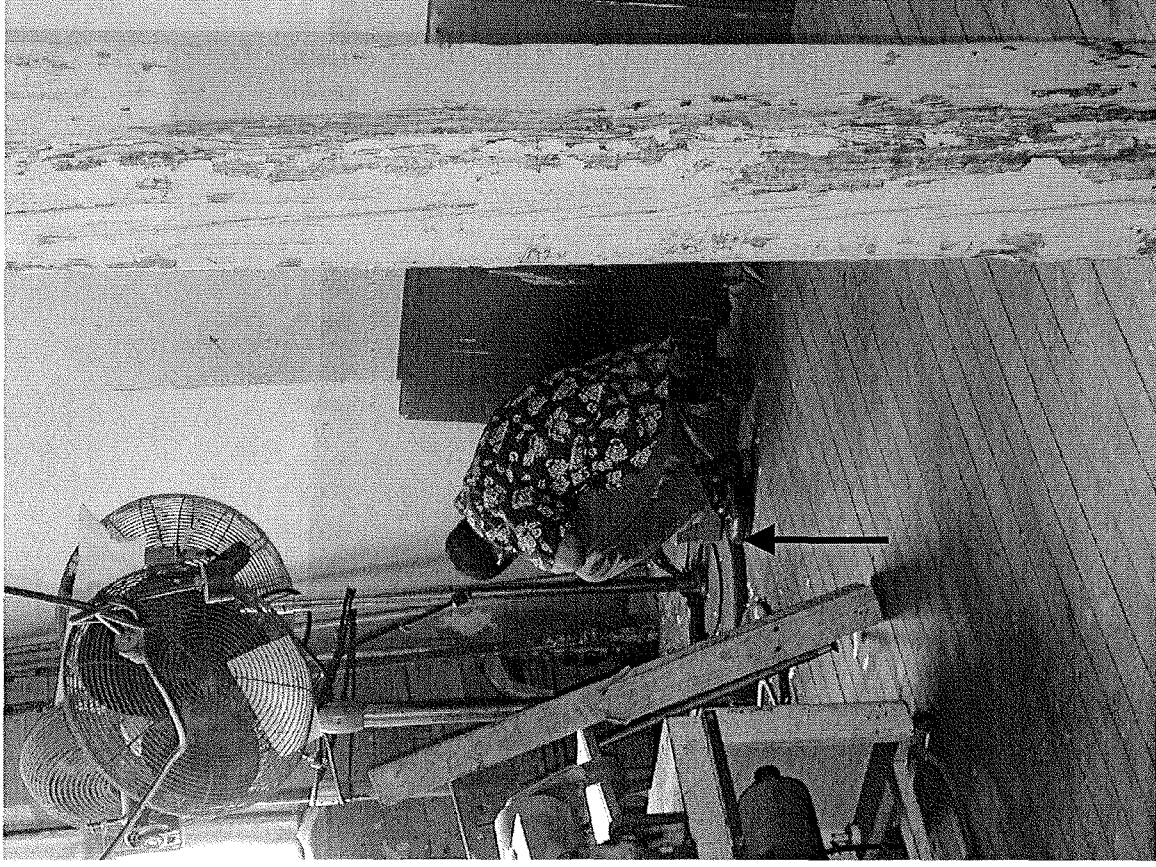
Belco- Fifth Floor

Building 2,
Storage 2-
contamination
found on floor
by fans and
wall.

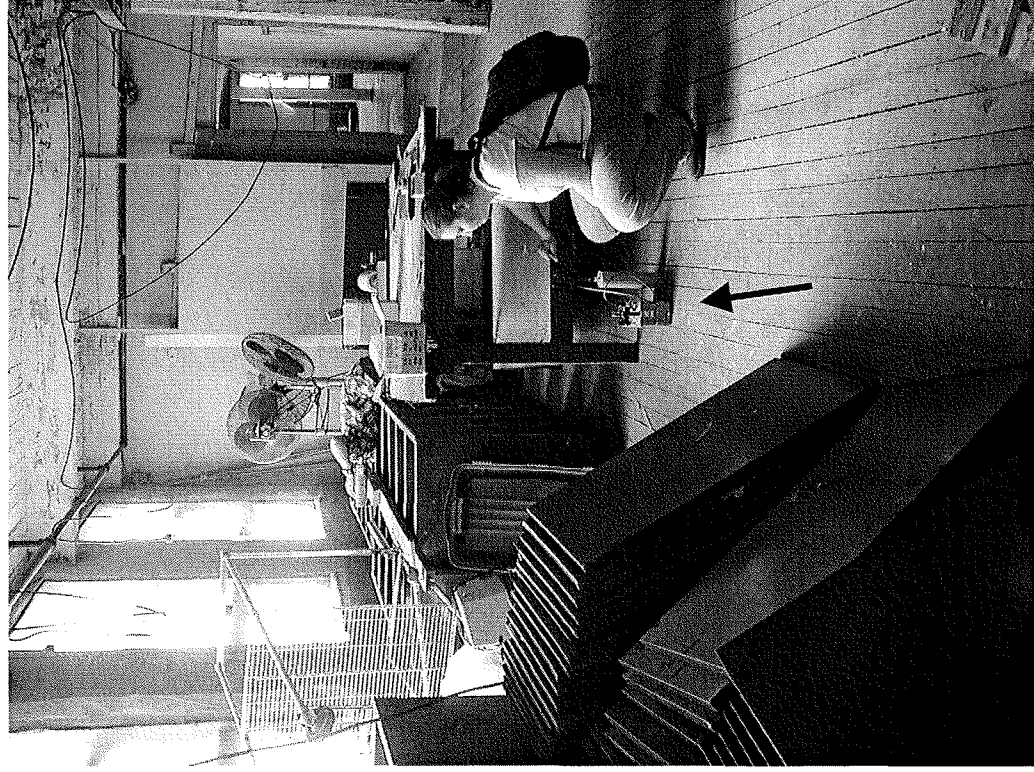
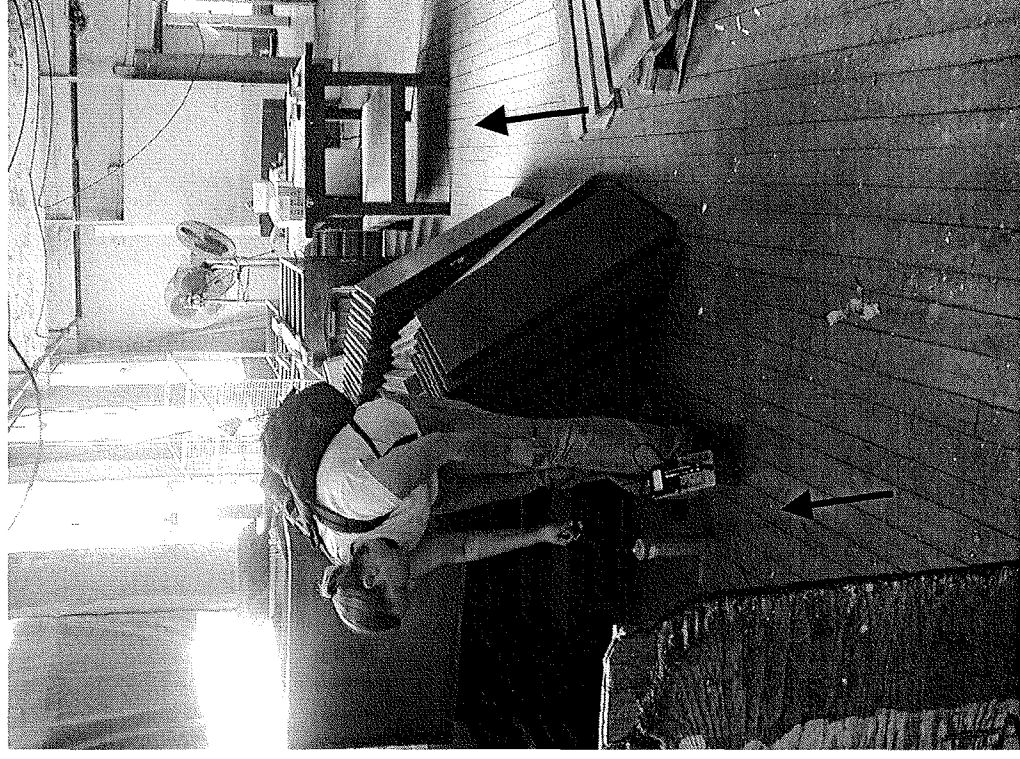
Belco- Fifth Floor

Building 2, Storage 2- contamination found on a few floor spots
by windows.

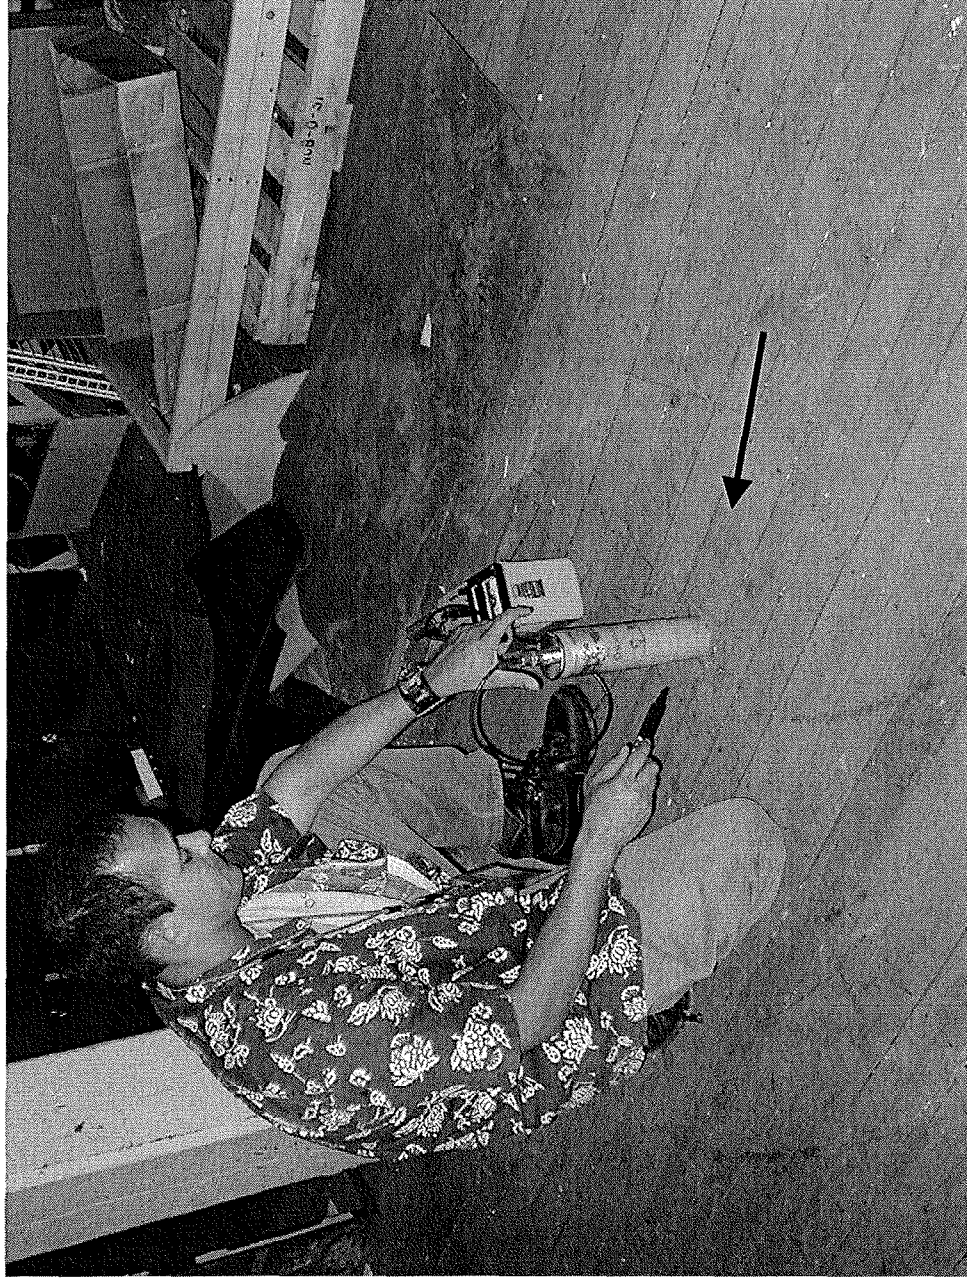
Belco- Fifth Floor

Building 2,
Storage 2-
contamination
found on floor
spot.

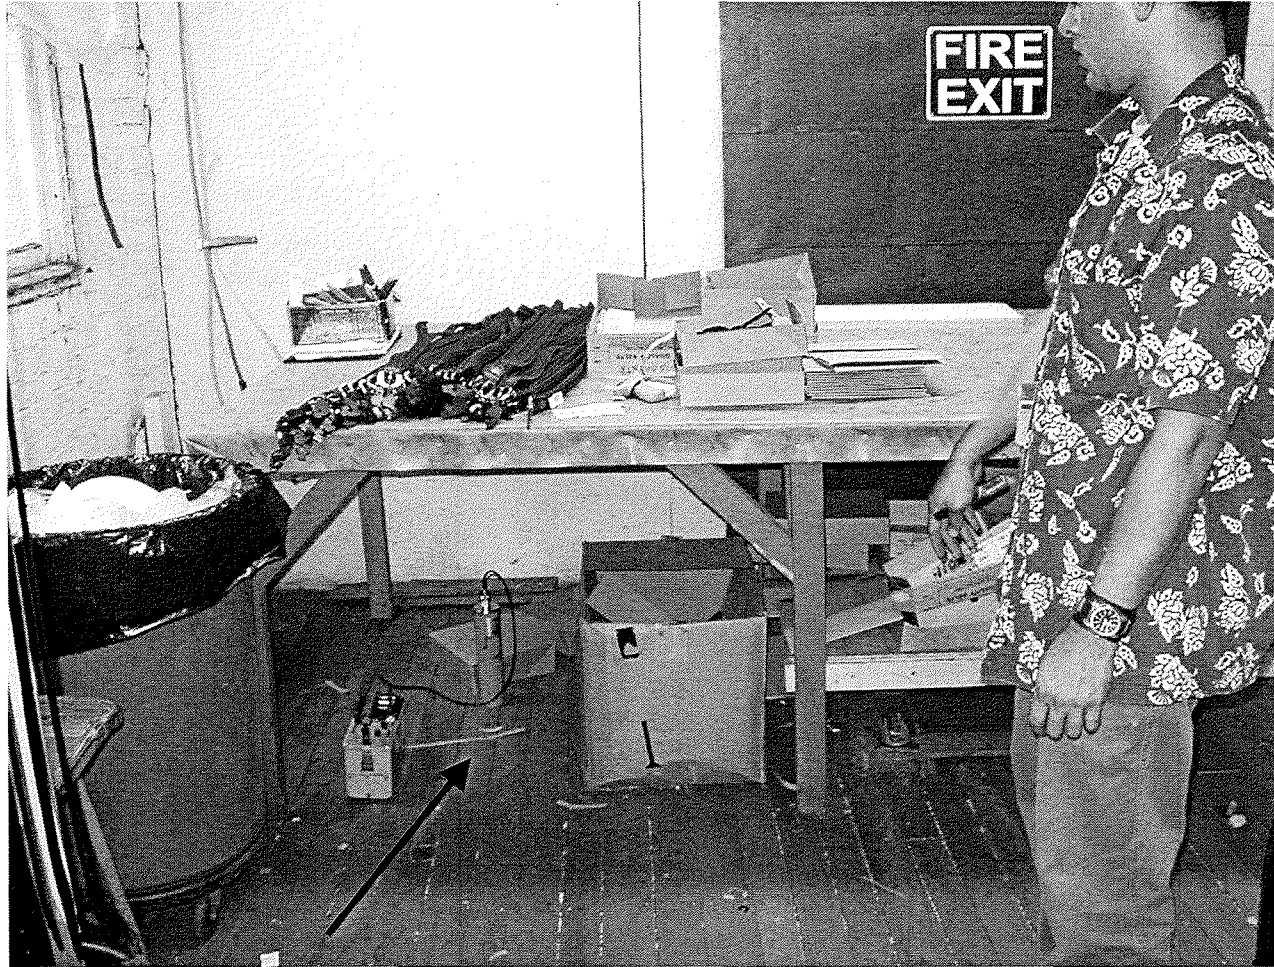
Belco- Third Floor

Building 2, Liba Room A- contamination found on
floor area 3' x 3' under desk.

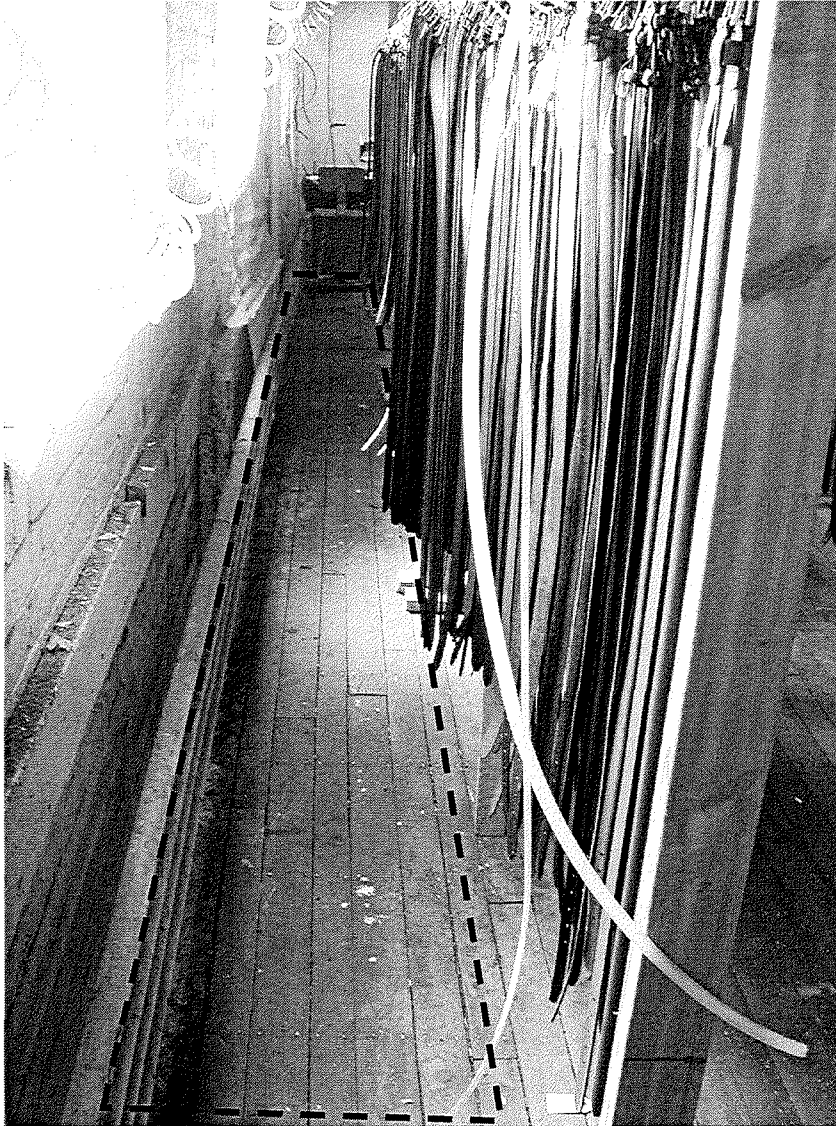
Belco- Third Floor

Building 2, Liba
Room A-
contamination found
on 2' x 50' floor
along windows
(might be shine).

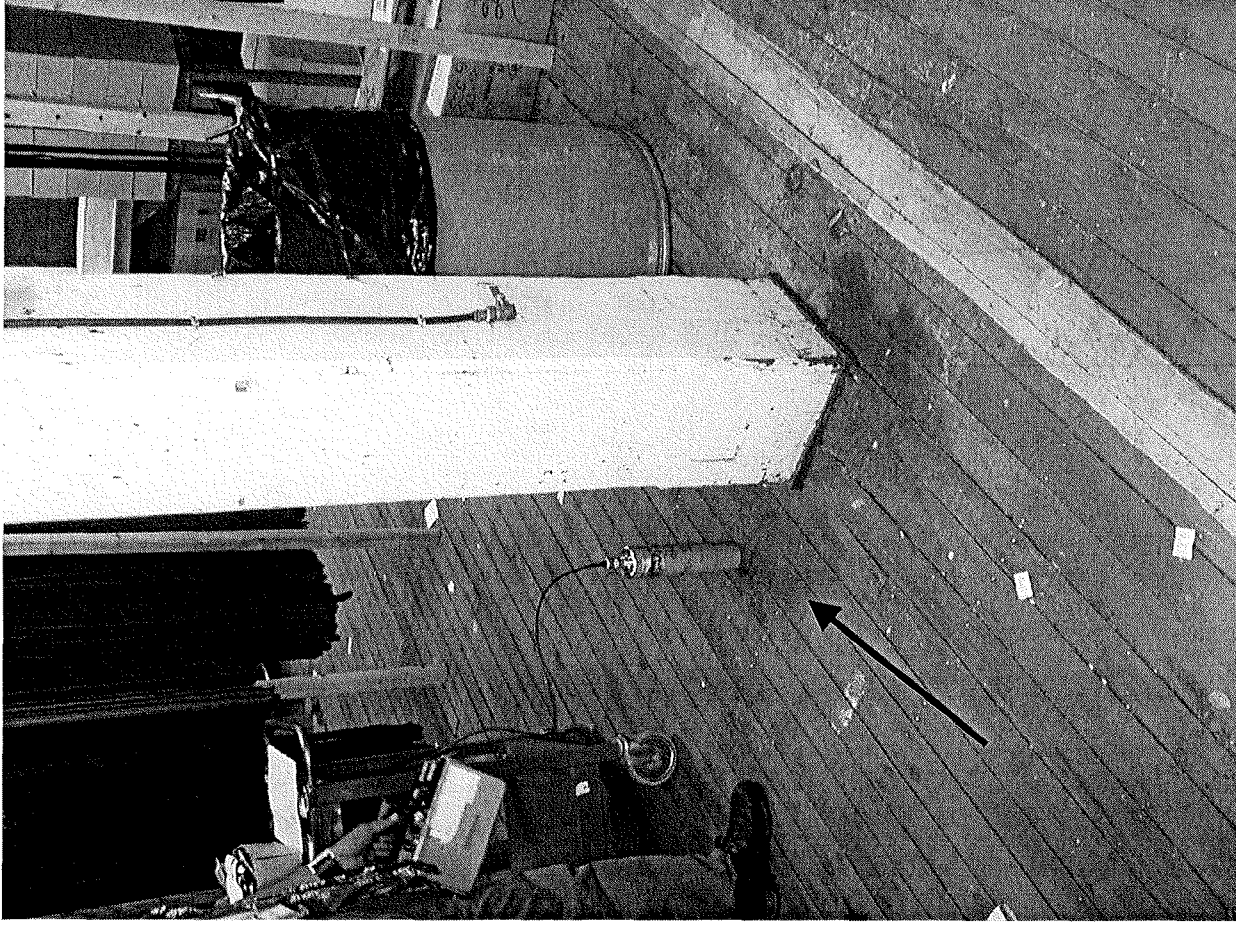
Belco- Third Floor

Building 2, Liba
Room A-
contamination found
around most pillars.

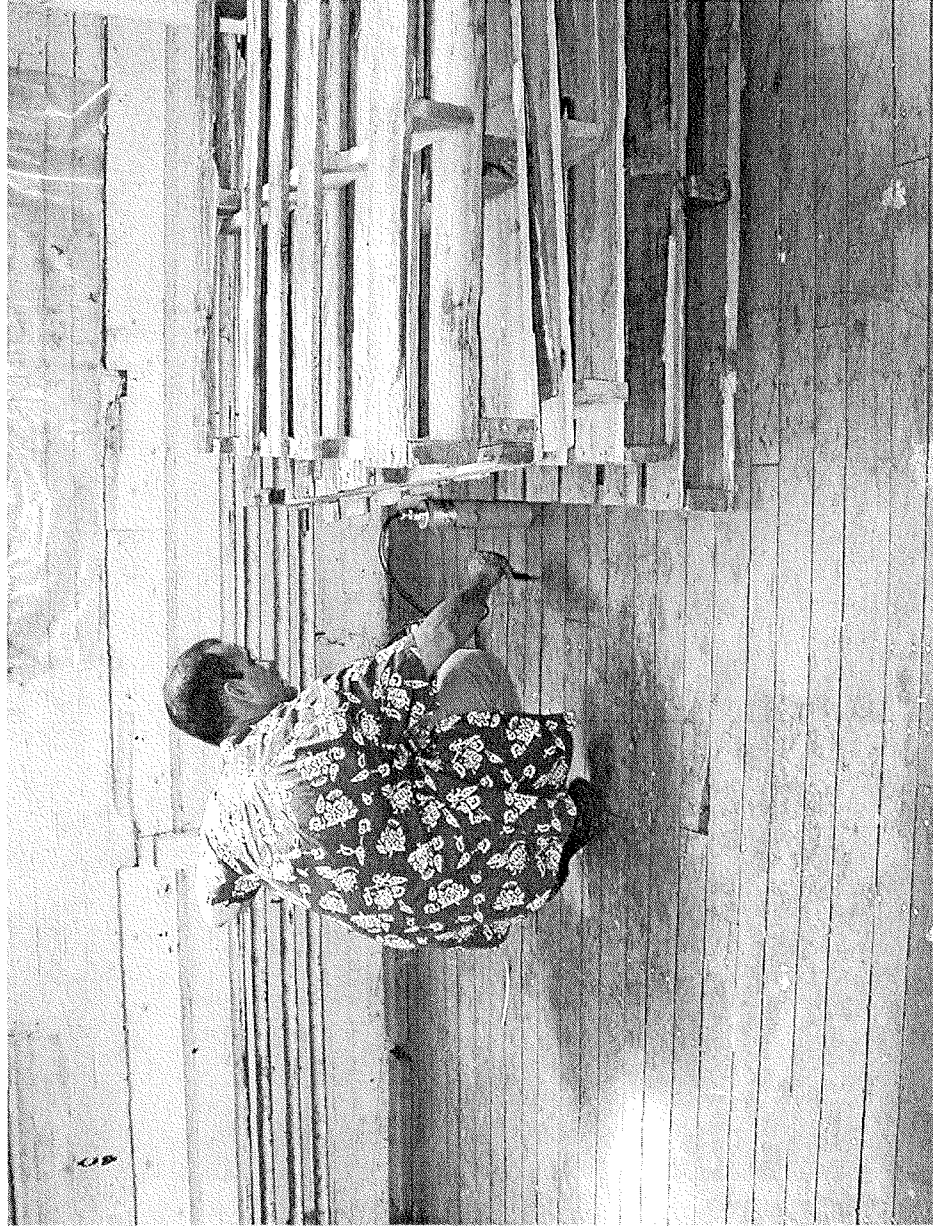
Belco- Third Floor

Building 2,
Liba Room A-
contamination
found on floor
by windows.

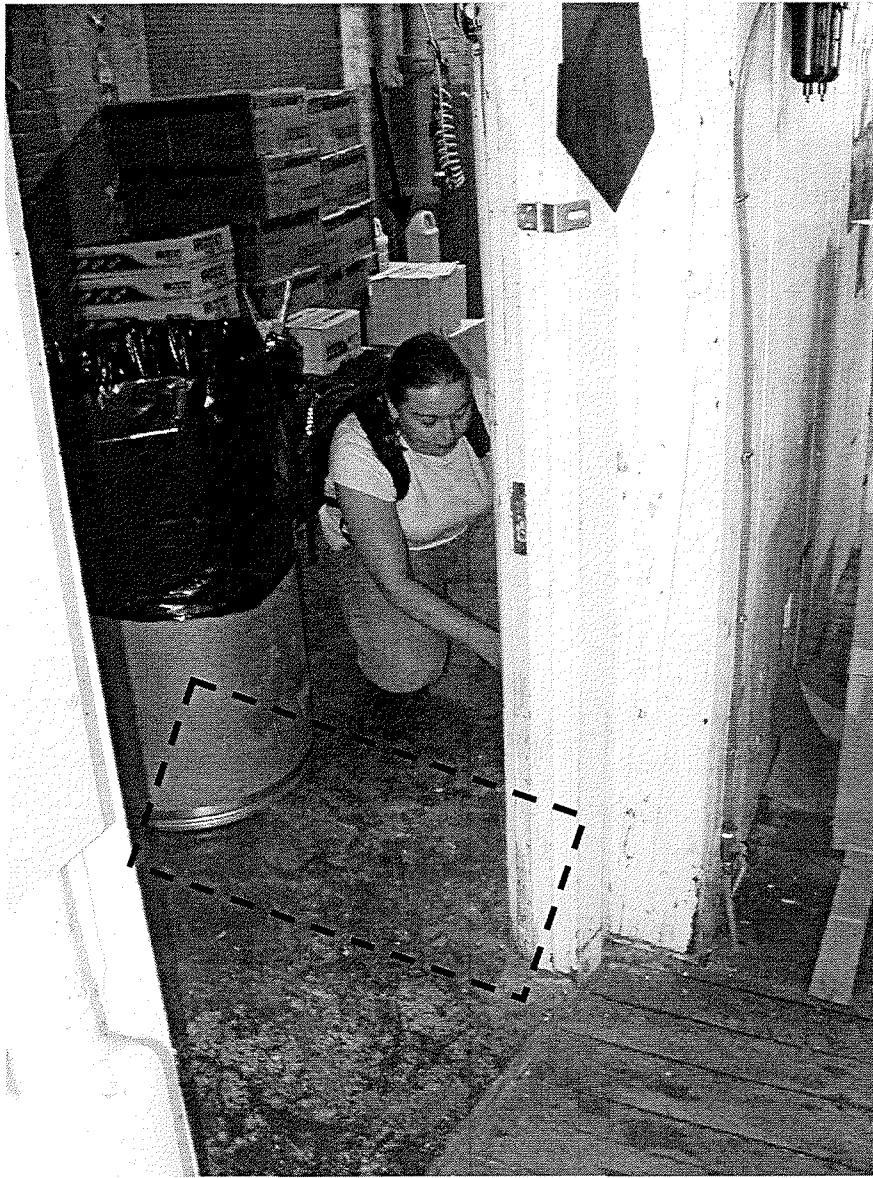
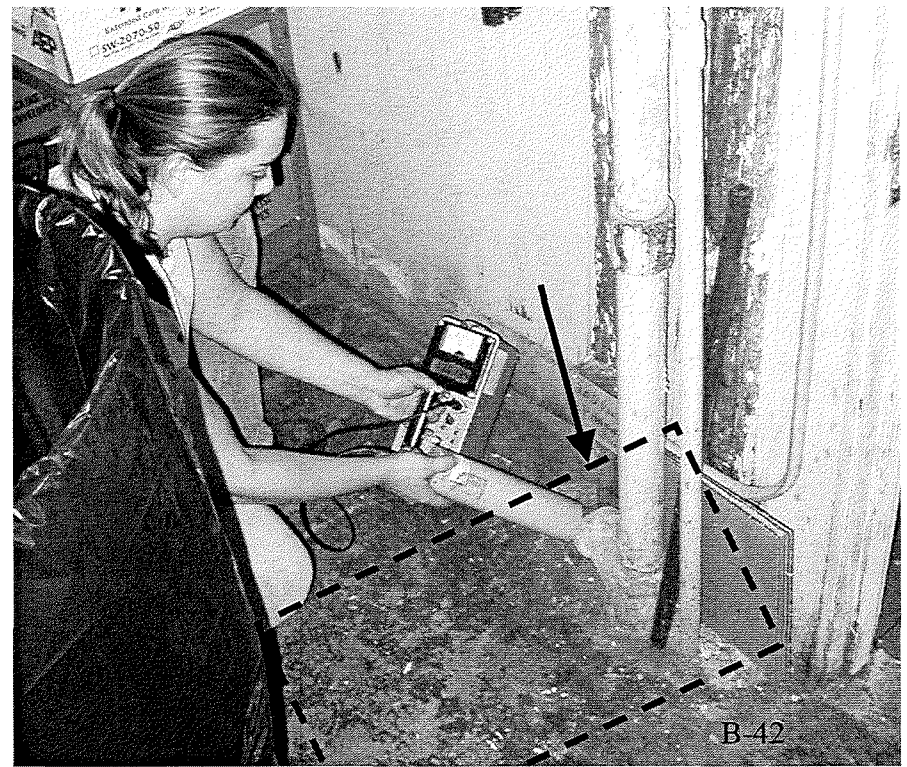
Belco- Third Floor

Building 2, Liba Closet-
contamination found near piping
and on 2" deep concrete floor
(also in floor area in rear corner).

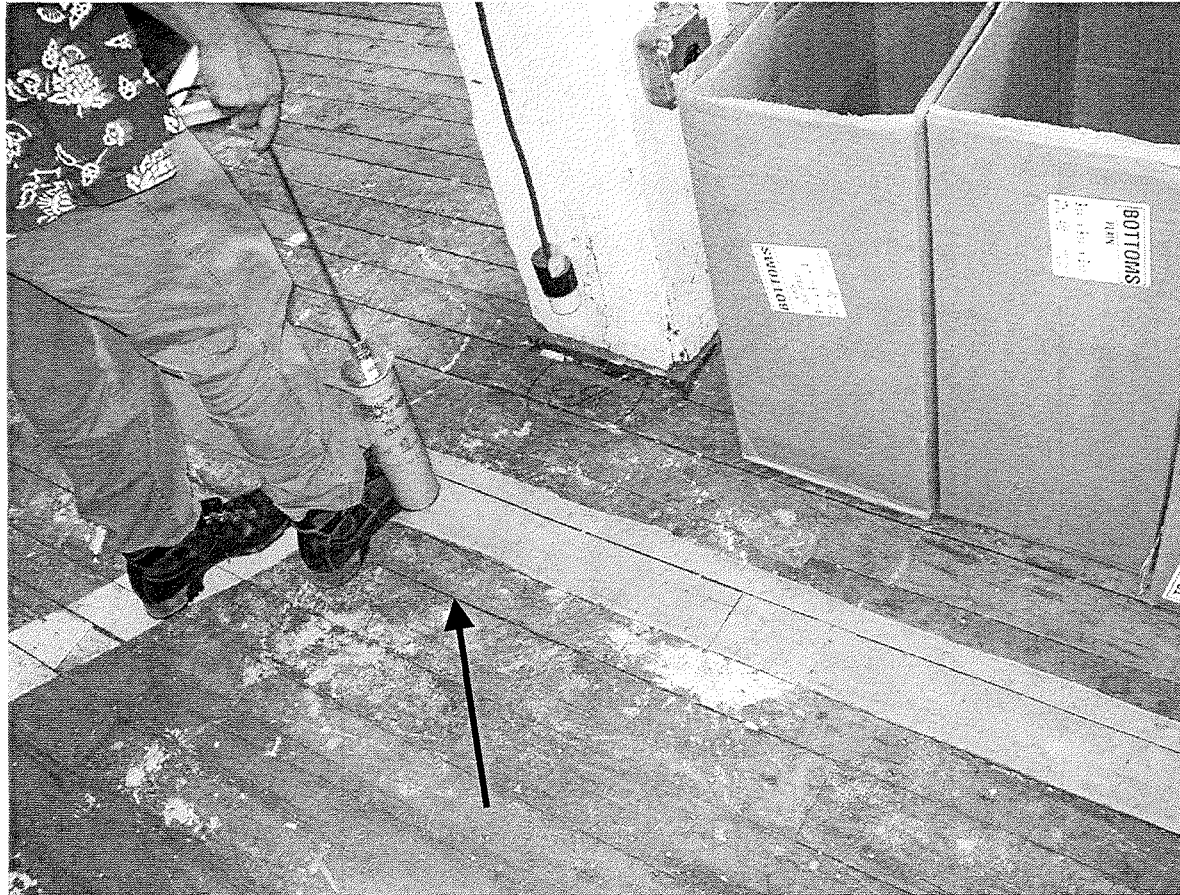
Belco- Third Floor

Building 2, Liba Room A- contamination found on various floor spots throughout the room.

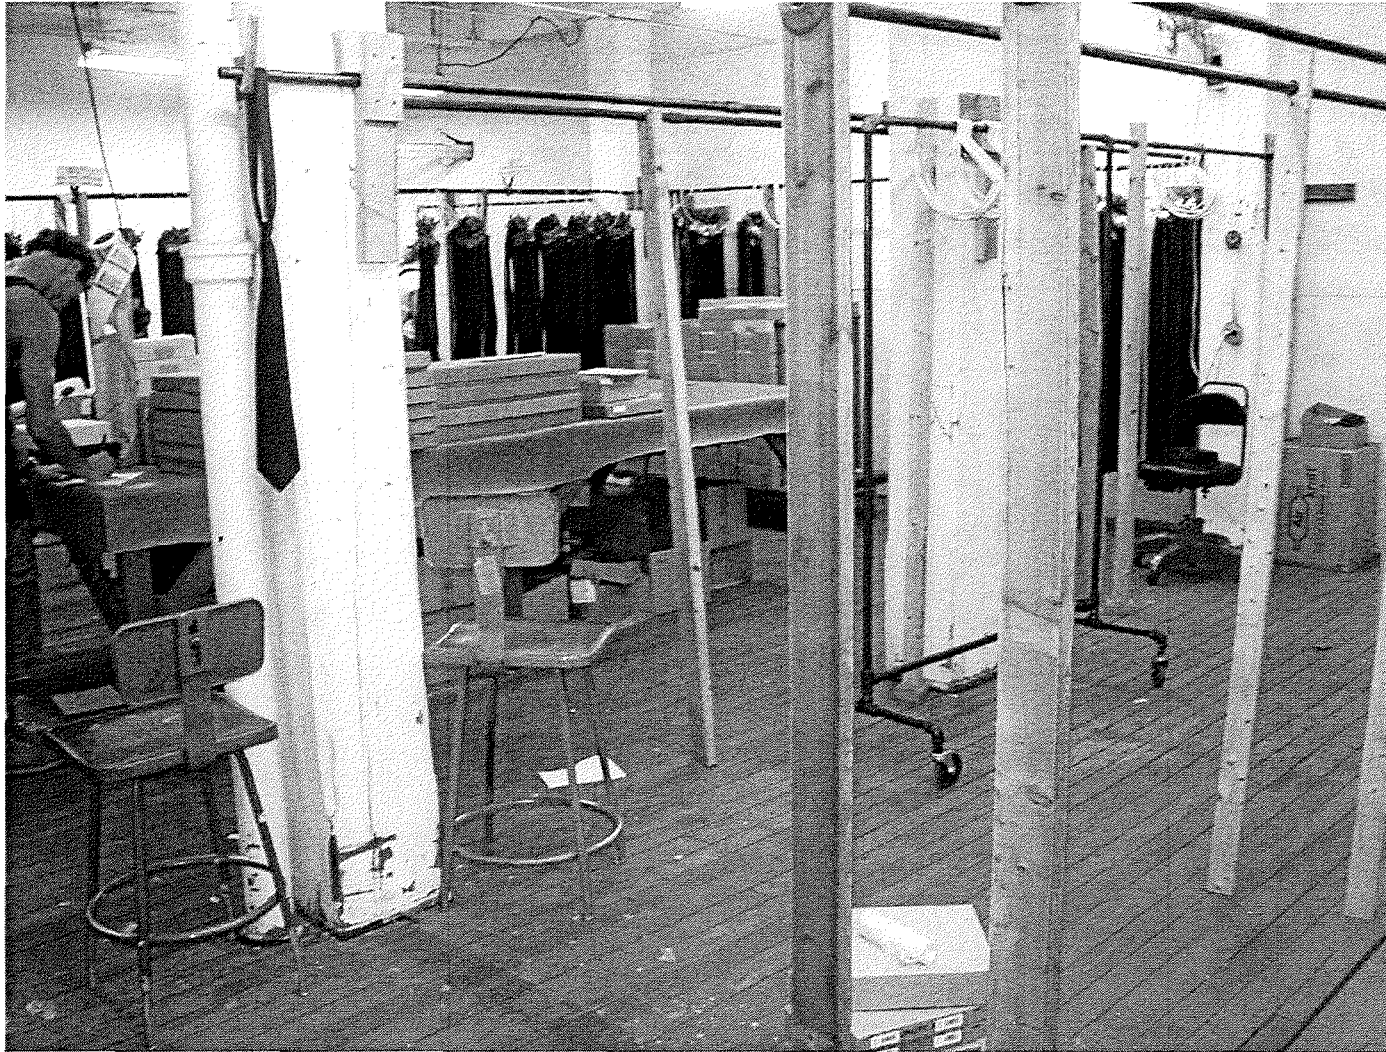
Belco- Third Floor

Building 2, Liba Room B- Extensive contamination
found throughout room.

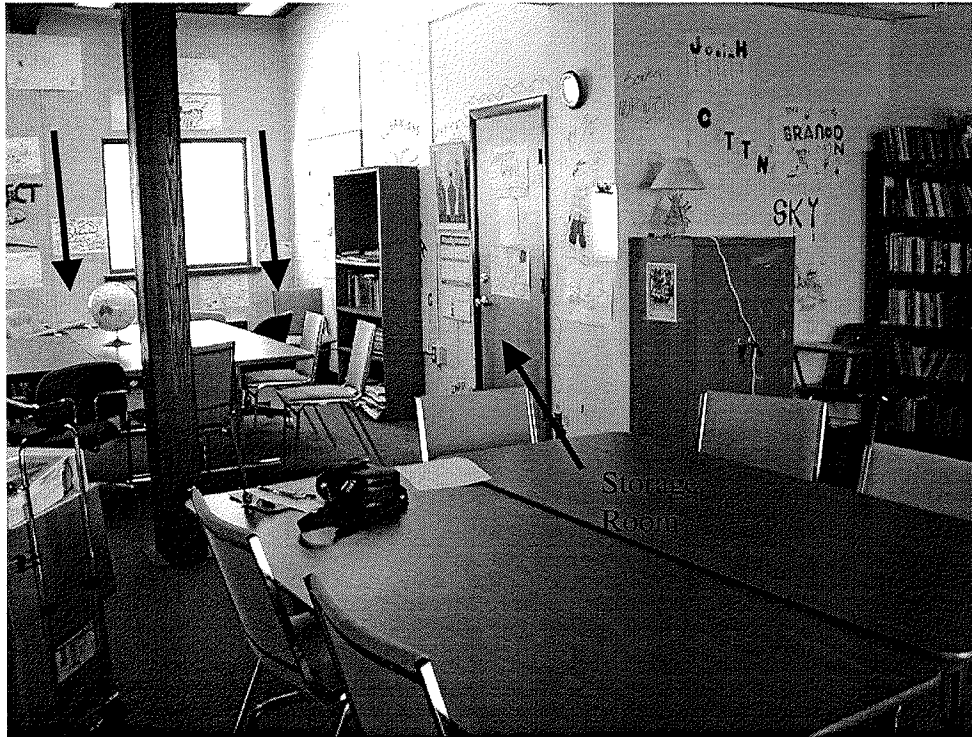
NOW- Reading Room (Rec. Area)

Contamination found along the entire floor area by windows.

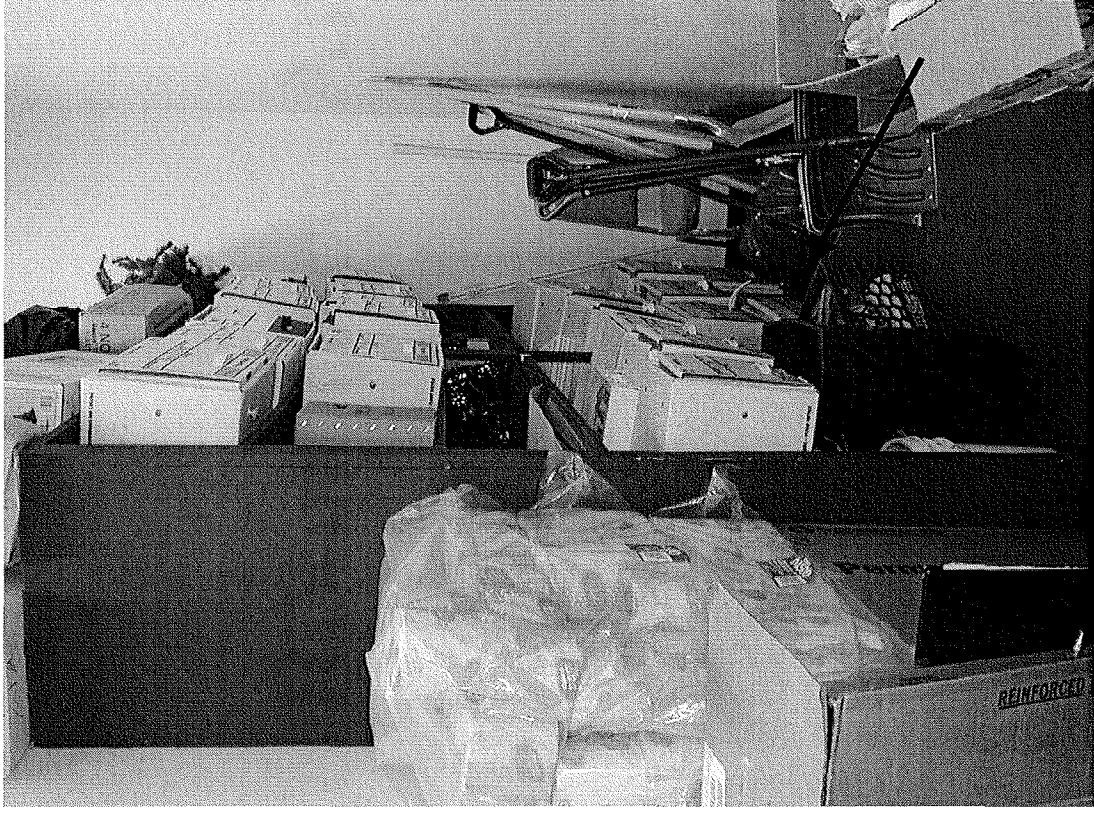
NOW- Storage Room (Rec. Area)

Contamination found
on floor by shelves.

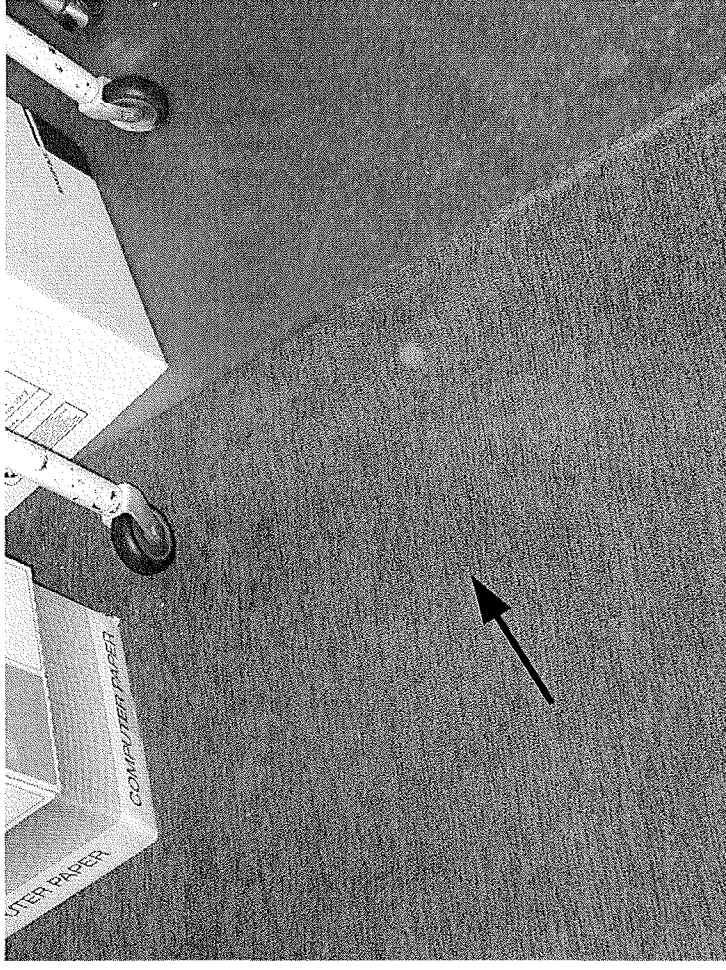
NOW- Office (Computer Room)

Contamination found
on floor spot

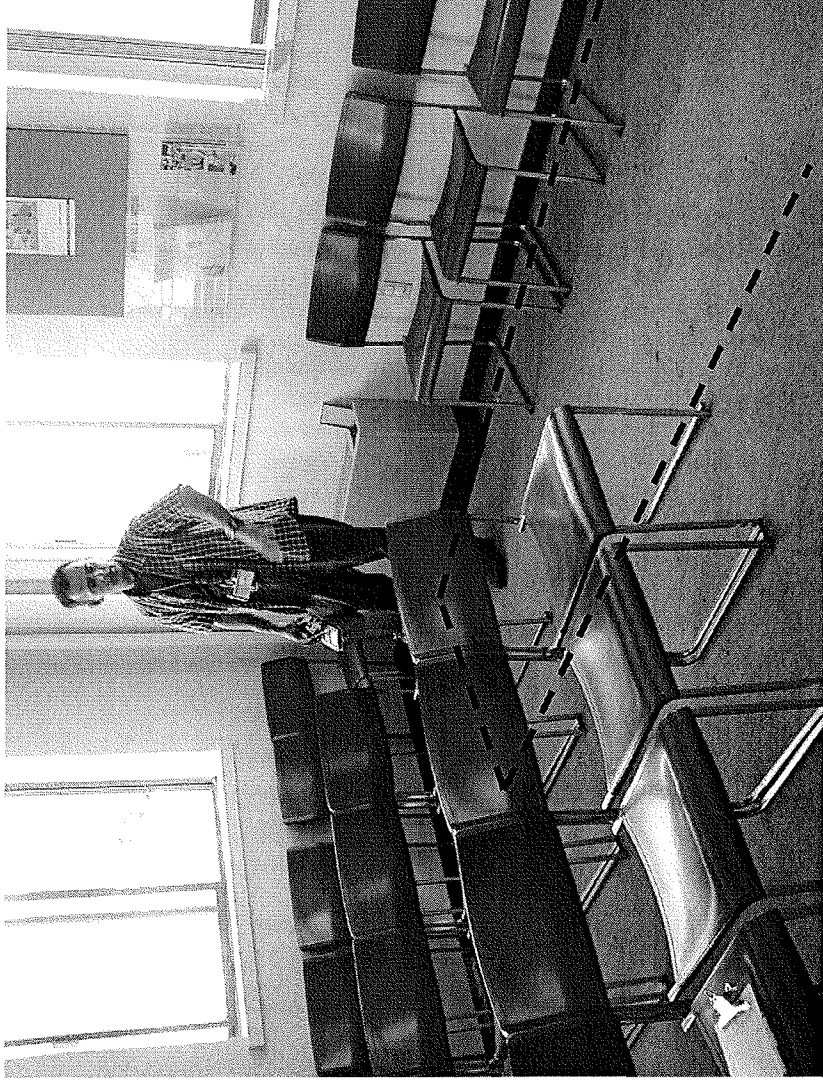
NOW- Waiting Room

Contamination found throughout strip of floor by windows

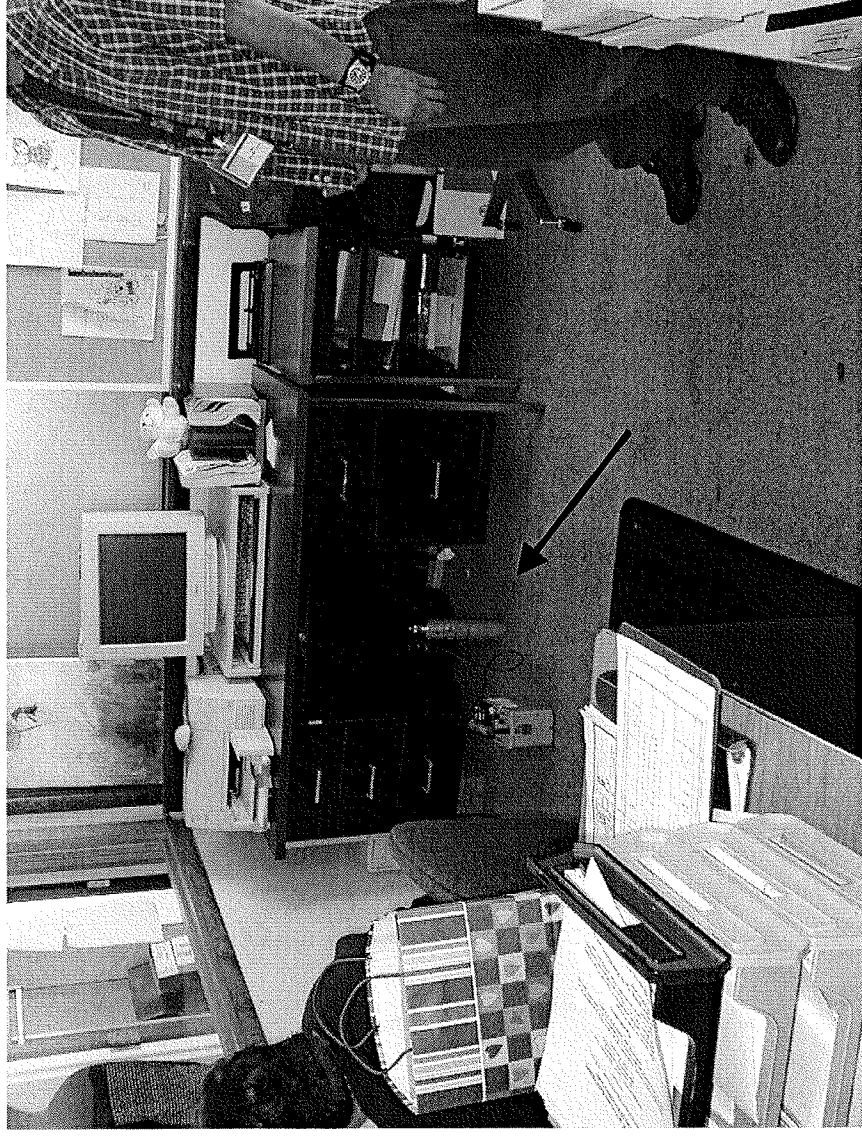
NOW- FN Office

Contamination found on floor spot under desk.

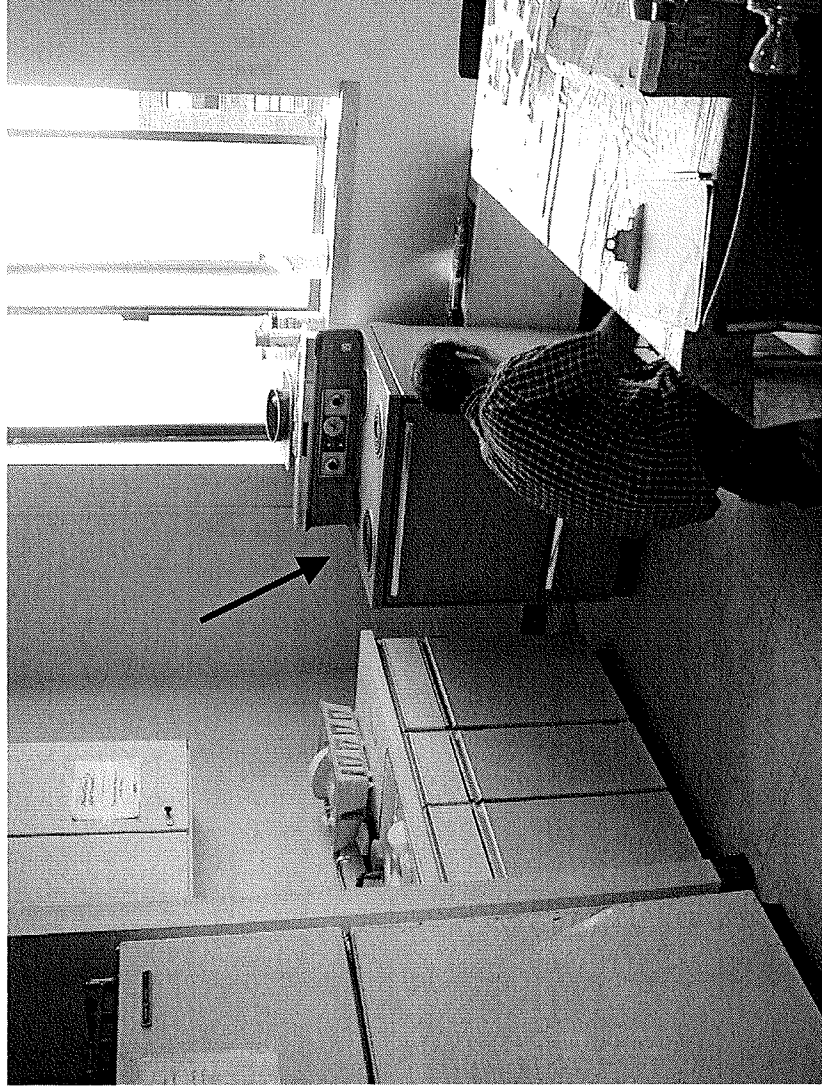
NOW - Kitchen

Contamination found on floor spot behind stove.
