Valley Council of Governments

Connecticut Radium Sites Verification Survey

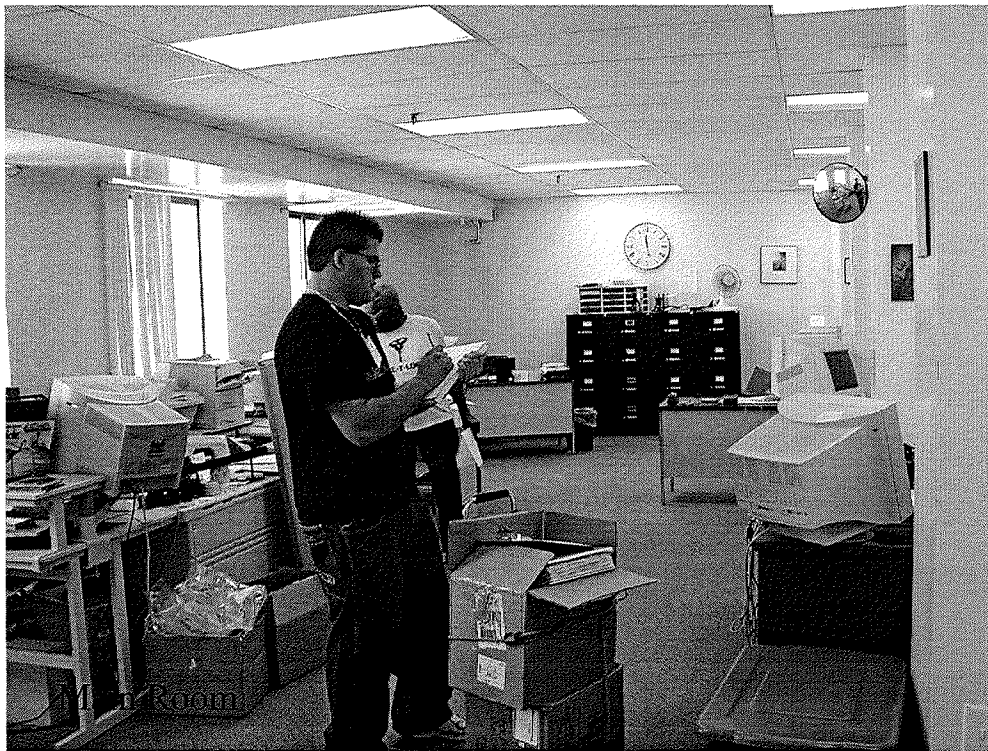
NOW- Family Preservation

Spotty contamination found throughout the Main Room floor.
Entire floor is twice background.

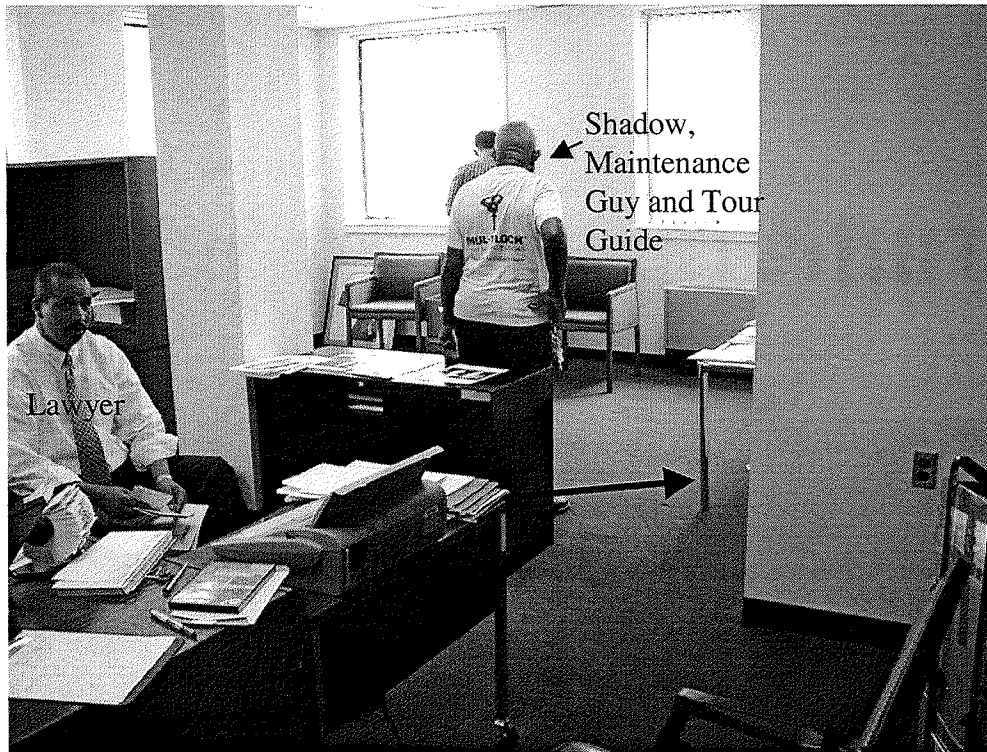
NOW- Head Start (Law Office)

Contamination found on floor spots.

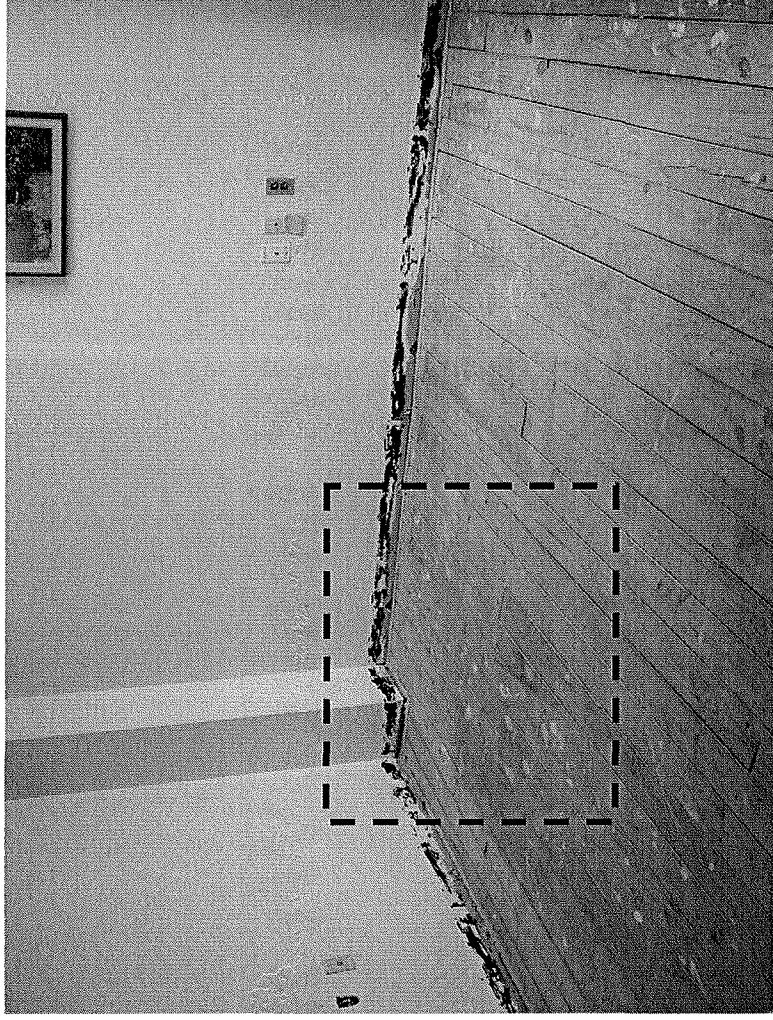
NOW- Head Start (Cont.)

Contamination found on floor spots (may be shine from
Law Office)

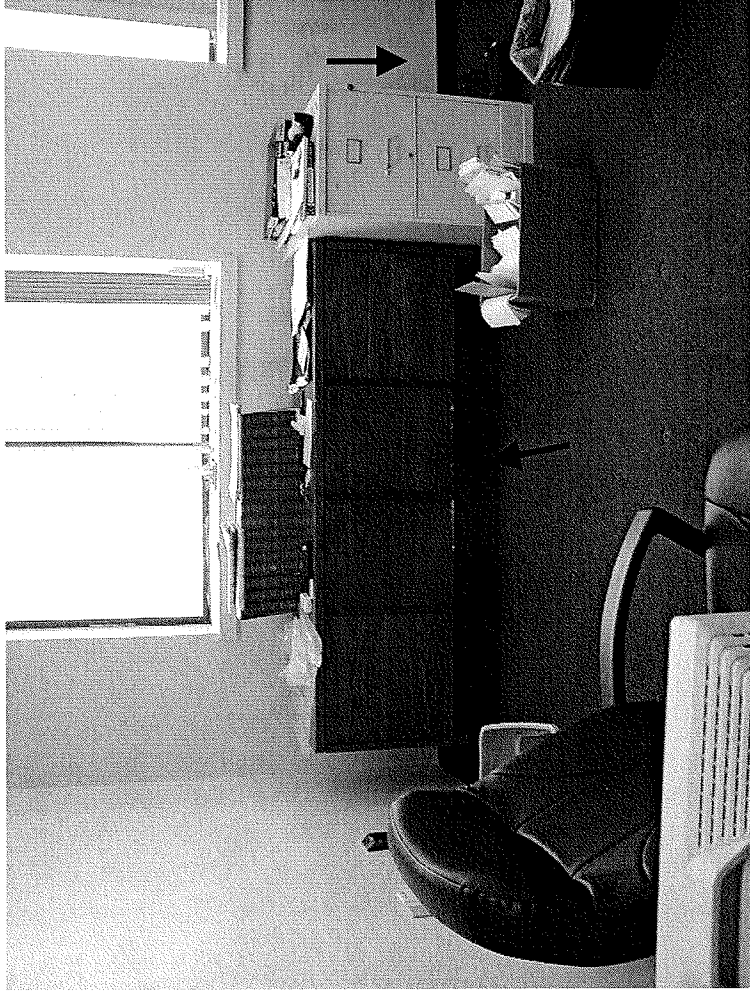
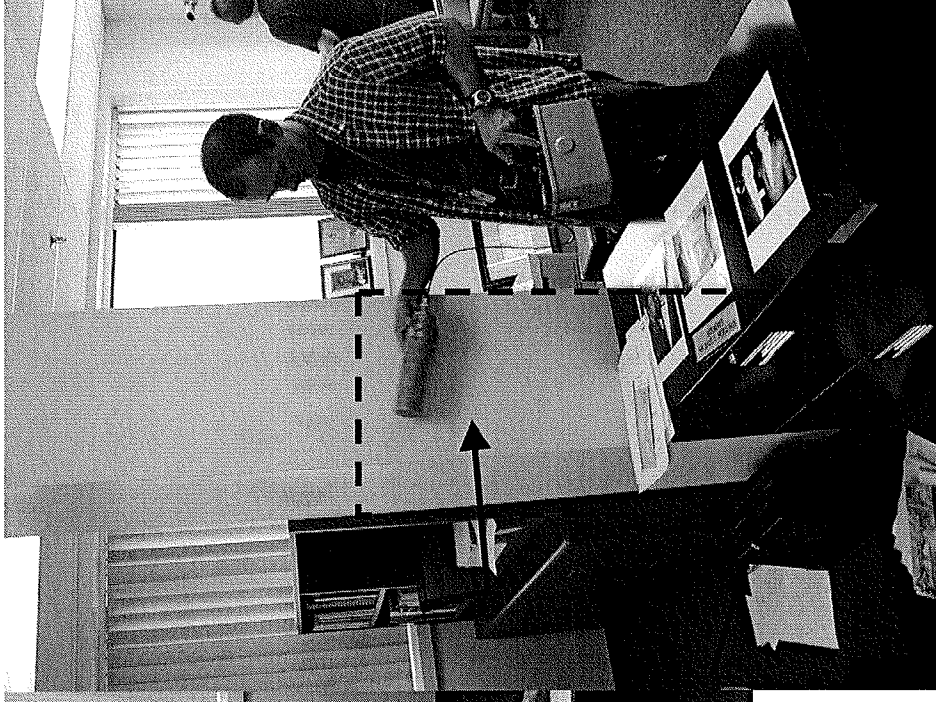
NOW- Head Start (Cont.)

Contamination found on floor
spots under and next to desk and
on pillar (up to 3')

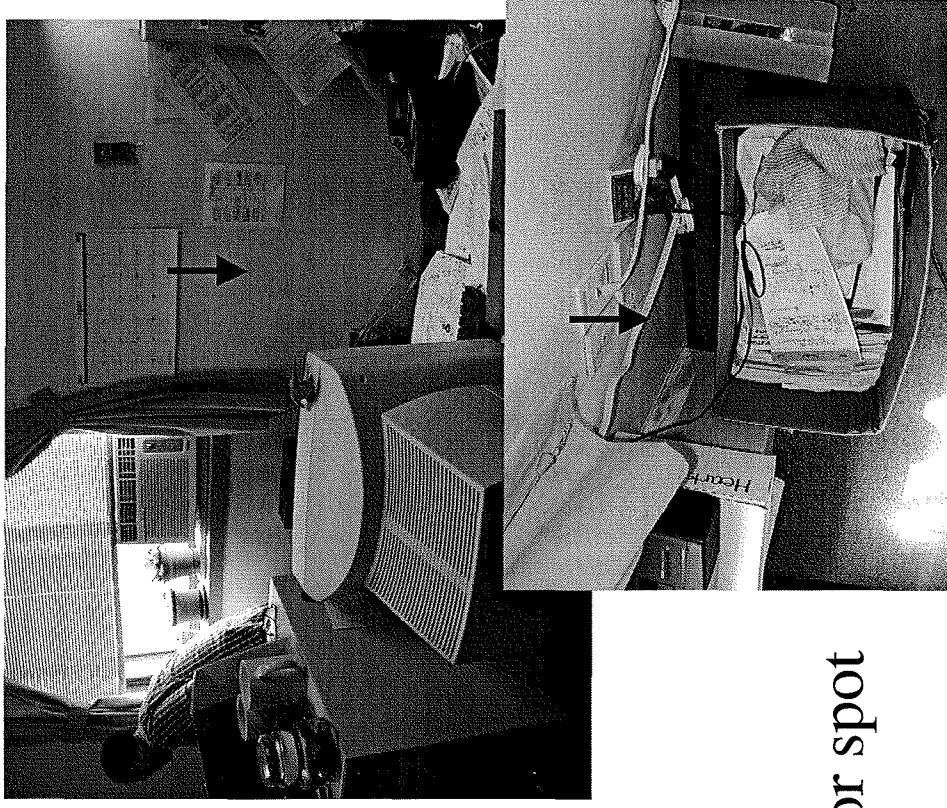
NOW- RSVP Office

Contamination found on floor spot
by window.

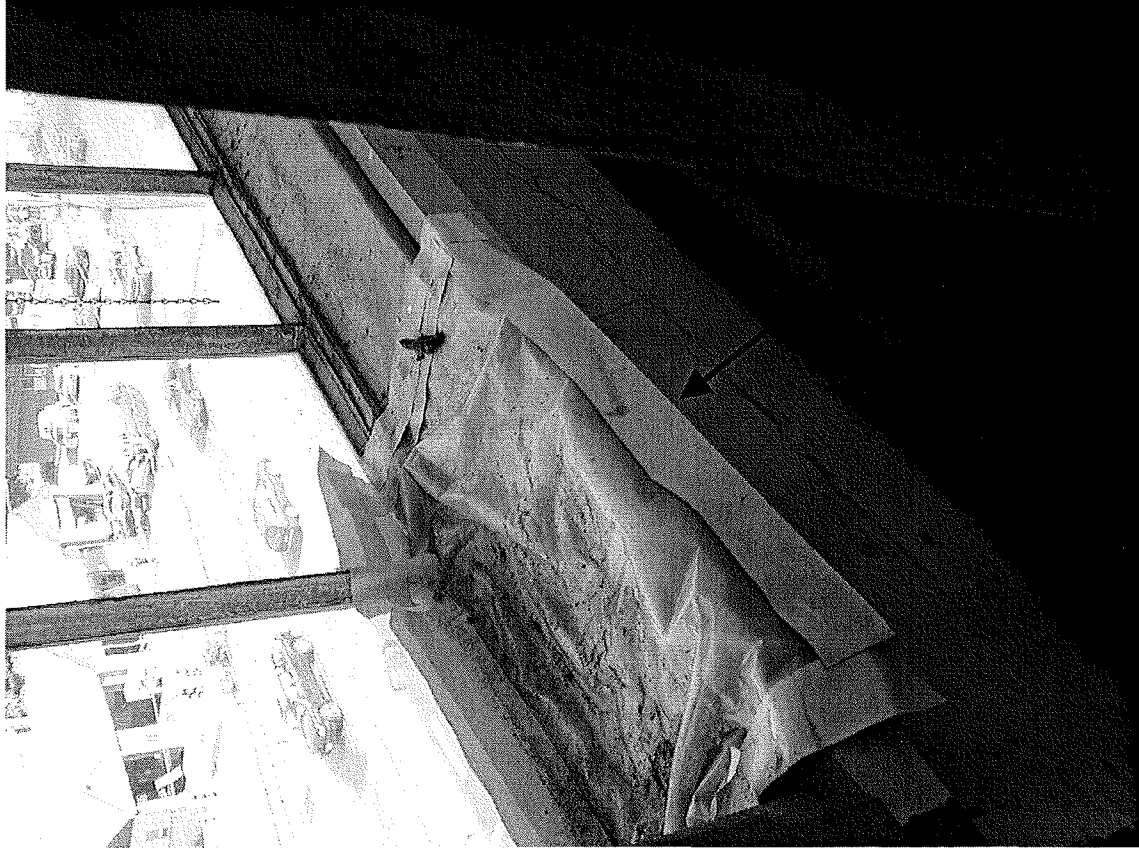
Thomaston- Location A

Contamination found on
window sill.

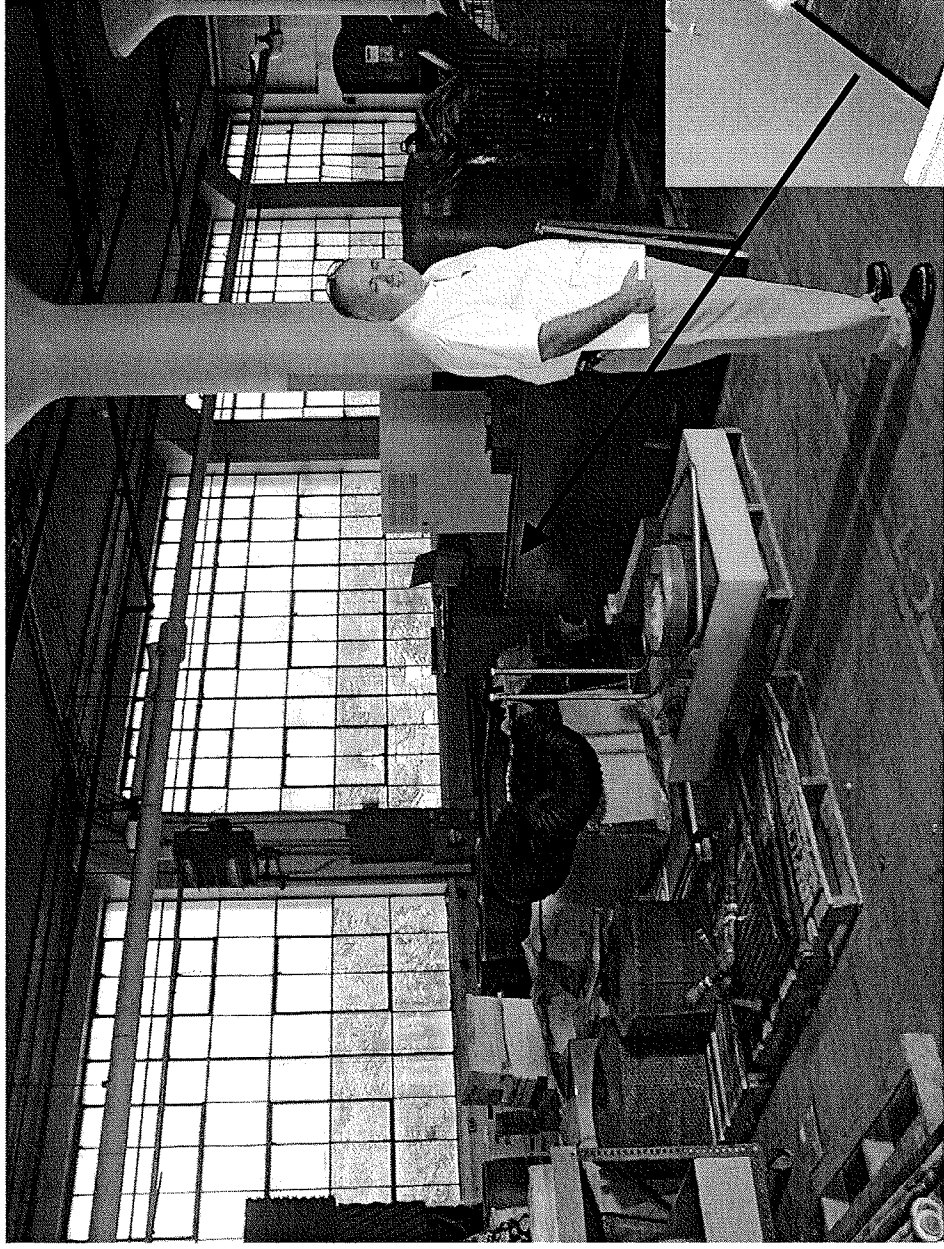
Thomaston- Third Floor Location B

Contamination
found on floor
spot by bin.

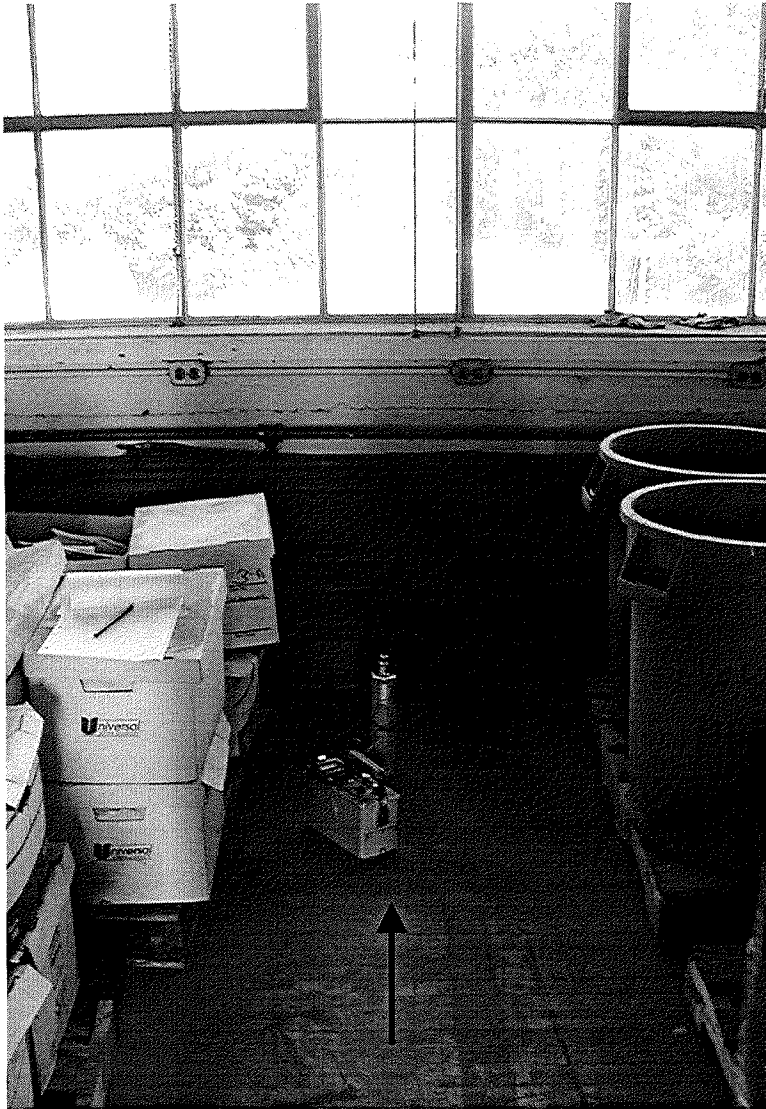
Thomaston- Third Floor Location M

Contamination found
on floor spot (35 feet
from Italian
American Club).

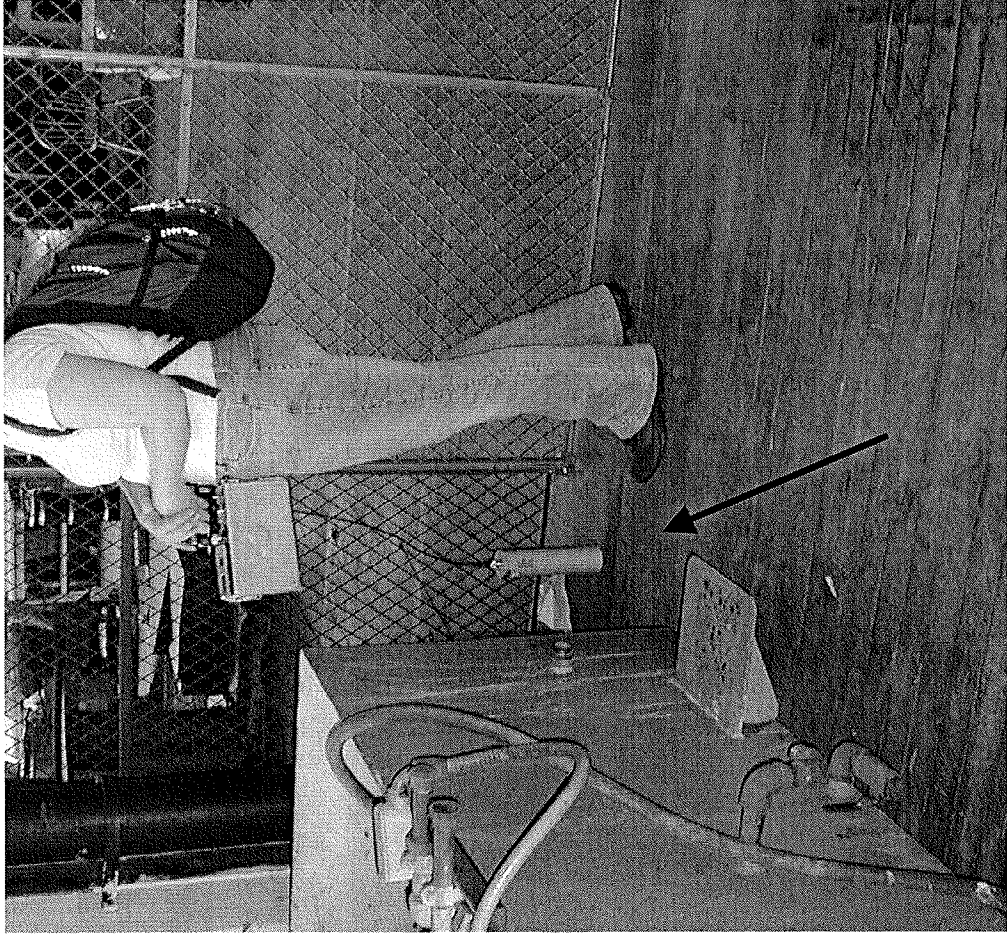
Thomaston- Third Floor Location C

Contamination
found on floor
spot by cage.

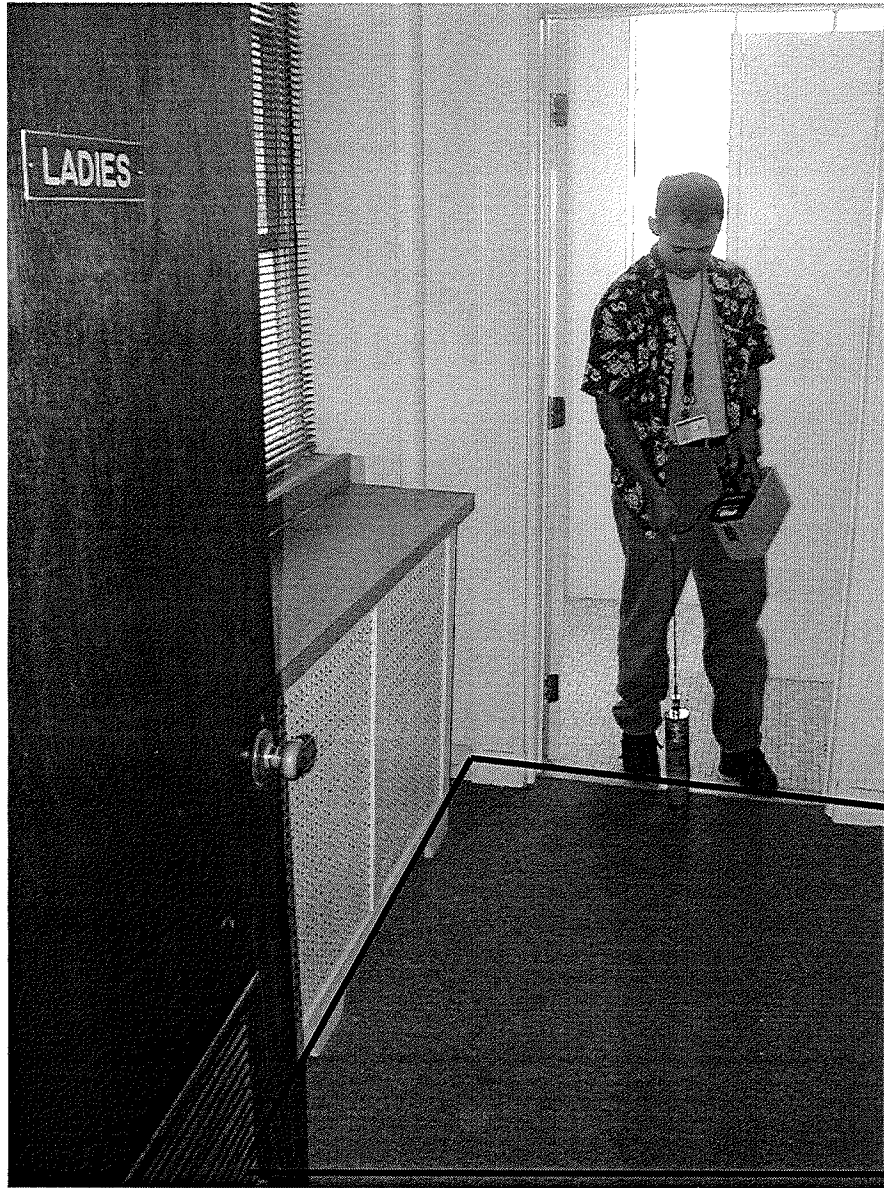
Thomaston-Third Floor Location O

Contamination found along the entire floor of ladies bathroom (glued-on carpet).

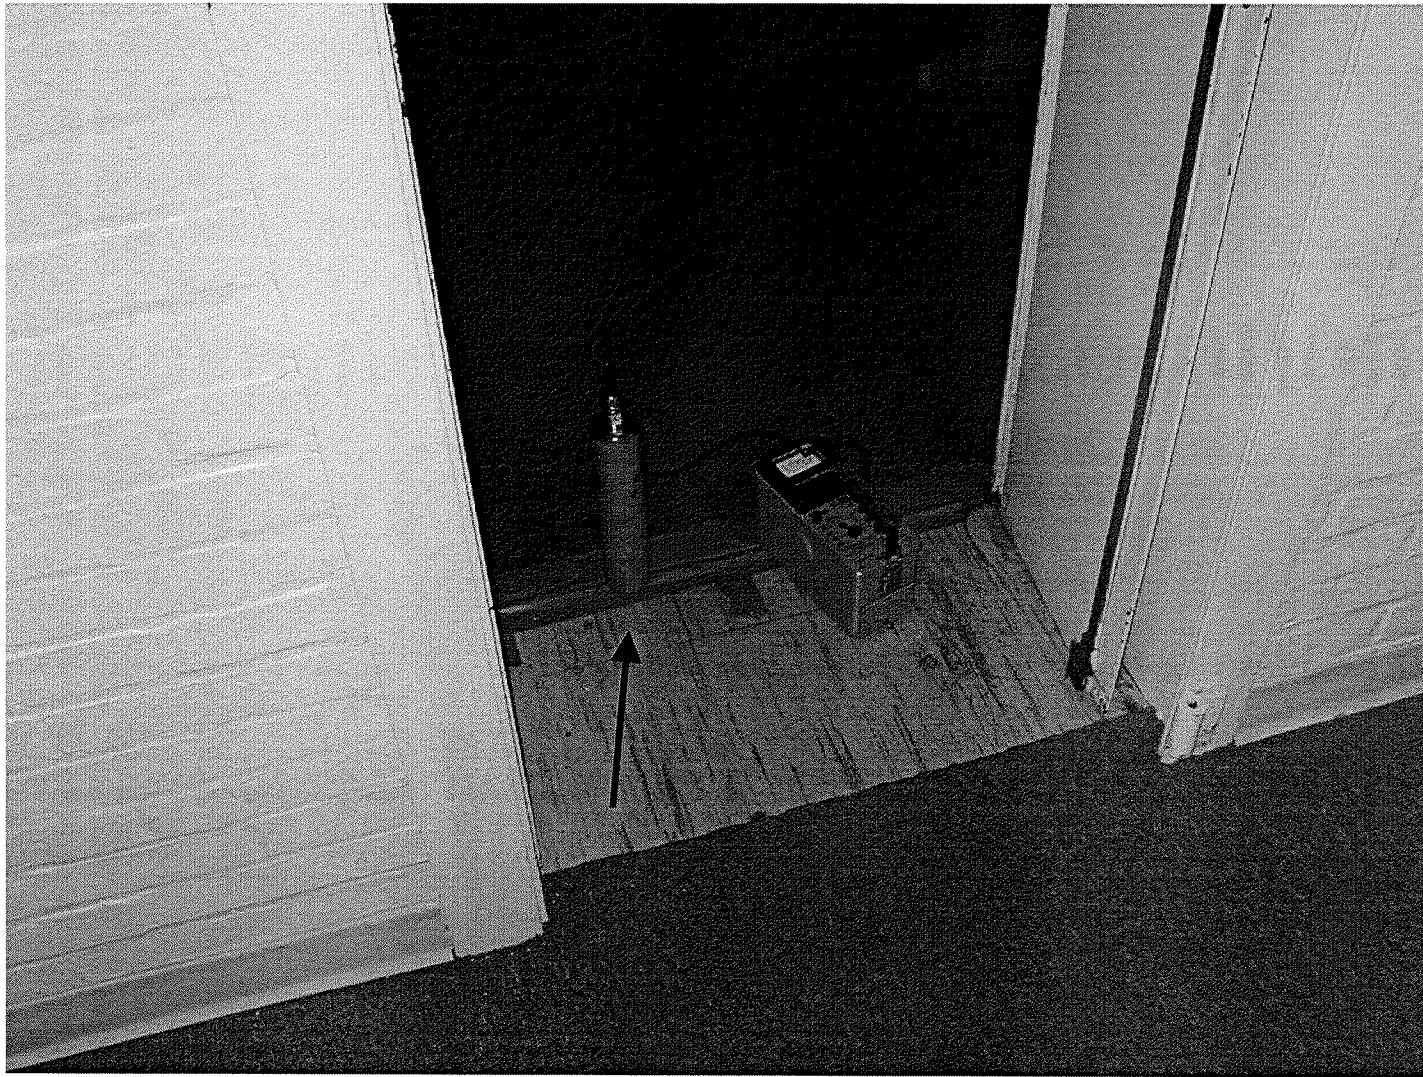
Thomaston-Third Floor Location P

Contamination found on floor spot at entrance of closet (no lights).

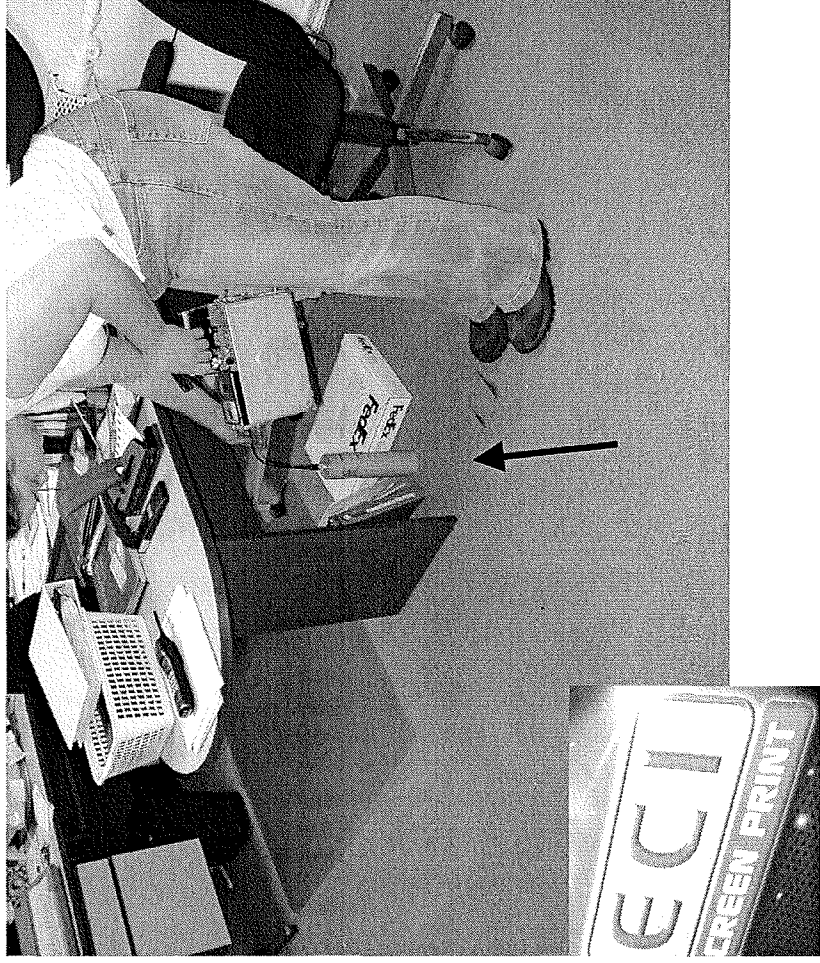
Thomaston-Third Floor Location G

Contamination found on various floor spots in ECI office.

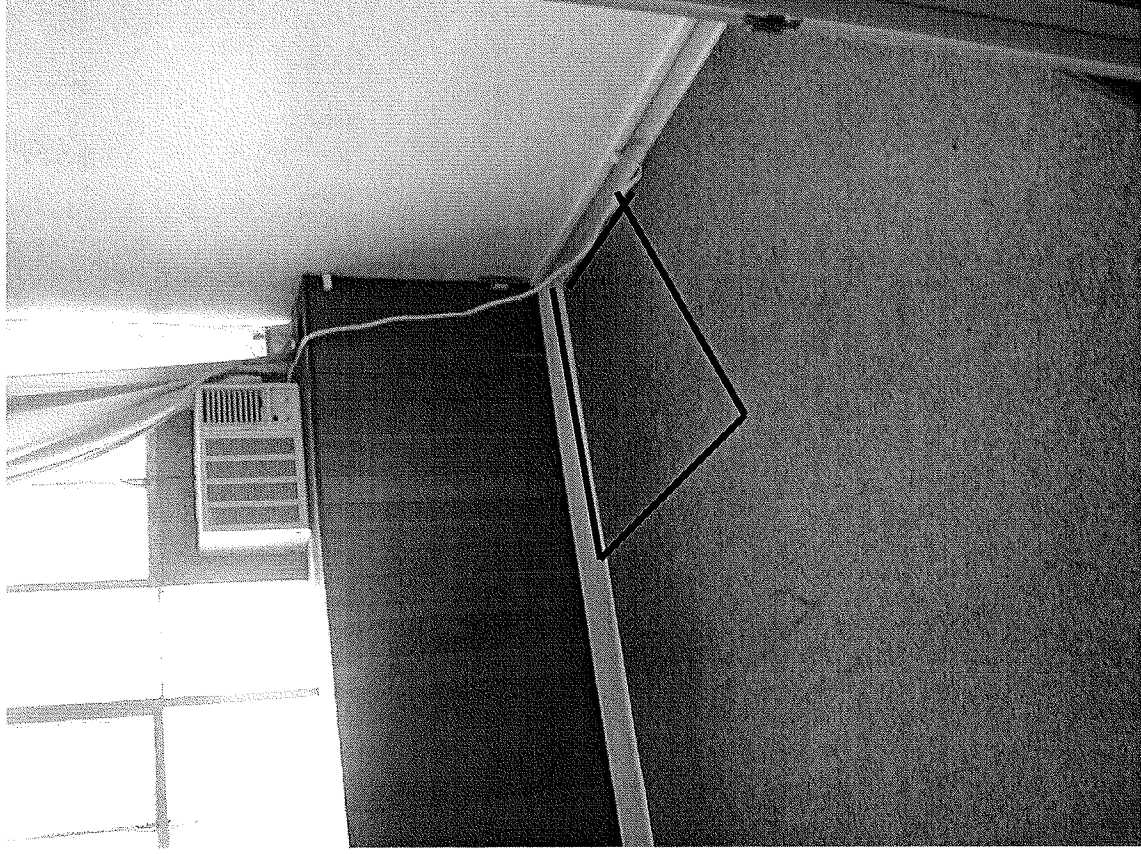
Thomaston Third Floor Location F

Contamination found on
floor 1' x 2' by corner in
Outreach office.

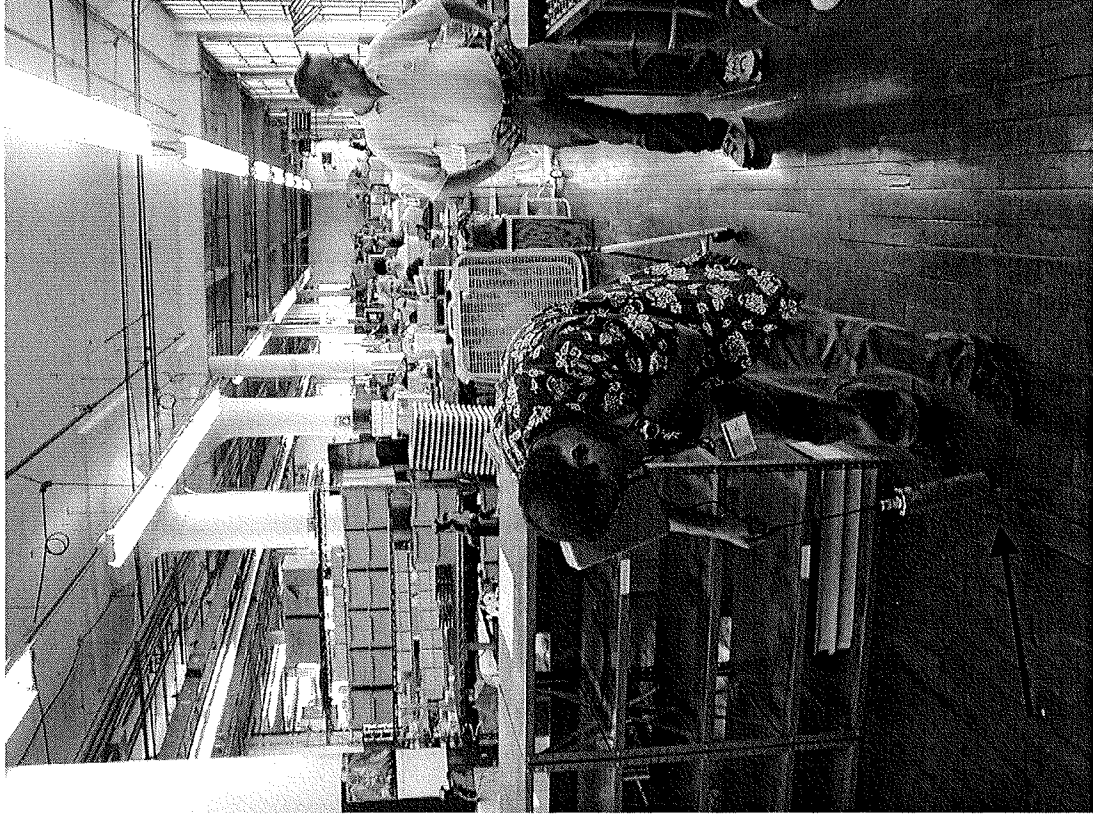
Thomaston-Second Floor Location H

Contamination found on various floor spots (finished floor).

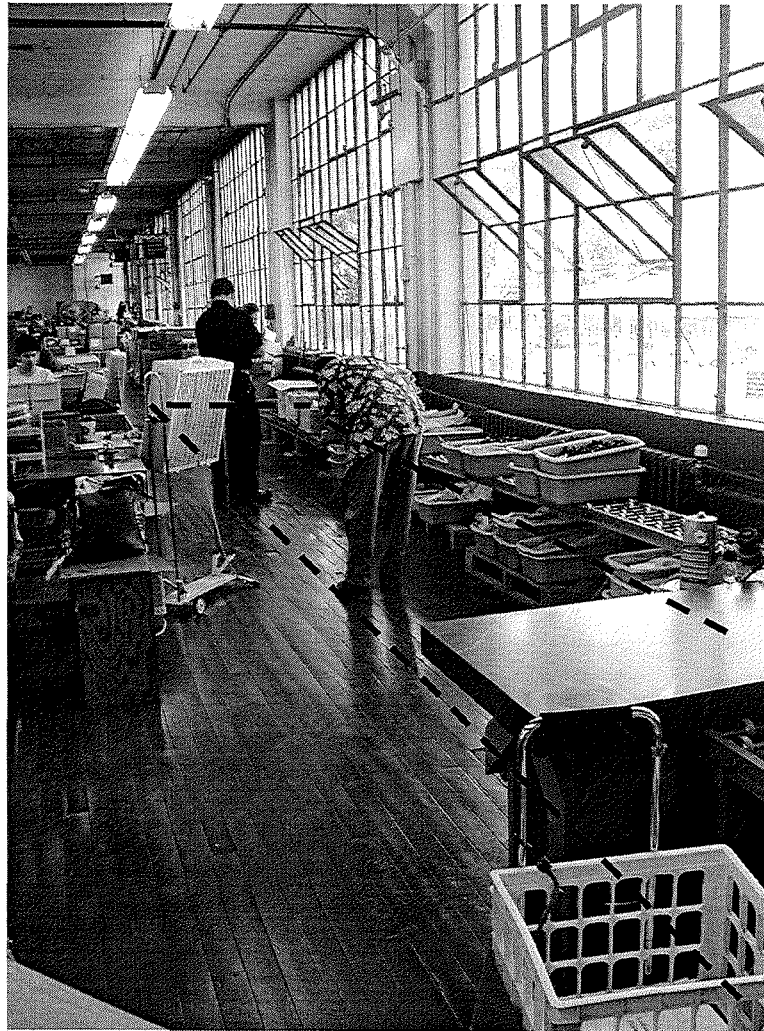
Thomaston-Second Floor Location Q

Contamination found in area 30' x 8' along windows
on finished floor.

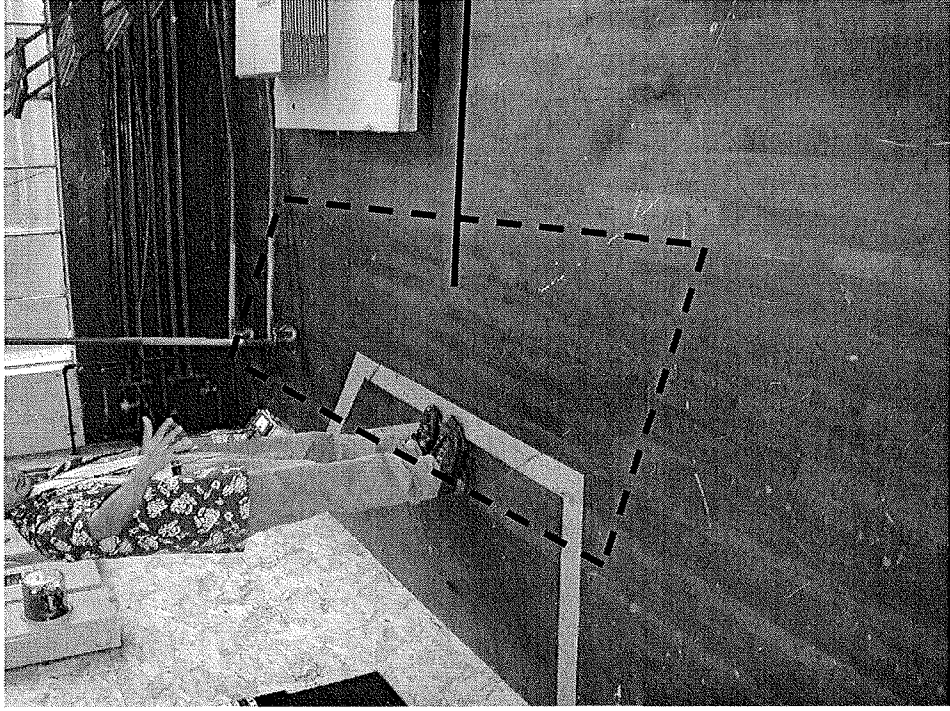
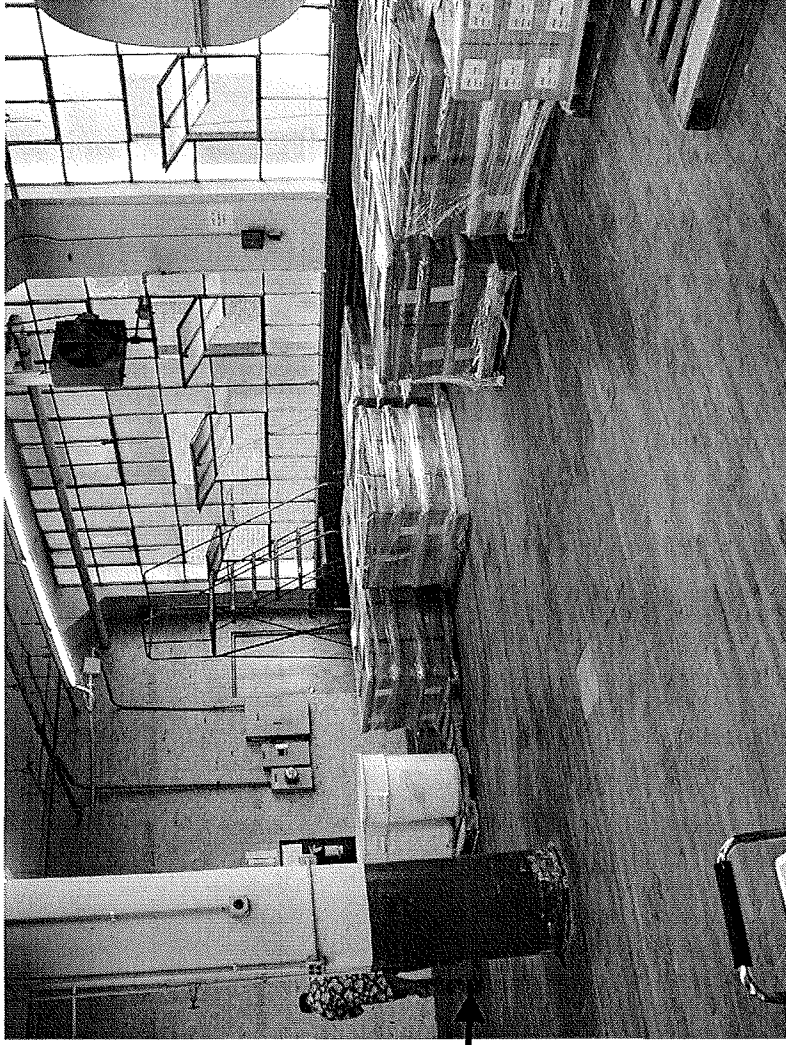
Thomaston-Second Floor Location K

Contamination found on
4' x 10' floor area.

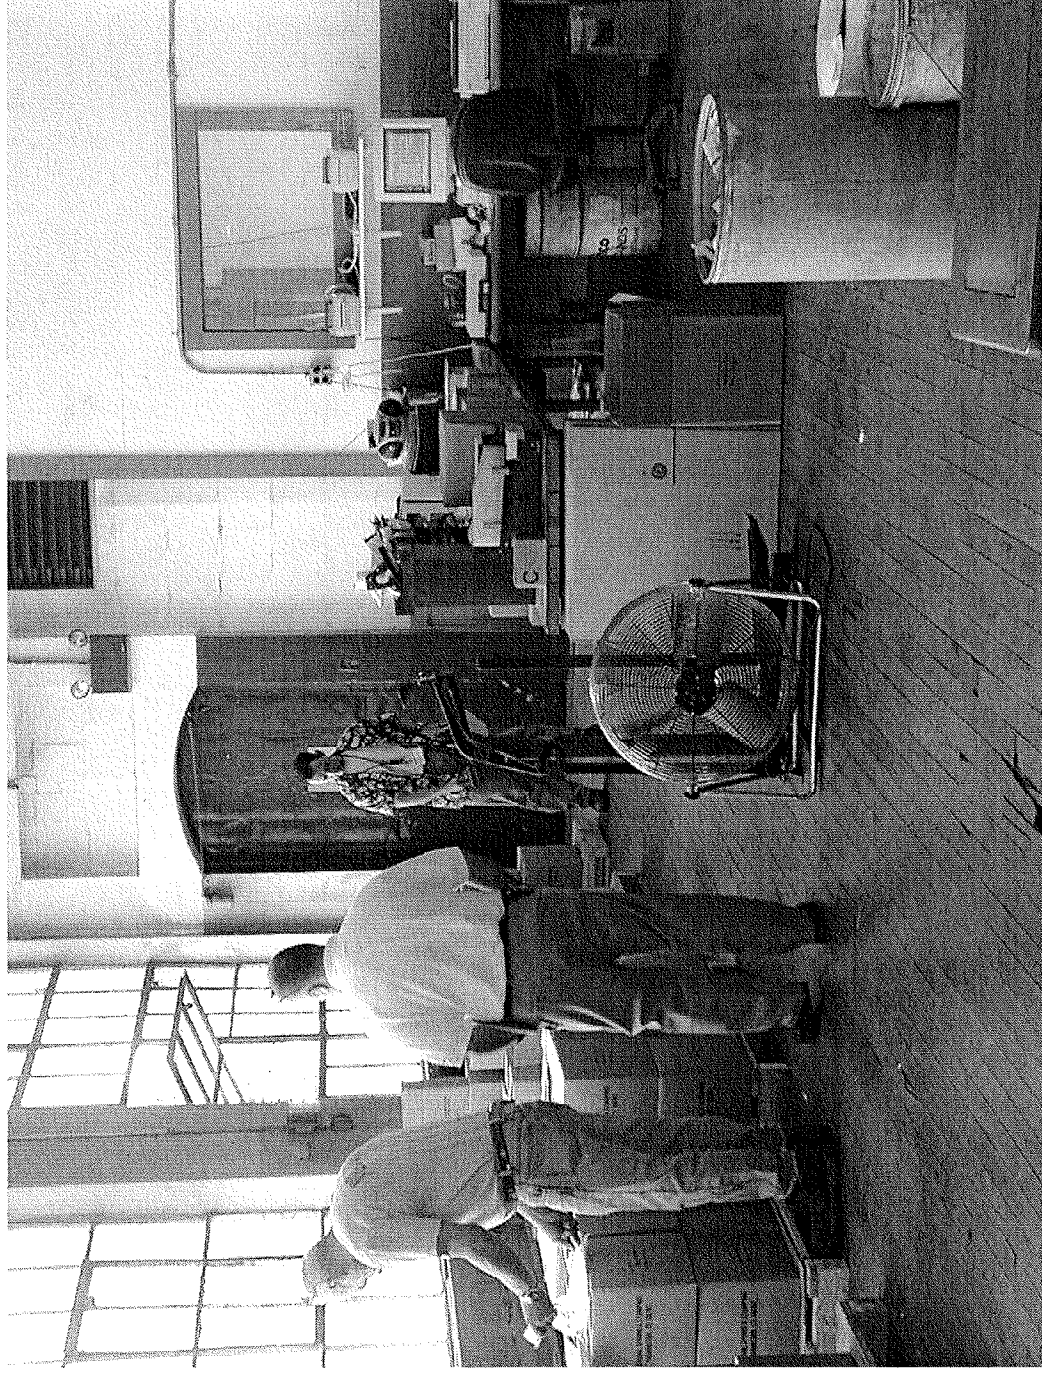
Thomaston-Second Floor Location I

Contamination found on various spots on floor.
