Palo Verde

Nuclear Generating Station

Subject: **Palo Verde Nuclear Generating Station (PVNGS) Unit 3**
Docket No. STN 50-530 / License No. NPF 74
Licensee Event Report 2016-002-00

1. FACILITY NAME Palo Verde Nuclear Generating Station (PVNGS) Unit 3						2. DOCKET NUMBER 05000530				3. PAGE 1 OF 6				
4. TITLE Emergency Diesel Generator Failure Resulting in a Condition Prohibited by Technical Specifications

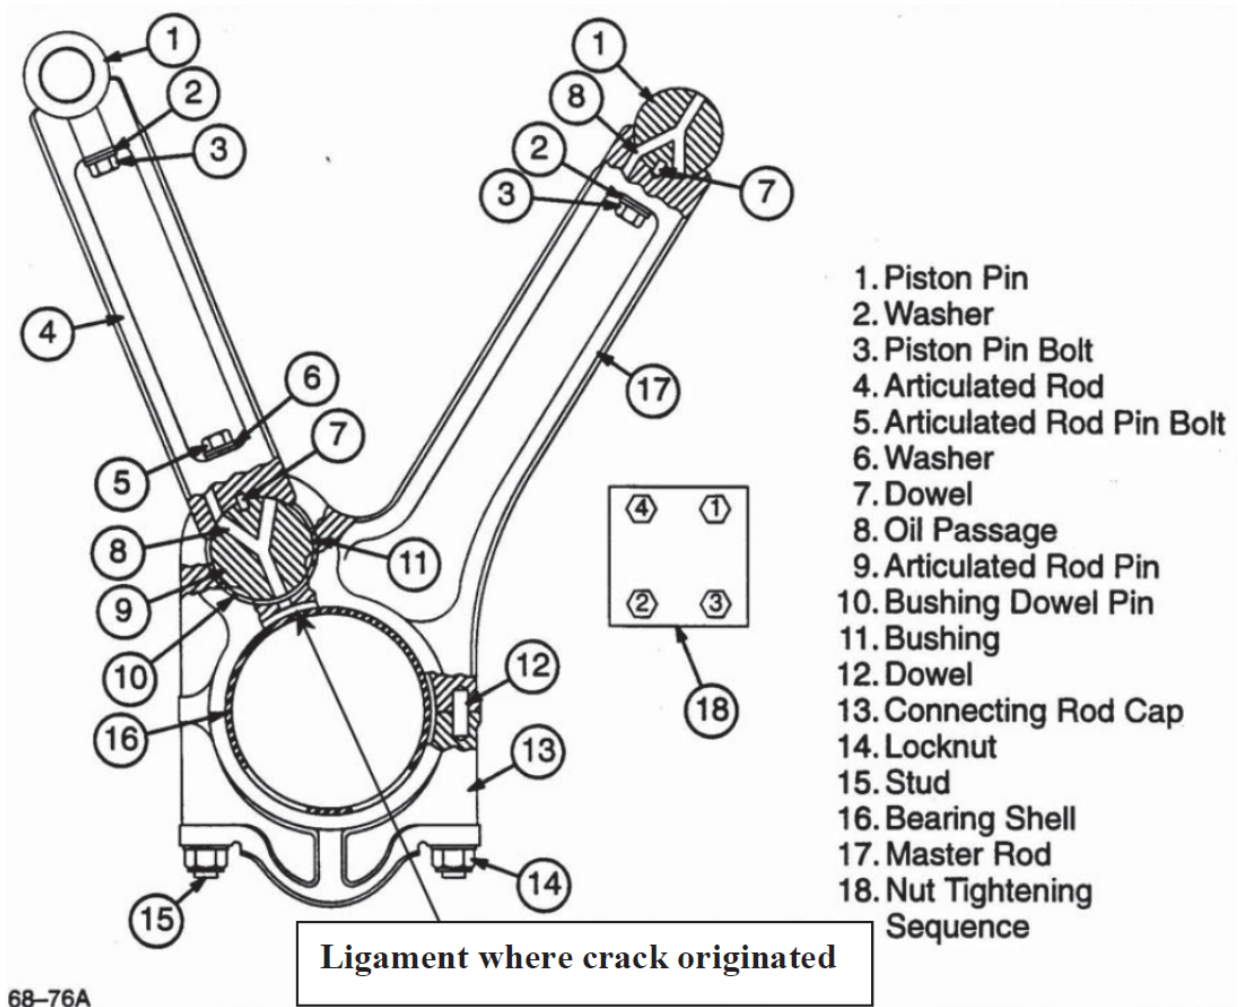
Attachment 1
Figure of the Connecting Rod Configuration

The PVNGS DGs are Cooper-Bessemer Model KSV-20 diesel engines designed in a v-type configuration. The DGs are 20-cylinder engines that incorporate 10 pairs of right and left bank power cylinders. Each power cylinder includes a cylinder liner, head assembly, piston, connecting rod, and associated crankshaft throw and bearings. The connecting rods for each pair of power cylinders include one master rod and one articulating rod, each made of forged steel and configured as shown in Attachment 1, Figure of the Connecting Rod Configuration.

The direct cause of this event was high cycle fatigue of the #9 master rod ligament. The preliminary cause analysis determined the 3B DG had a misaligned crankshaft bore that resulted from a previous failure of the 3B DG that occurred in 1986. The misalignment of the crankshaft bore resulted in sufficient cyclic stresses at the #9 master rod ligament to initiate and propagate a fatigue crack. Refer to Attachment 1 for a figure of the master rod configuration and the location of the ligament crack.

The damaged equipment has been repaired or replaced, and the misalignment of the crankshaft bore has been corrected by precision line boring, which restored the crankshaft bearing alignment to within manufacturer specifications. However, additional analytical work is in progress to validate the preliminary conclusions of the cause investigation team.
