Oct. 13, 2016 — Day 27

Team continues work on reactor head

The Emergent Issues Team (EIT) is continuing to work through a plan for addressing the reactor vessel head following the leak on the core exit thermocouple nozzle assembly (CETNA). The plan includes removing 14 control rod drive mechanism coil stacks and 13 dummy cans to remove boron accumulation and install canopy seal weld clamps.

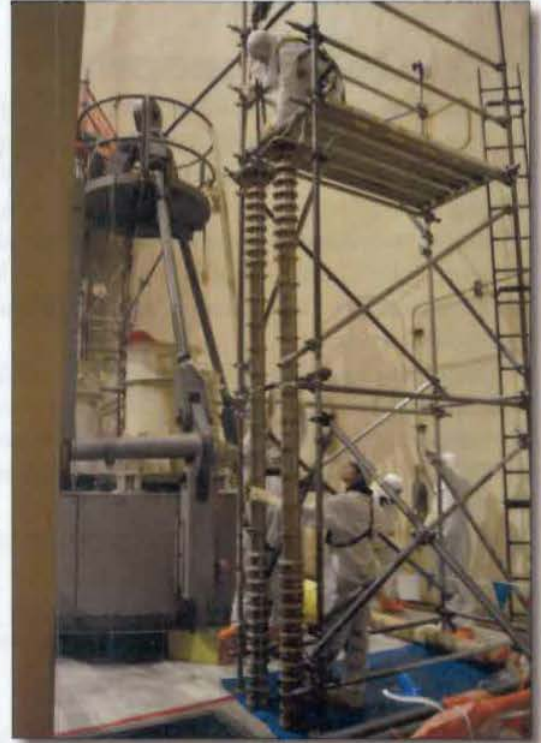
Following removal of the coil stacks and the under-head inspection, clamps will be installed on the location of the leaking canopy seal weld, penetration #77, and four additional spare locations. The four spare penetrations being clamped were identified as the most susceptible to future leakage based on internal and external operating experience and vendor recommendations. The plan is to complete these activities within the water jet peening window.

The Emergent Issues Team is working a plan to remove control rod drive mechanism coil stacks and dummy cans on spare penetrations to address the reactor head issues.

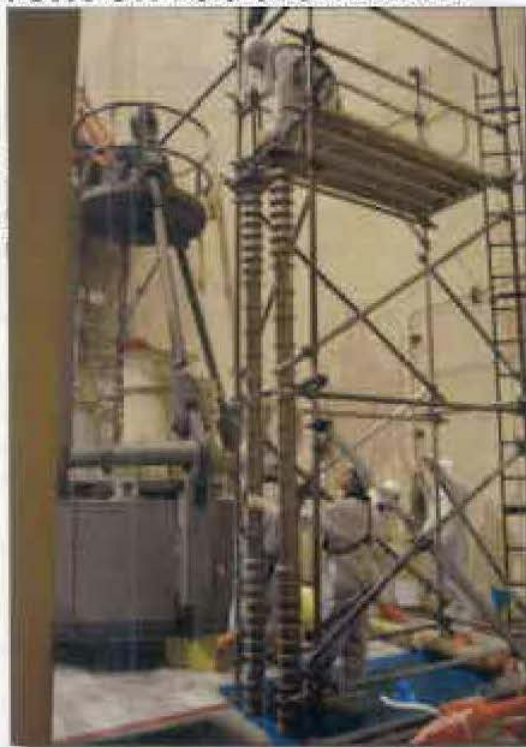
Following removal of the coil stacks and the under-head inspection, clamps will be installed on the location of the leaking canopy seal weld, penetration #77, and four additional spare locations. The four spare penetrations being clamped were identified as the most susceptible to future leakage based on internal and external operating experience and vendor recommendations. The plan is to complete these activities within the water jet peening window.

The Emergent Issues Team is working a plan to remove control rod drive mechanism coil stacks and dummy cans on spare penetrations to address the reactor head issues.
