From: Anchondo, Isaac
To: [Collins, Jay](#)
Cc: [Werner, Greg](#); [Proulx, David](#); [Kopriva, Ron](#); [Alley, David](#)
Subject: Leak Location
Date: Thursday, October 13, 2016 1:39:00 PM
Attachments: [leak location.pdf](#)

4. Reason for Request

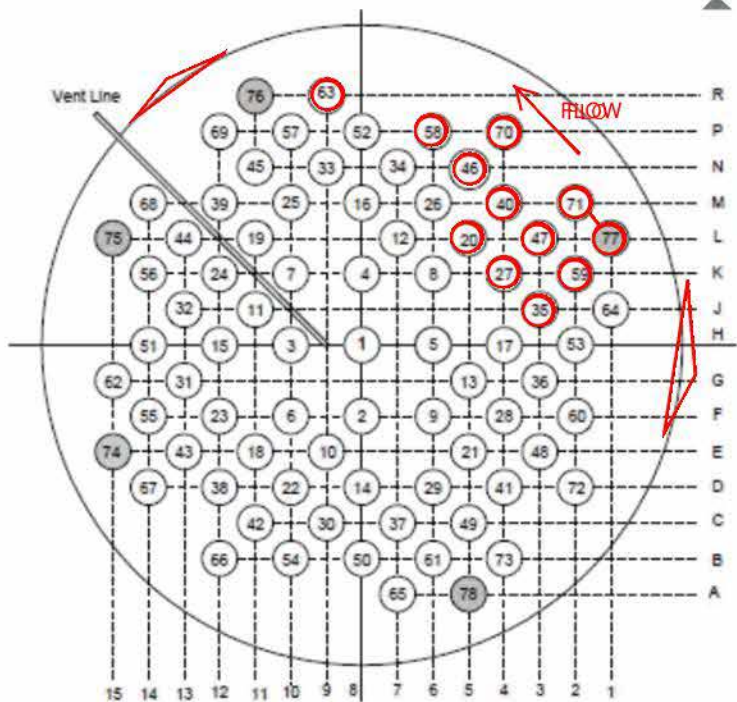
INSERT FIGURE SHOWING PENETRATION LOCATIONS

Based on visual examination (VE), deposits resulting from leakage in the canopy seal weld on penetration 77 are on the Reactor Vessel Closure Head. These deposits are dispersed on the reactor head in such a way that it is evident they resulted from the spray pattern, or spray deflection, from the canopy seal weld leak. Other observations noted were: 1) the condition of the head which only had surface rust present rather than wastage; 2) the color and location of these deposits were consistent with spray following the crud burst that was then oxidized by exposure to the atmosphere; 3) there was a layer of white boric acid on top of the deposits in a similar pattern indicating that clean borated water had followed the same path; and 4) no penetrations other than those in the path of the spray/deflection show any abnormal indications.

With this evidence indicating the condition resulted from the canopy seal weld leak above the head the deposits still obscure the head and prevent the required VE from being performed on the affected penetrations. WCNOG will perform supplemental examinations of the affected penetrations.

Twelve penetrations require supplemental examination in accordance with code requirements. Per paragraph -3200(b) of N-729-1 these supplemental examinations "...shall include volumetric examination of the nozzle tube and surface examination of the partial-penetration weld,...".
