**UNITED STATES  
NUCLEAR REGULATORY COMMISSION**

**SUBJECT: PALO VERDE NUCLEAR GENERATING STATION – NRC SPECIAL  
INSPECTION REPORT 05000528/2017008, 05000529/2017008 AND  
05000530/2017008**

Inspection Report 05000528/2017008,  
05000529/2017008,  
and 05000530/2017008

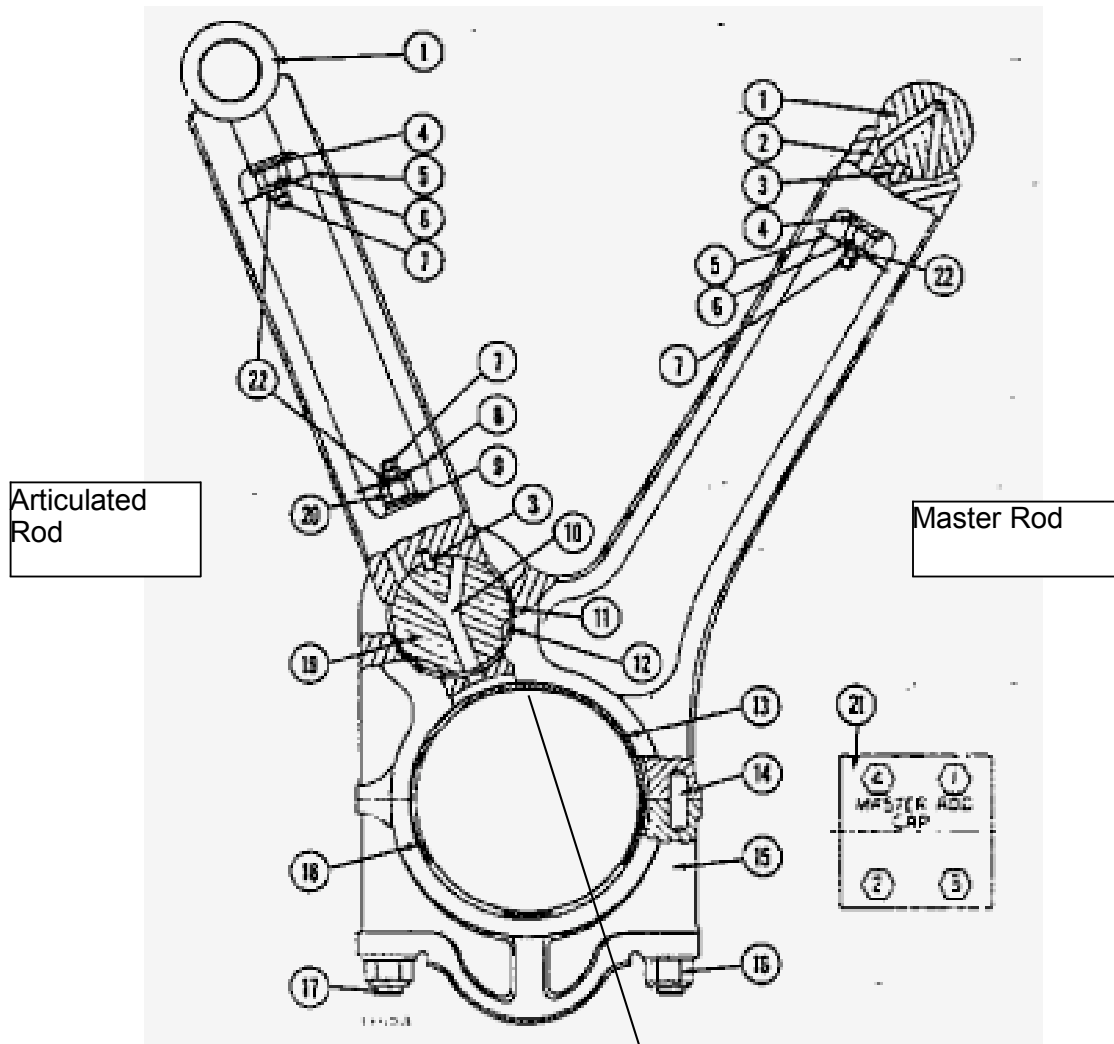
Diagram of Connecting Rod

The failure occurred in the ligament between the articulated rod bushing and the main crankshaft throw journal bearing. The primary failure caused the articulated bearing straps to subsequently fail due to overload.

The team found that the licensee's root cause conclusion at the time of the inspection was that the Emergency Diesel Generator 3B failure was the result of centerframe main bore misalignment from the 1986 master rod failure event. The misaligned centerframe main bore caused high cycle fretting fatigue in the master connecting rod at the interference fit between the connecting rod and the backside of the crankpin bearing shell. The result of the fretting was a fatigue crack on the cylinder 9R master connecting rod, which initiated at a ligament between the articulated pin bore and the crankshaft pin bore.

Site of crack initiation (on the master rod under the bearing shell)
