**UNITED STATES
NUCLEAR REGULATORY COMMISSION**

May 10, 2017

**SUBJECT: PILGRIM NUCLEAR POWER STATION – SUPPLEMENTAL INSPECTION
REPORT (INSPECTION PROCEDURE 95003 PHASE ‘C’) 05000293/2016011
AND PRELIMINARY GREATER-THAN-GREEN FINDING**

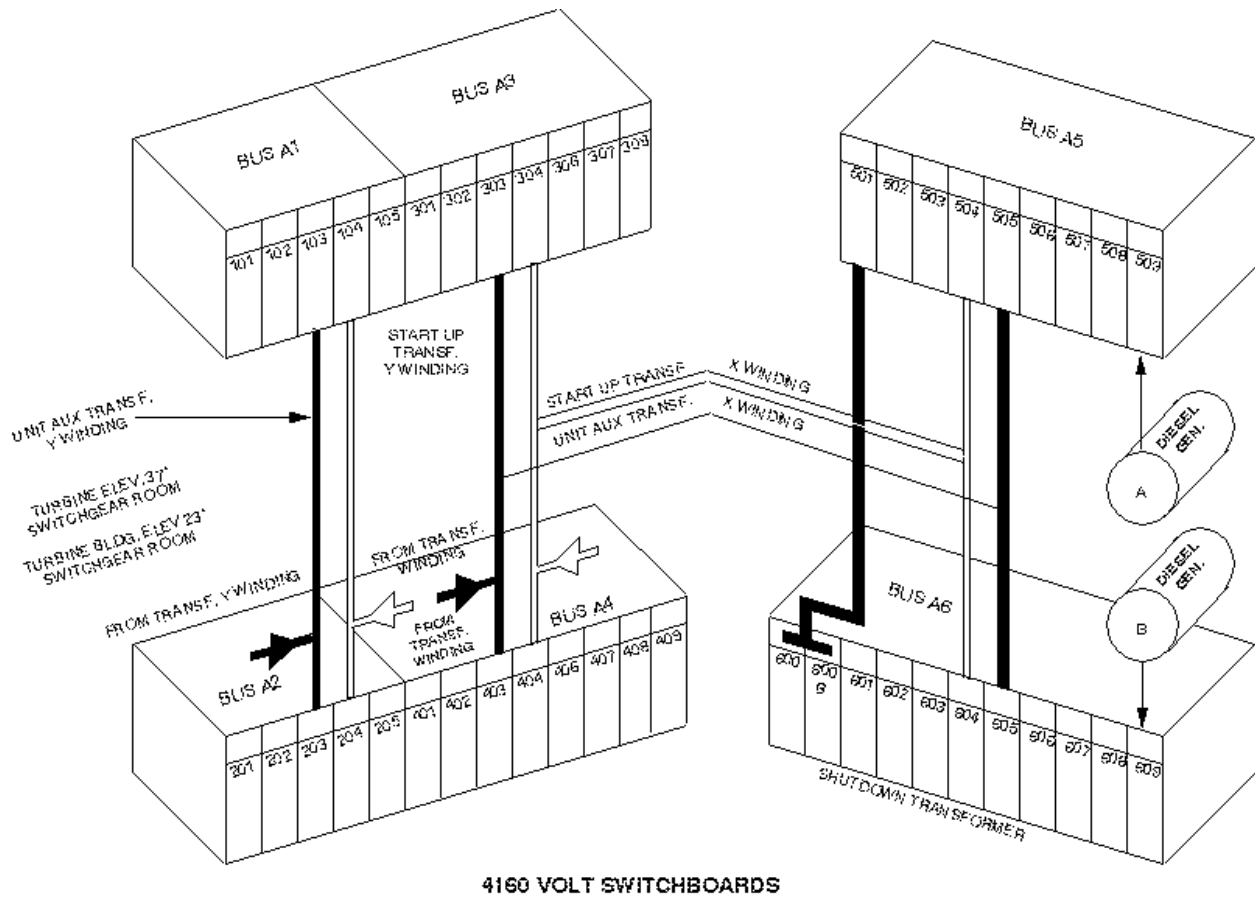
Figure 3

Bus A6 contains 11 cubicles. These include feeds from 'B' emergency diesel generator, offsite power via the startup transformer and unit auxiliary transformer, and power from the 23KV line via Bus A8. Based on the potential to damage the bus work it was assumed that a high energy arcing fault in Bus A6 would result in the unrecoverable loss of the 23KV (Bus A8 feed), SBO diesel generator, unit auxiliary transformer, startup transformer, and B emergency diesel generator feeds. Since a fault on the supply side of the breaker is assumed either as the direct cause or due to fire damage, this would also prevent offsite power from feeding Bus A5 ('A' train safety-related 4KV). Evaluation of small and large fires in Bus A6 breakers was also evaluated. Based on the fire size and location to various control power feeds, various off-site feed damage states and recoveries were evaluated. For cases where recovery could be credible, a failure probability of 0.1 was assumed. Although the manual operation of a 4KV breaker is not complex, the actions would have to occur post-fire, possibly in the vicinity of fire damage. Given this scenario, a 0.1 value seems appropriate for screening.

Bus A4 adjoins A2 and they are parallel to and six feet away from bus A6. There are 13 breaker cubicles in A2/4. A bus duct connects A6 to A4. Two cable trays run between A2/4 and A6 approximately even to the tops of the switchgear. Control cables from A6 run in the tray closest to A2/4. For a high energy arcing fault, these cables are in the zone of influence. Additionally, small and large electrical fires originating in the cabinets have the potential to propagate and cause cable damage. Based on the fire size and location to various control cables, various off-site feed damage states and recoveries were evaluated. For recovery, a failure probability of 0.1 was assumed. Although the manual operation of a 4KV breaker is not complex, the actions would have to occur post fire, possibly in the vicinity of fire damage. Given this as stated above, 0.1 seems appropriate for screening.
