LaSalle Unit 2 HPCS Injection Valve Failure during the February 2017 Refueling Outage

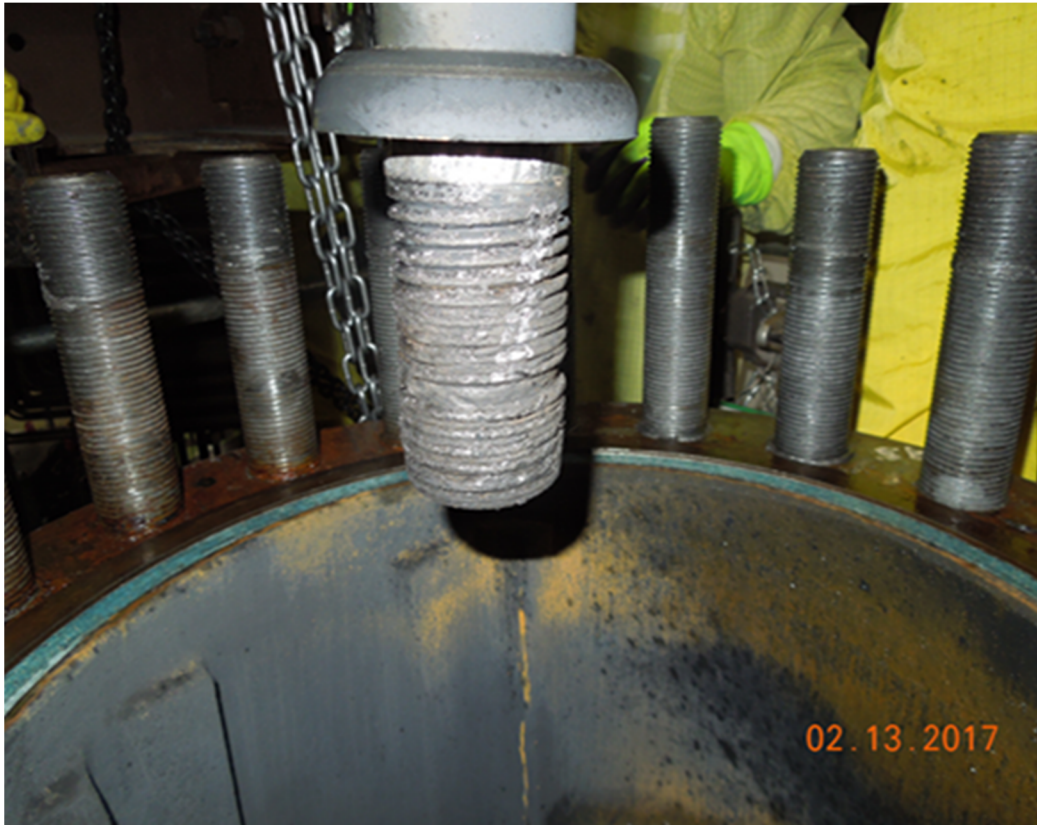
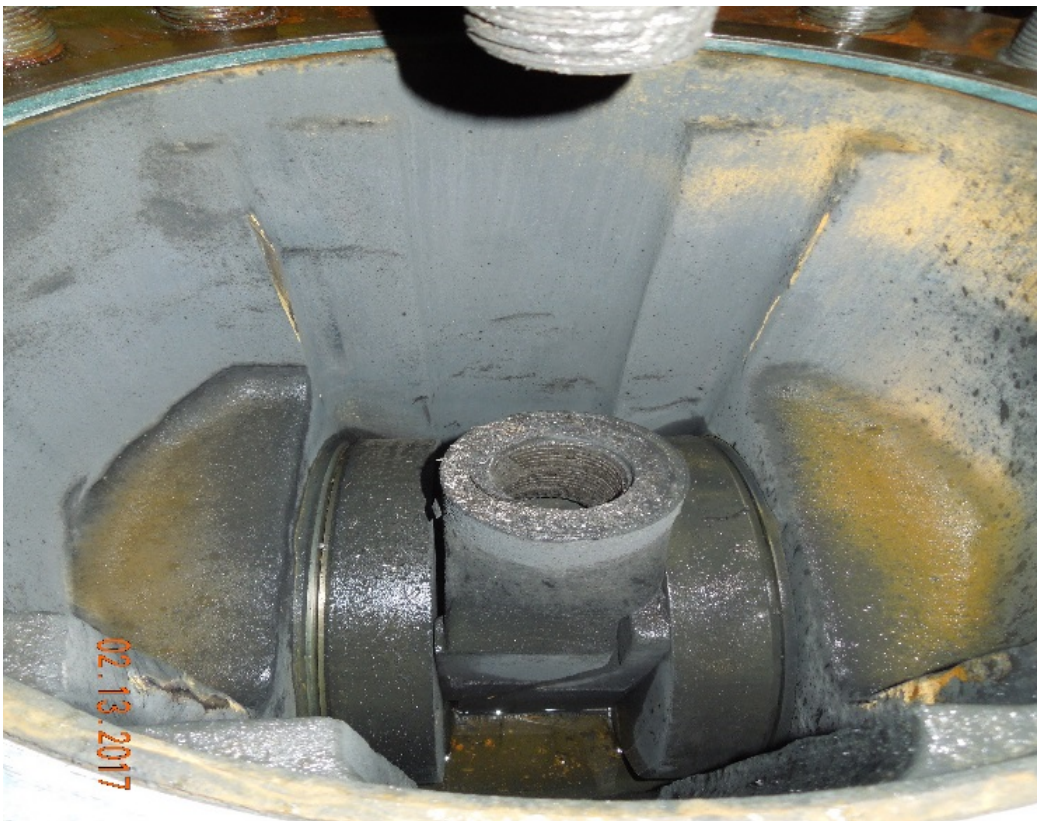
On February 11, 2017, the Unit 2 HPCS injection valve stem was found to be separated from the upper wedge/disc assembly during a fill and vent activity¹. Prior to the failure, the valve had successfully passed a local leak rate test where the valve had cycled successfully several times. Valve disassembly and inspection revealed the wedge pin had sheared and the valve stem threads were damaged. This valve was an Anchor/Darling 12 inch Double Disc Gate Valve (ADDDGV) and was included in those valves associated with the Flowserve and Browns Ferry Part 21 reports submitted in 2013 (ADAMS ML13008A321 and ML13064A012). The licensee was addressing the Part 21 reports by using industry guidance provided by the Boiling Water Reactor Owners Group (BWROG) prior to the failure. Following the identification of the separation, the licensee redesigned and repaired the failed Unit 2 HPCS Injection valve.

Figure 1: As Found Pictures of Failed Unit 2 HPCS Injection Valve Stem to Wedge Connection
