UNITED STATES
NUCLEAR REGULATORY COMMISSION
OFFICE OF NUCLEAR REACTOR REGULATION
OFFICE OF NEW REACTORS
WASHINGTON, DC 20555

June 15, 2017

NRC INFORMATION NOTICE 2017-03: ANCHOR/DARLING DOUBLE DISC GATE VALVE
WEDGE PIN AND STEM-DISC SEPARATION
FAILURES

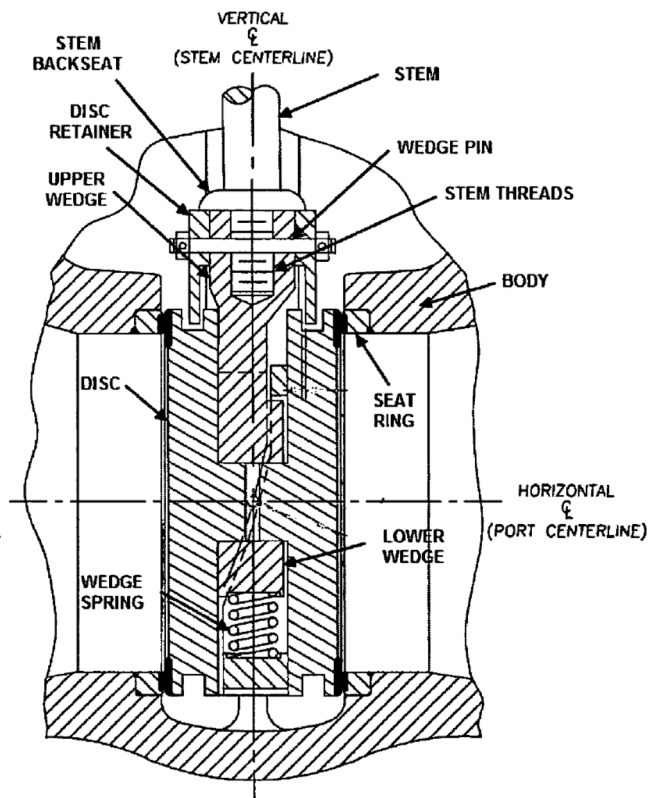
Figure 1 Typical Anchor/Darling DDGV (ADAMS Accession No. ML13064A012)

The stems on most double-disc (DD) gate valves larger than size 2" are attached to the upper wedge using UN [unified constant pitch] threads. A pin is installed through the hub of the upper wedge and stem threaded section to prevent the stem from loosening and eventually unscrewing from the wedge. In addition, the disc retainers on some DD gate valves are attached using the wedge pin. See Figure 1. The output torque of the actuator is transmitted to the stem/wedge joint through the stem and is resisted by the disc wedge pack, therefore the stem to wedge connection is loaded by the stem torque and thrust. The wedge pin is not designed to withstand the full actuator output torque. The actuator torque direction tends to tighten the stem into the wedge during closing and tends to loosen the stem during opening.
