August 9, 2017
17-063

Subject: 60-Day Written Report for Event Notification Number 52840

60-Day Written Report for Event Notification #52840 - July 4, 2017**Event Description:**

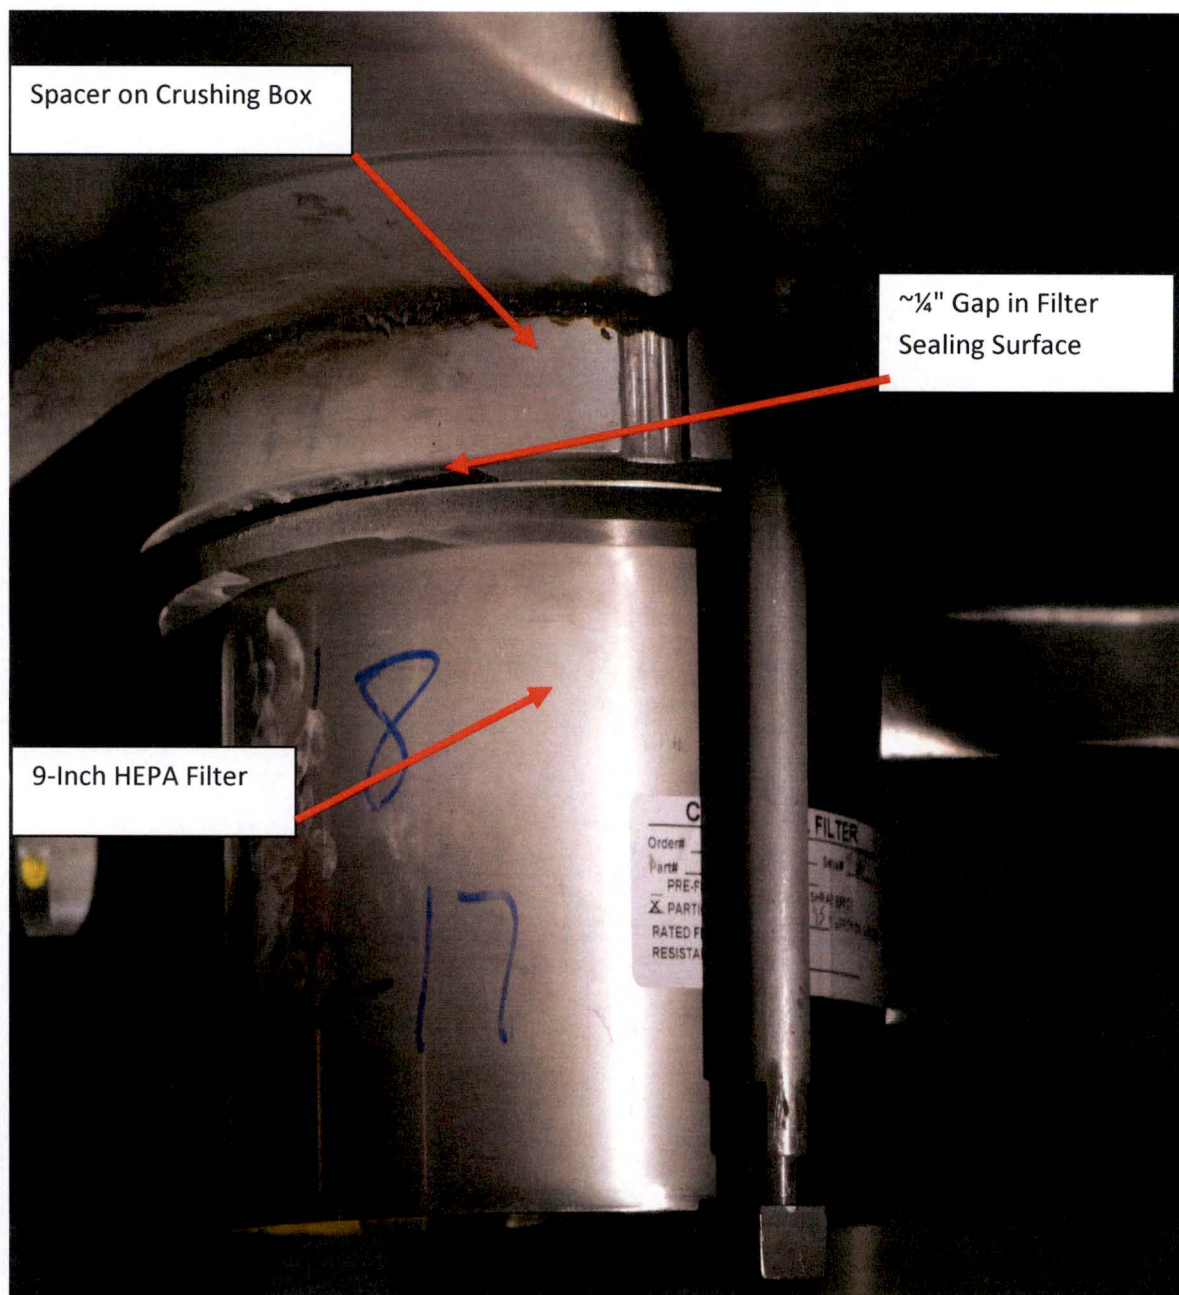
Figure 1 - Pre-Filter Installation in Interior of Crushing Glovebox

BWXT's investigation of how the UAl_x HEU accumulated in the purification system focused on the pre-filters installed to control UAl_x HEU from entering the purification system piping and eventually depositing in the purifier media which acted as a collection point for particulate passing through the purification system. An interview with a retired employee familiar with the process indicated that after the 1986 cleanout, the process restarted with carburetor type filters until new HEPA filters could be ordered. This statement leads BWXT to conclude that in 1986 upon restart that some amount of UAl_x HEU once again made its way into the purification system through the carburetor type filters which had already been proven ineffective in controlling fuel accumulations in the purification system. The retiree speculated, but could not recall specifically, that losses from the UAl_x HEU process were tracked and/or routine surveys were conducted of the purification system during this period until HEPA filters were installed, and the mass-loss monitoring control associated with the 1986 analysis was determined to no longer be necessary.

The first root cause was identified through careful analysis of the effectiveness of the sealing of the 9 inch pre-filter design and installation. A root cause analysis, "An Unexpected UAl_x Accumulation In the Desiccant Containers of the Purification System Discovered During Maintenance," was performed using the TapRoot® methodology. This analysis identified two root causes.

- Root Cause (1) Less than adequate design and installation of the 9 inch HEPA pre filter assemblies in the Crusher and Blend Gloveboxes
- Root Cause (2) BWXT was not monitoring for buildup of ^{235}U or changing out the desiccant in the system purifiers on a periodic basis to ensure accumulations above the NCS limit did not occur as recommended by NCS in 1986.

8. Redesign and replace the 9 inch HEPA pre-filter assemblies on the Crusher and Blend Glove boxes prior to returning them to operation. (6/1/18)
9. Modify the Radiation Work Permit procedure to specifically require RWP request originators and evaluators to consider the potential for fuel accumulations in ancillary systems servicing processes being addressed under the RWP. The RWP program will be modified to direct the inspection of potential fuel accumulations using the NDA method established in corrective action number 6. (10/1/17)

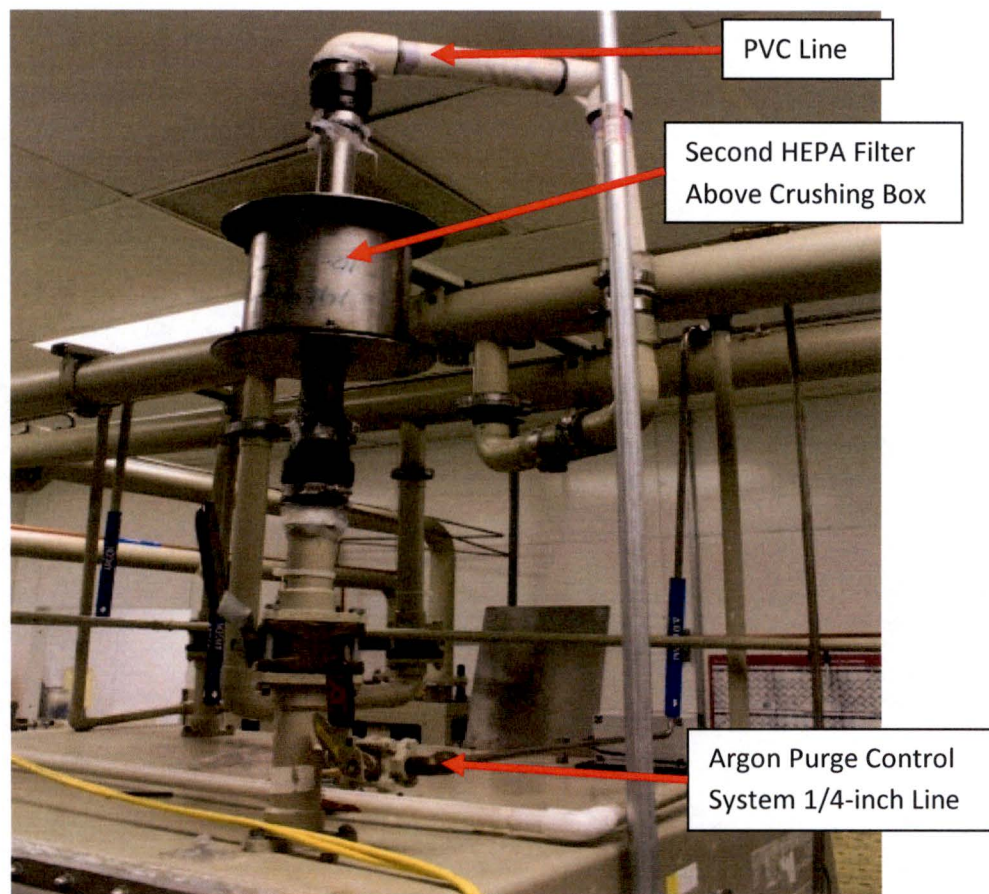
Figure 2 - Purification System Control Piping

BWXT's investigation of the installed HEPA filters and inlet and outlet piping associated with the purification system identified that the pathway for UAl_x HEU fuel to have accumulated in the purification system was through less than adequate design and installation of the HEPA pre-filter assemblies. This allowed fuel to enter the desiccant through two paths, the three inch piping to the purifiers and the Argon Purge lines. Upon detailed examination of the 9-inch diameter pre-filters installed in the crushing and blending portions of the UAl_x HEU glovebox line and through discussions with the current operators, it was identified that the 9-inch pre-filters were particularly difficult to install and gain an effective seal against a spacer which had been installed on the ceiling surface of the glovebox. The investigation team observed that the 9-inch pre-filter installed in the crushing section of the glovebox has a significant gap (~ ¼ inch) between the spacer and the gasket of the pre-filter (Figure 1). In addition, the investigation revealed a gap between the spacer and the glovebox in the Blend Box and the assembly was loose fitting. These provided a pathway for UAl_x HEU into the purification system. This was confirmed by gamma measurements of the purification system piping which indicated accumulation of fuel beyond the 9-inch pre-filters. It is important to note, that at some point, the poor fit of the Crusher Glovebox 9-inch pre-filter must have been recognized by BWXT management because a second pre-filter (Figure 2) was installed on the glovebox outlet pipe to the purification system directly outside the crusher portion of the boxline. Measurements of the PVC piping installed downstream of the second filter indicate that this filter is effective in controlling UAl_x HEU from passing further into the purification pipe work and eventually into the desiccant containers.

The second pathway for UAl_x HEU to enter the purification system into the purifier media was through the purification system control piping ($\frac{1}{4}$ inch Argon Purge line) that attaches to the main purification system piping (3-inch) on the outside of the UAl_x HEU glovebox directly above the 9-inch pre-filter described above (Figure 2). Similar to the leakage to the desiccant containers from the main purification system 3-inch piping, when the vacuum pump for the purification system is operating HEU can be drawn through the piping into the desiccant container.

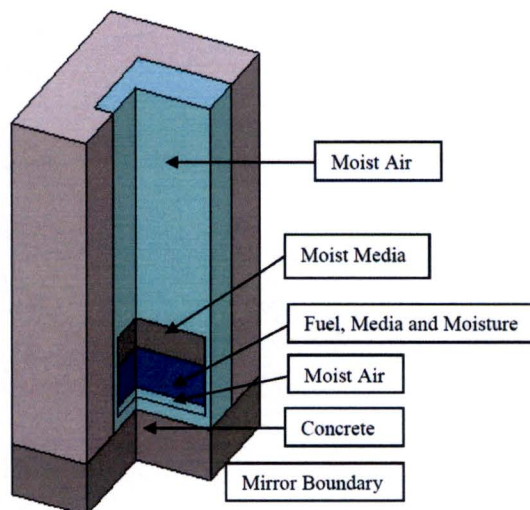
Figure 3 - Illustration of Model Geometry

The first step in assessing the risk presented by an accumulation of fuel material in the Dri-Train Air Purification System is to determine the ^{235}U mass values for the normal operating and upset conditions per the requirements of NRC License SNM-42. Standard material modeling practices for the BWXT NOG-L facility were applied to the calculations (Figure 3). Utilizing field measurements, the two desiccant containers were modeled as 18 1/2 inch tall by 19 3/8 diameter cylinders spaced 2 inches apart and 3 inches off the concrete floor. The container walls were modeled as 1/8 inch thick 316 stainless steel based on UT measurements of the wall thickness and vendor correspondence with respect to material of construction. The interior of the desiccant containers were modeled with a 2 3/4 inch lower plenum (based on field measurement) and purifier media filling the remainder of the cylinder. The purifier internals (i.e., inlet pipe to lower plenum, support plate, heating coils, etc.) were not modeled; the volume was filled with media material which provides a conservative result. Although the purifiers contained layers of two media types white (molecular sieve) and black (Q5), the purifier media types were analyzed independently. The chemical compositions, densities, and packing fractions of the media were based on laboratory analysis. The model included a tight fitting 12 inch thick water "wall" around the purification unit.

The HEU fuel material was modeled with an enrichment of 93% ^{235}U in the form of UAl_2 to maximize the uranium density. In both the normal and upset cases the HEU fuel material is either 1) assumed to be distributed with cylindrical geometry having an H/D of 1 within the purifier media with variable fuel radius (which in turn defines the height) or 2) assumed to be uniformly distributed in the radial direction within the purifier media with variable fuel height. The latter distribution was confirmed by field measurements with a gamma assay instrument to be the most representative, whereas the former conservatively takes no credit for actual fuel distribution within the media. No fuel material was modeled in the lower plenum, whereas the upper plenum was assumed to be occupied by media and could contain fuel depending on the defined fuel geometry. Visual inspection of the plenums of both

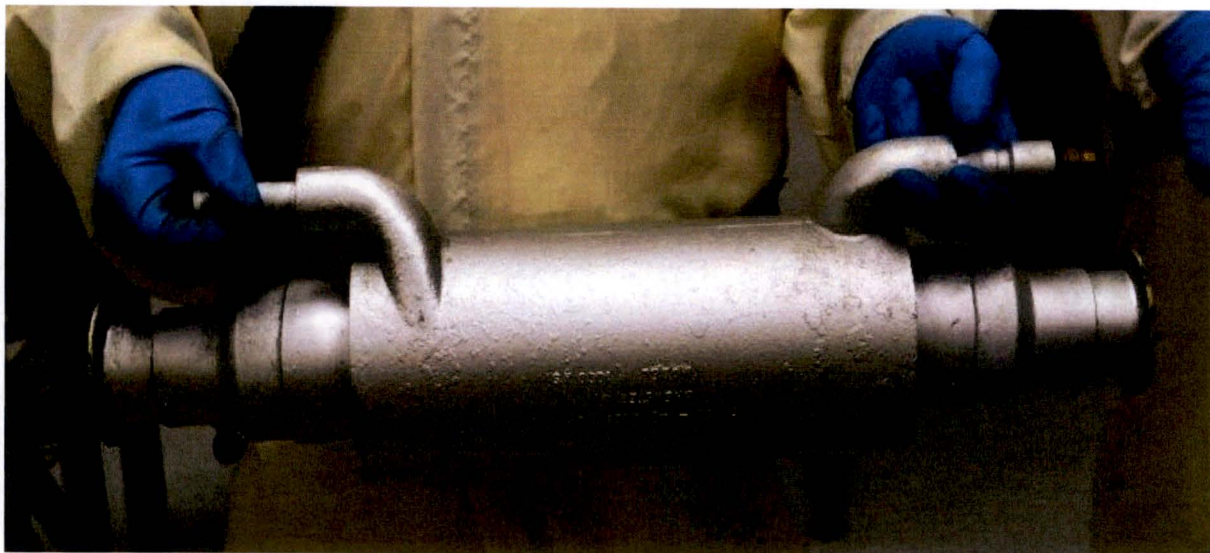
Figure 4 - Heat Exchanger Installed in Dri-Train Air Purification System

The heat exchanger is an un-credited passive engineered control (Figure 4). The design of the heat exchanger provides an extremely high degree of reliability and protection from a coolant leak (Figure 5). The glovebox atmosphere passes through the larger diameter tube of the heat exchanger. Heat is conducted to the tube wall by a heat exchange assembly which is formed by a central expanded tube and a fin construction. Water flowing through an external cooling coil encircling the larger tube provides a source of coolant to the heat exchanger. The heat exchangers were leak tested to verify the integrity of the tubing. No leaks were identified. X-ray evaluation of the heat exchangers confirmed the interior configuration and detected no signs of degradation in

the tube walls (Figure 6). For water to enter the gas stream, the wall of the water line and the gas line must fail simultaneously at adjacent points. The probability of this combination of failures is extremely remote.
