**UNITED STATES
NUCLEAR REGULATORY COMMISSION**

August 31, 2017

**SUBJECT: LASALLE COUNTY STATION, UNITS 1 AND 2—SPECIAL INSPECTION
TEAM REPORT AND EXERCISE OF DISCRETION; INSPECTION
REPORT 05000373/2017009; 05000374/2017009**

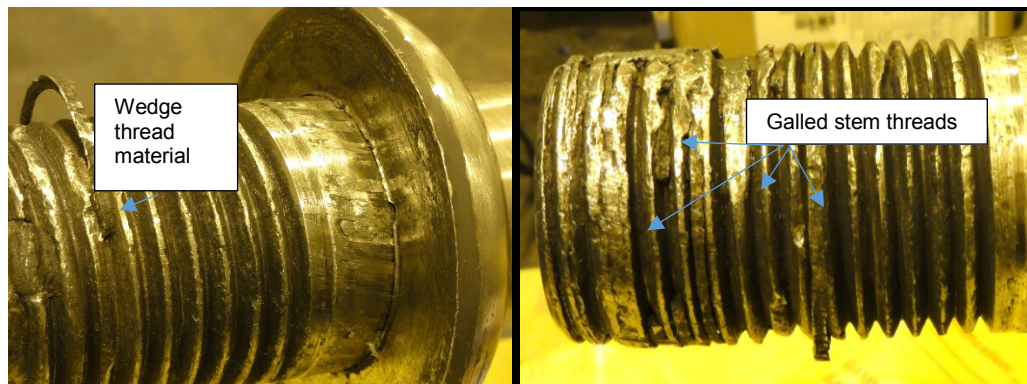
Figure 1 - As-Found Stem of Failed 2E22-F004 Valve

- The 2E22-F004 valve, which failed around February 11, 2017, was installed during plant construction and was used during pre-operational testing in the early 1980s. The stem and wedge assembly and associated threaded connection had not been inspected, maintained, or modified, from original installation to failure.

- On February 8, 2017, the valve stem was cleaned and lubricated. A stem rotation check was then performed during a scheduled refueling outage. The stem rotation check was verified to be less than approximately 5–10 degrees between the open and closed strokes. This met the procedural acceptance criteria.
- On February 8, 2017, a local leak rate test was performed using water with a differential pressure of 1000 psi gauge plus or minus 50 psi across the valve. The leak rate test passed with minimal leakage. System parameters indicated that the valve stem and wedge/disc were cycling without issue.
- On February 11, 2017, the valve stem was identified to have separated from the wedge during a system fill and vent activity. Pictures of the degraded stem and embedded wedge thread fragments are shown below.

- In February 2017, a 100 ton lift was used at near rated capacity to remove the wedge and disc from the seat. The 2E22-F004 valve was repaired using a new stem with an integral collar as compared to the pressed-fit collar on the original stem that shifted up as shown above. The new stem was pre-torqued into the wedge to approximately 7000 ft-lbs of torque.

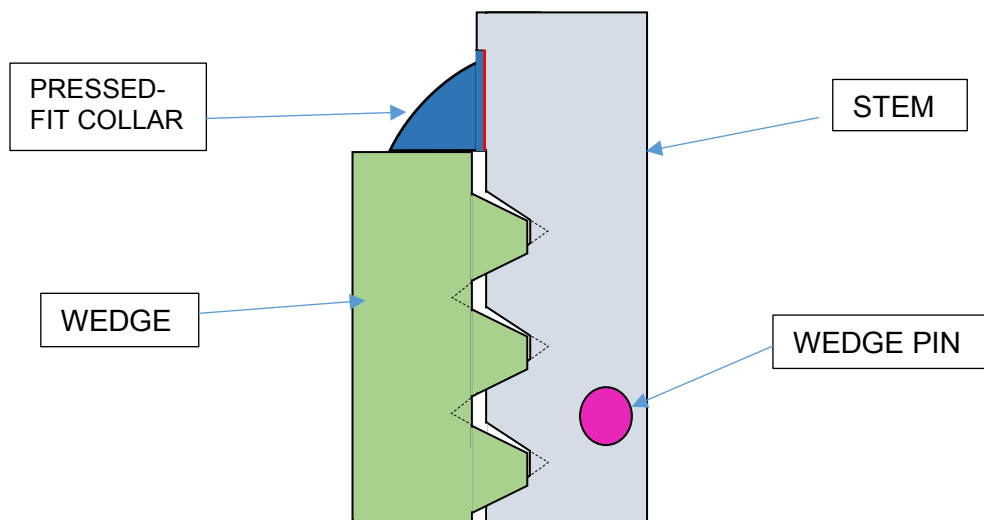
Figure 2 - Threaded Connection Diagram Initial Condition

- **Initial Conditions.** The stem was manually threaded into the wedge with an initial preload that loaded the collar and put the stem threads into tension. The stem-to-wedge threaded connection was then pinned by drilling a hole through the wedge-stem-wedge. The initial installation torque and preload applied was very low and estimated to be less than 38,000 lbf based upon the pressed-fit collar capacity.

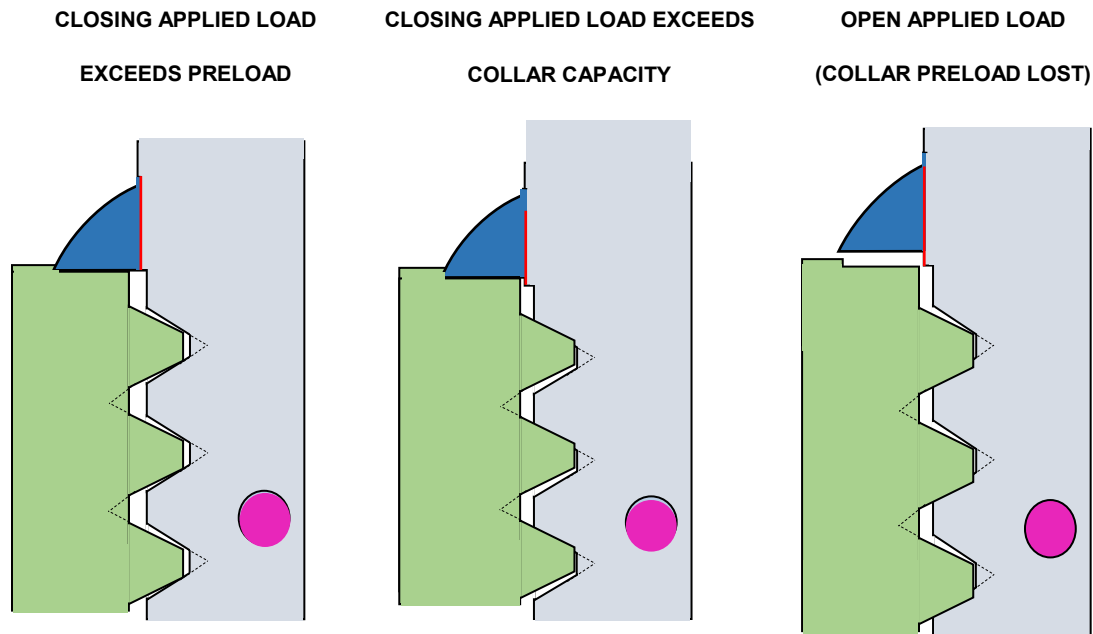
Figure 3 - Threaded Connection Degradation Diagram

- **Collar Slip/Loss of Preload.** The normally applied closed thrust loads of over 200,000 lbf exceeded the pressed-fit collar load capacity, causing it to slip. Once the collar slipped, preload was lost.

- **Pin Shear.** After loss of preload, a portion of the axial loads were applied to the wedge pin, along with torsional loads, which exceeded the capability of the thread and collar friction. The subsequent applied torsional loads in the closing direction failed the wedge pin.

- **Joint Loosening/Rotation Movement.** Following failure of the wedge pin, the joint loosened allowing relative movement between the stem and wedge. The stem-to-stem nut threads are left handed threads, and the stem-to-wedge threads are right handed threads such that the stem, under torque, acted similarly to a turnbuckle. While only incremental, the motion led to unthreading and rethreading of the stem-to-wedge connection during subsequent valve opening and closing strokes. Even with minor unthreading in the open direction, small gaps formed between the stem collar and wedge. During a subsequent closing stroke with the gap, the closing axial loads were reacted upon primarily by the threads. However, the torsional component in the closing direction attempted to re-thread the stem into the wedge until the collar and thread resistances equaled the applied torque.

- **Thread Degradation and Wear.** Besides the failed pin allowing relative motion, the failed pin itself imparted damage to adjacent threads. The wedge threads began to wear and locally deform due to excessive and uneven thread loading in the loose connection. The wear was a combination of adhesive wear (i.e., galling) and aggressive abrasive wear (i.e., pseudo-machining under high load with damaged thread debris between the adjacent thread surfaces.) In this process, any residual broken pin fragments were pushed into the adjacent

threads with increased resistance. The stem threads material, 17-4 PH ferritic stainless steel, was significantly harder than the cast carbon steel wedge threads. This suggested that the stem threads acted similar to a machine tool when the wedge threads provided resistance. Evidence of this rotational loading and resistance was shown in the lab report, corresponding to the wiped stem threads at the pin location. Based upon the extent of the wiped threads, angular rotation up to about 270 degrees had occurred prior to the final joint thread failure.

- **Failure.** The lab investigation concluded that the wedge threads began to locally deform due to excessive and uneven thread loading in the loose connection. The threaded connection completely failed when the axial closing forces exceeded the strength of the remaining available thread cross-sections.
- **Post-Failure Troubleshooting.** After the stem-to-wedge threaded connection failed, the valve was cycled an additional number of times for troubleshooting. During these strokes, only the stem was moved open with some rotation and was re-inserted into the wedge thread hole until the collar and any residual interference in the threads resisted movement. In each case, the collar was pressed up upon the stem until it cocked to prevent further movement which caused the motor to trip.

This violation was entered into the Corrective Action Program as Issue Report 3972901 and has been corrected by replacing the 1E22-F004 and 2E22-F004 valve stems with integral collars.
