**Assessment of Hydrogeologic Conditions and
Need for Long-Term Groundwater Monitoring
at the Former Durita Uranium Mill, Naturita, Colorado**

Gene Peters and Randall Fedors

1. Purpose and scope of assessment

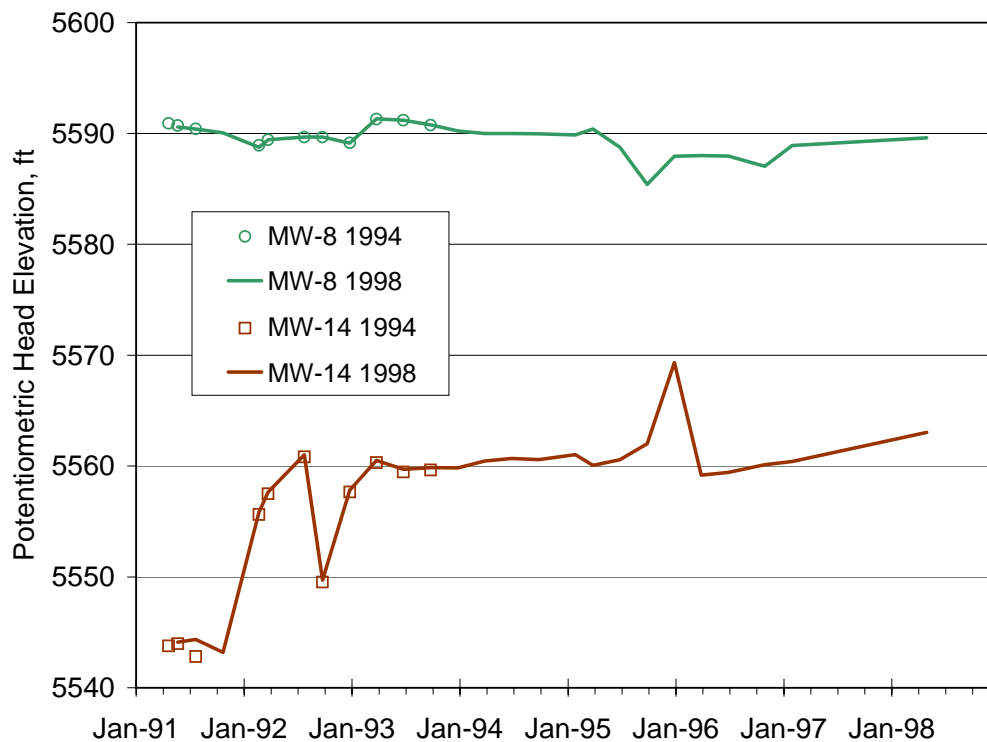
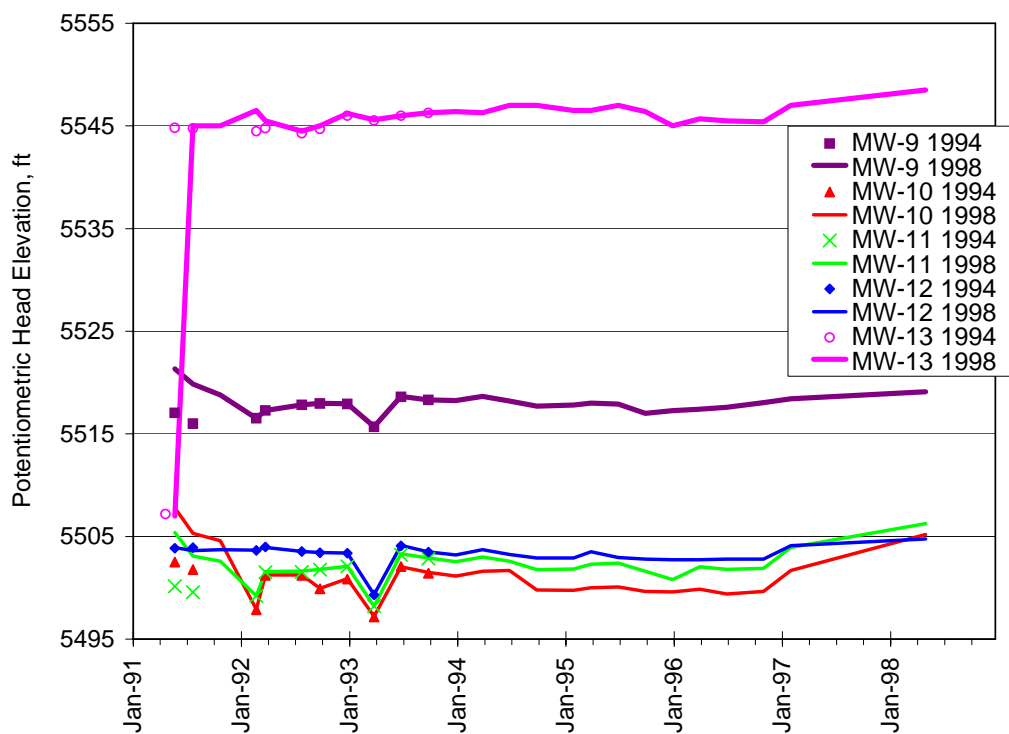
Two points on the reliability of the data warrant discussion. The first point concerns the two reports contained data from 1991 to 1993 (Hecla 1998; Studious Solutions 1994). The first point is that the two data sources were not consistent; the differences are illustrated in Figures 8 and 9. Monitoring wells MW-9, MW-10, and MW-11 have noteworthy inconsistencies in early data. The second point is that the earlier report contained references to ground surface and borehole collar data elevation errors that required a new survey. MW-8 and MW-9 were resurveyed and found to have ground and casing heights off by as much as 3 feet. It was not clear from documentation if the data were revised to reflect the new survey information.

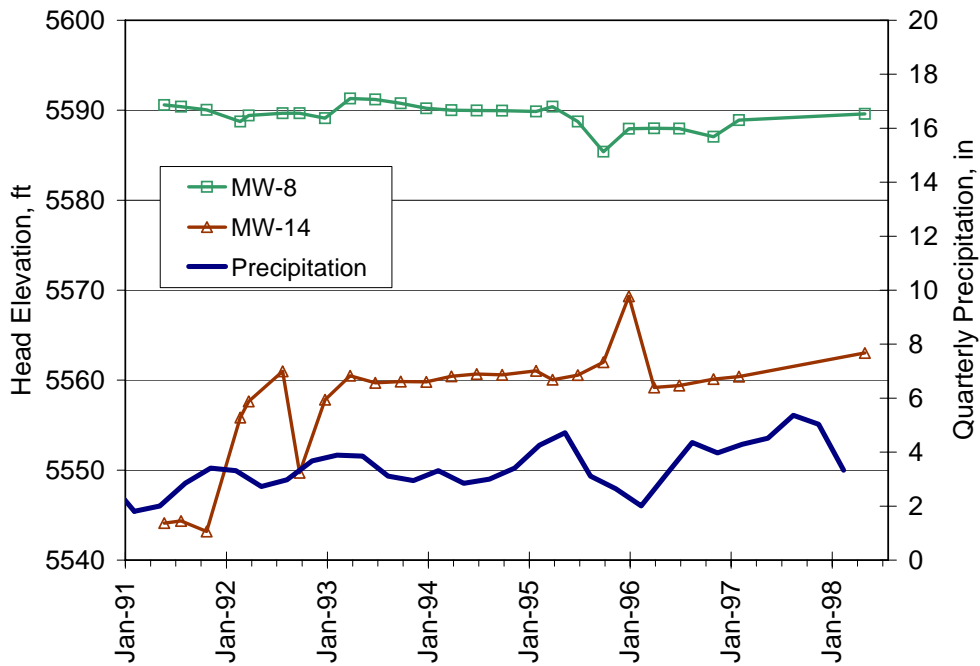
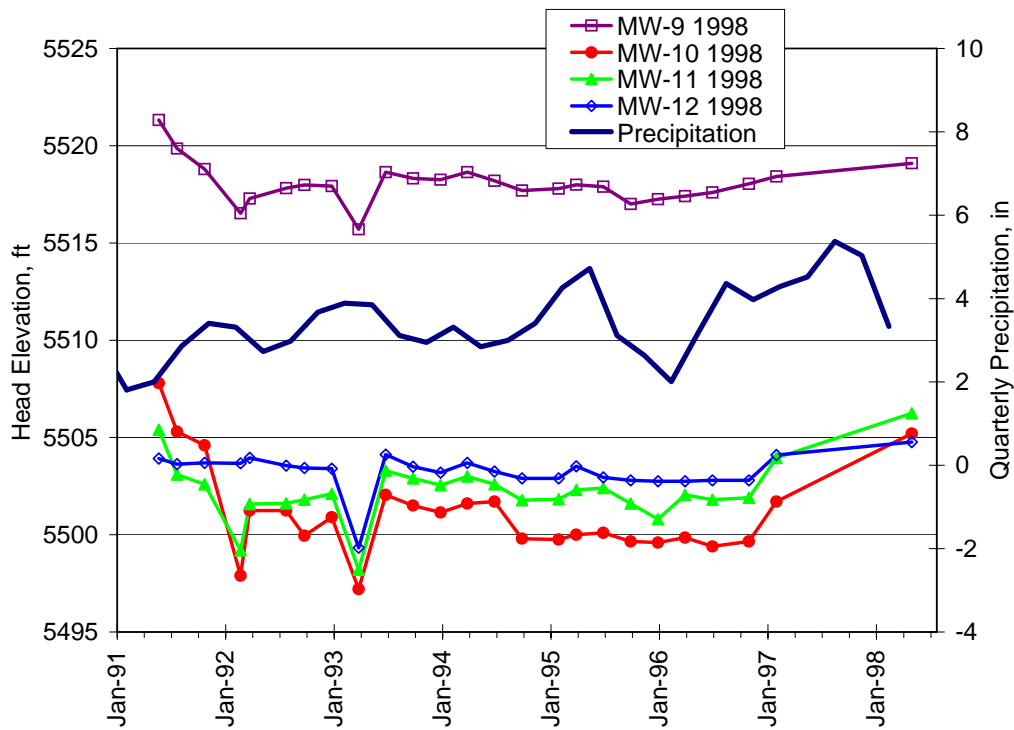
Temporal variations caused by climate stresses are evident when precipitation patterns are overlaid on the water level data (Figure 10 and 11). Two prominent observations are evident. First, a seasonal precipitation pattern is tracked by the water levels, particularly the downgradient (MW-10, MW-11, MW-12) and cross-gradient wells (MW-9 and MW-13). There is a significant dampening of the precipitation signal, and a slight delay in the propagation of the signal. The second prominent observation is that all the wells show an increase in water levels corresponding to the wetter years of 1996 and 1997. The aquifer response to the increased precipitation varies across the site from +1 to +5.5 ft from Nov 1996 to Jan 1998. Note that this period only has three measurements, so seasonal signals are lost. The spatial variation in the seasonal pattern supports a local source for the recharge, rather than an upslope recharge where the sand units intersect the ground surface (related to the synclinal structure). For example, MW-9 and MW-10 are closely spaced with MW-9 upgradient from MW-10. These two wells show the largest and smallest increases over the 1996 to 1998 period; MW-9 increased by 1.0 ft and MW-10 increased by 5.5 ft.

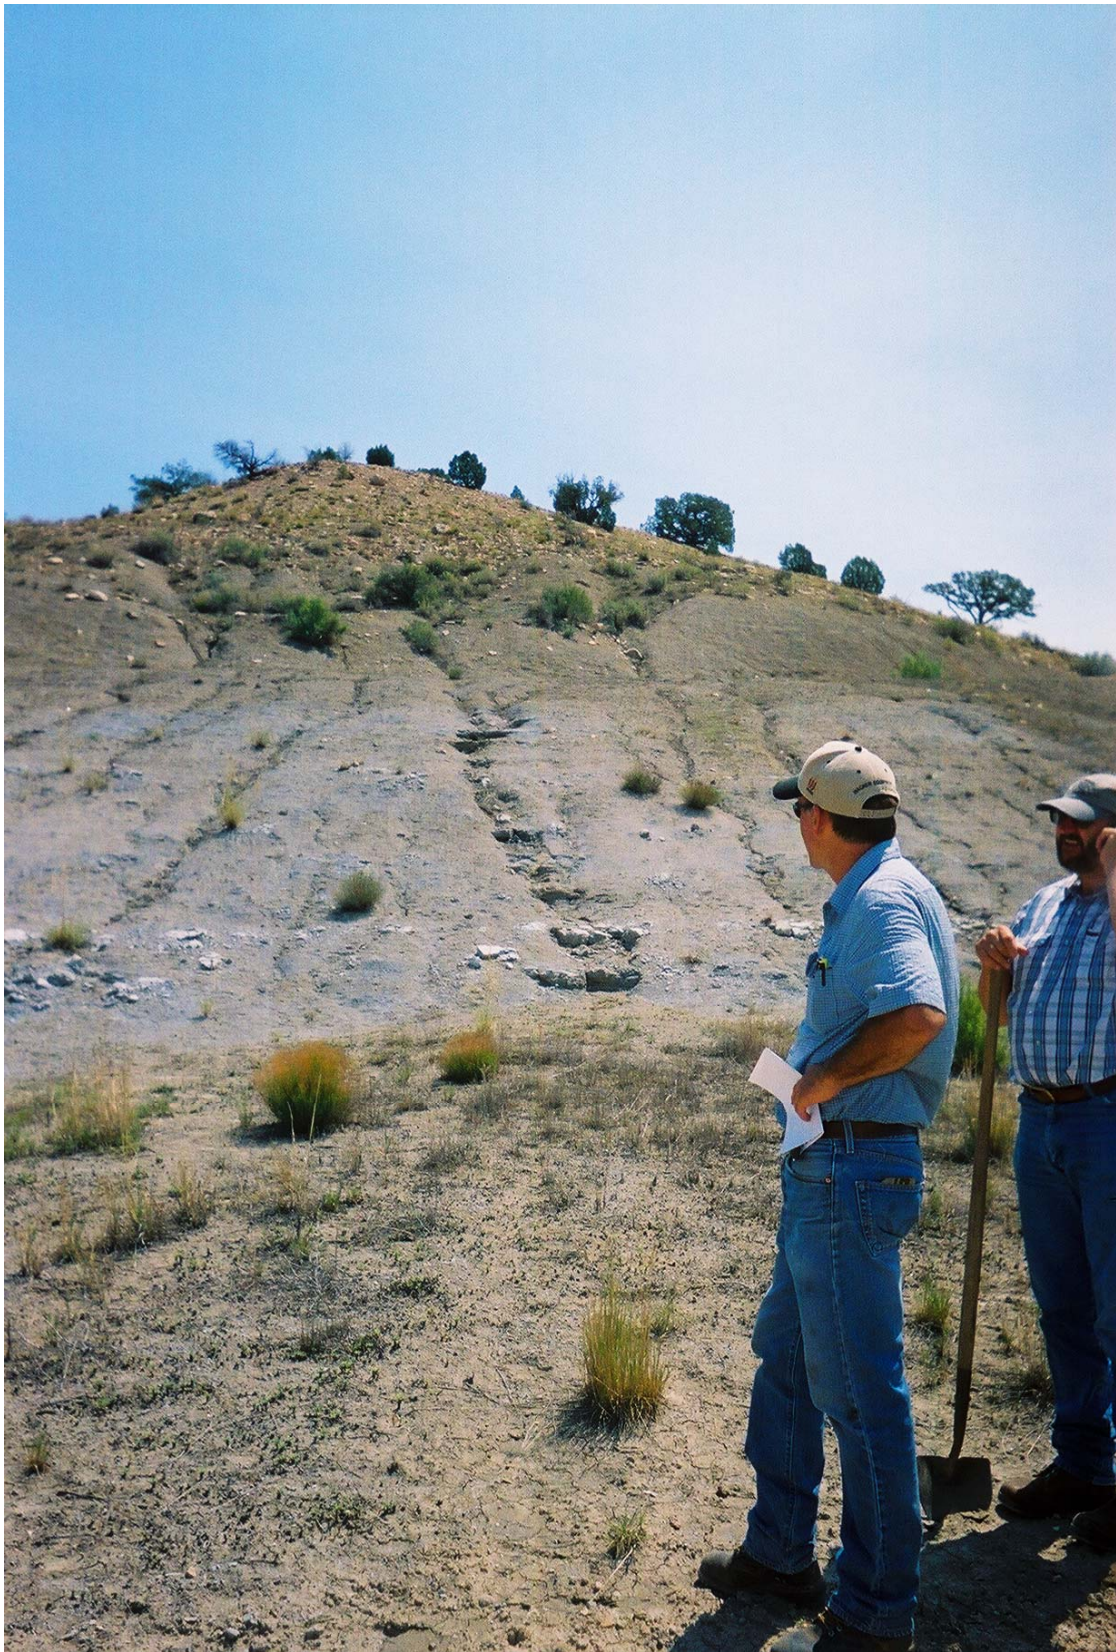
Photograph 16A

16A	Photo of base of Mancos Hill, north and northwest sides. Absence of vegetation may be related to reclamation activities, though no processes are reported to have occurred in this immediate area. Note prominent drainage rills, which are absent on other sides of Mancos Hill, exposing several layers of more competent, resistant claystone/shale. Visible in upper portion of photo, near top of Mancos Hill are much larger rock fragments of sandstone, ranging up to cobble-sized. Ground surface, in foreground of photo, more clay-rich; note desiccation cracks. Visible in photo are Earl Reams (left, of Ream Construction, representing Hecla) and Ed ???, DOE contractor.
15A	View of Mancos Hill from southeast side, facing northwest. The inclined linear feature dropping to right in photo, marked by vegetation change is related to reclamation activities, according to Earl Reams.
14A	Photo of dry tributary channel to Dry Creek, north of site boundary, off northeast corner of site. This channel leads to the cataract area depicted in subsequent photos. Channel may be fracture-controlled, based on several long (10-meter scale) vertical to subvertical fractures evident in channel bed, with orientation parallel to channel trace. Note fine-grained material present in channel bed, exhibiting very prominent desiccation cracks and fragment curling.

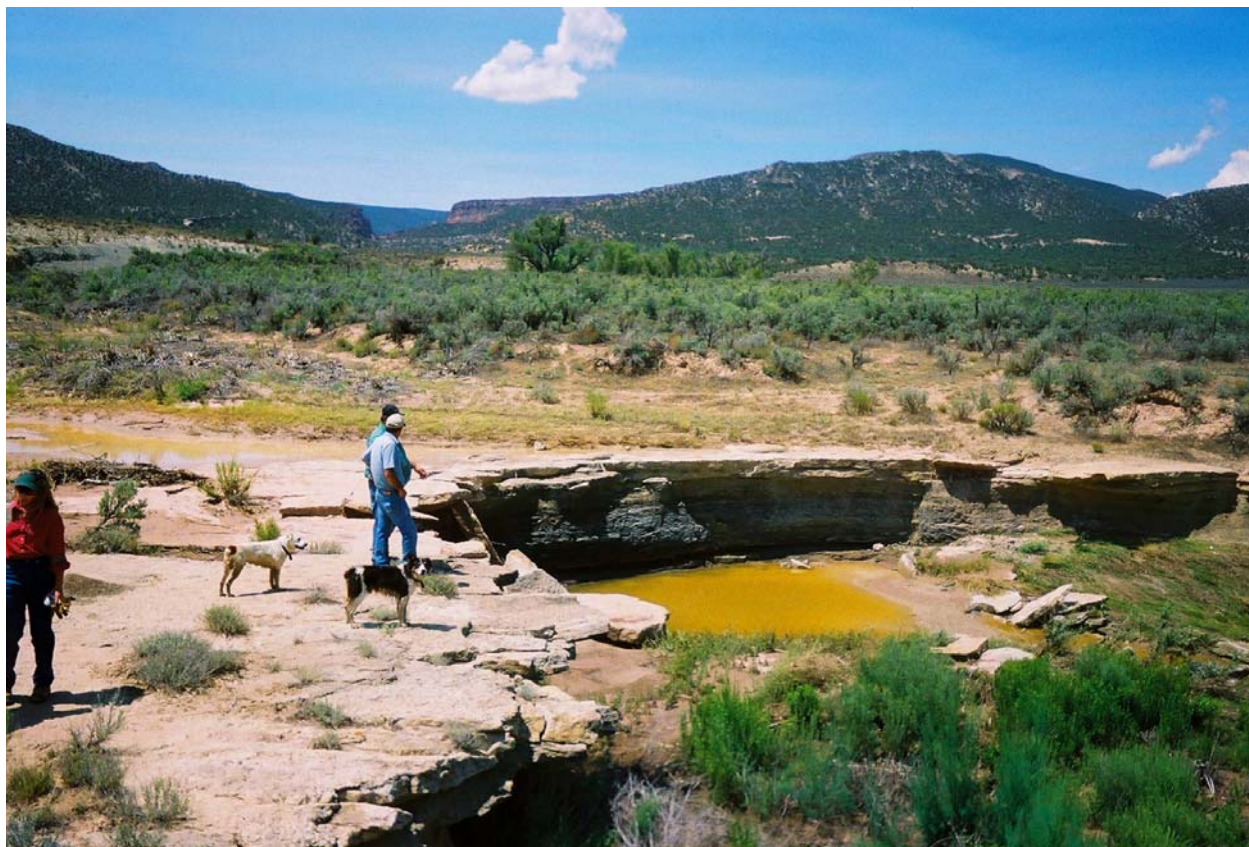
Photograph 12A

12A	View of upper cataract area facing east-northeast, approximately 1,660 feet north of site, close to centerline of site. Dry Creek not flowing, but with large pools several feet deep in areas. Note resistant sandstone caprock layer controlling cataract, underlain by easily eroded shale layers, suffering extensive block failure and headward erosion. Likely represents the general interbedded contact between the Mancos and Dakota units. Standing water on left represents principal channel for Dry Creek. Individual in lower left standing in area of dry tributary channel in which photo 12 A was taken. Several large joints visible at ground surface.
13A	View of lower cataract area facing east-northeast, approximately 1,660 feet north of site, close to centerline of site. Dry Creek not flowing, but with large pools several feet deep in areas. Note alternating layers of more resistant claystone material with layers of less resistant shale. Both interbedded with sandstone. Likely represents the general interbedded contact between the Mancos and Dakota units.

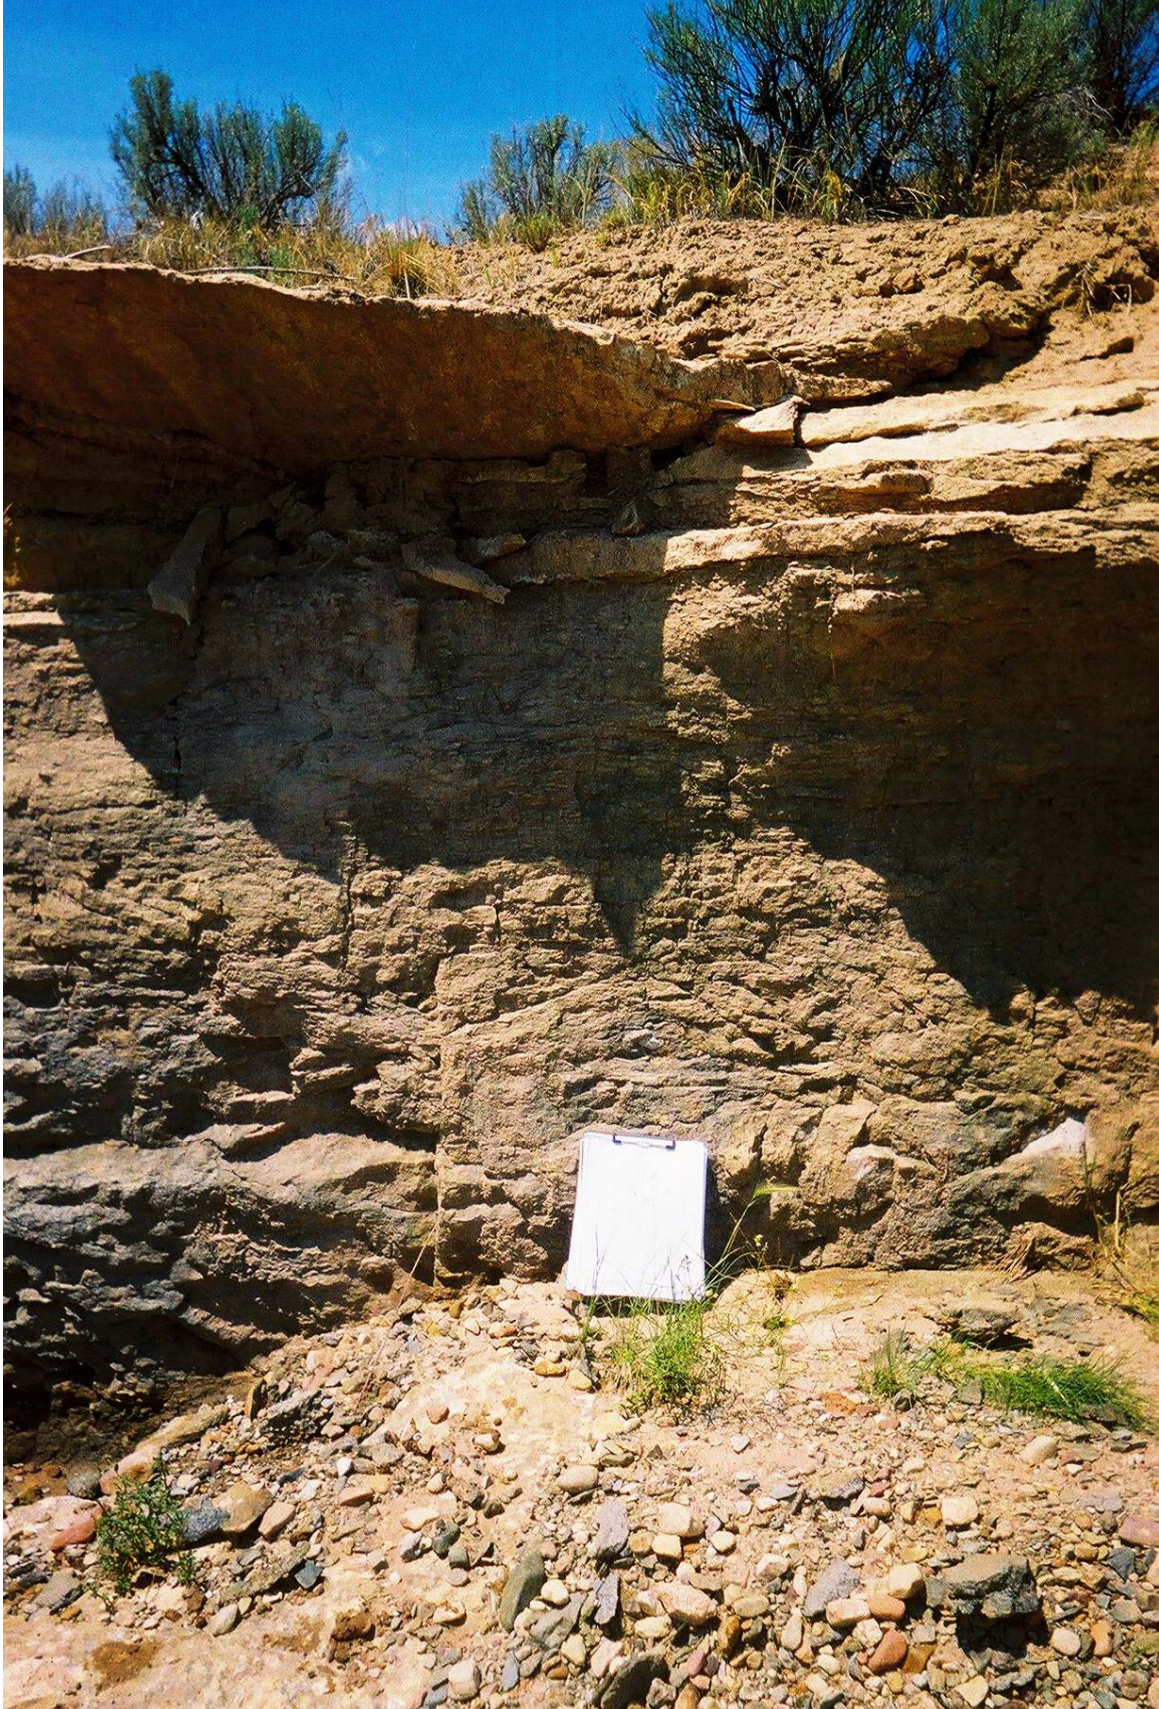
Photograph 11A

11A	View of cross section exposed in upper cataract area, facing approximately southwest. Clipboard for scale. Note extensive weathering in layers below sandstone caprock layer, with extensive vertical joints and fractures.
10A	View of cross section exposed at upper cataract area, facing approximately southeast. Note large, vertical fracture extending into plane of photo.

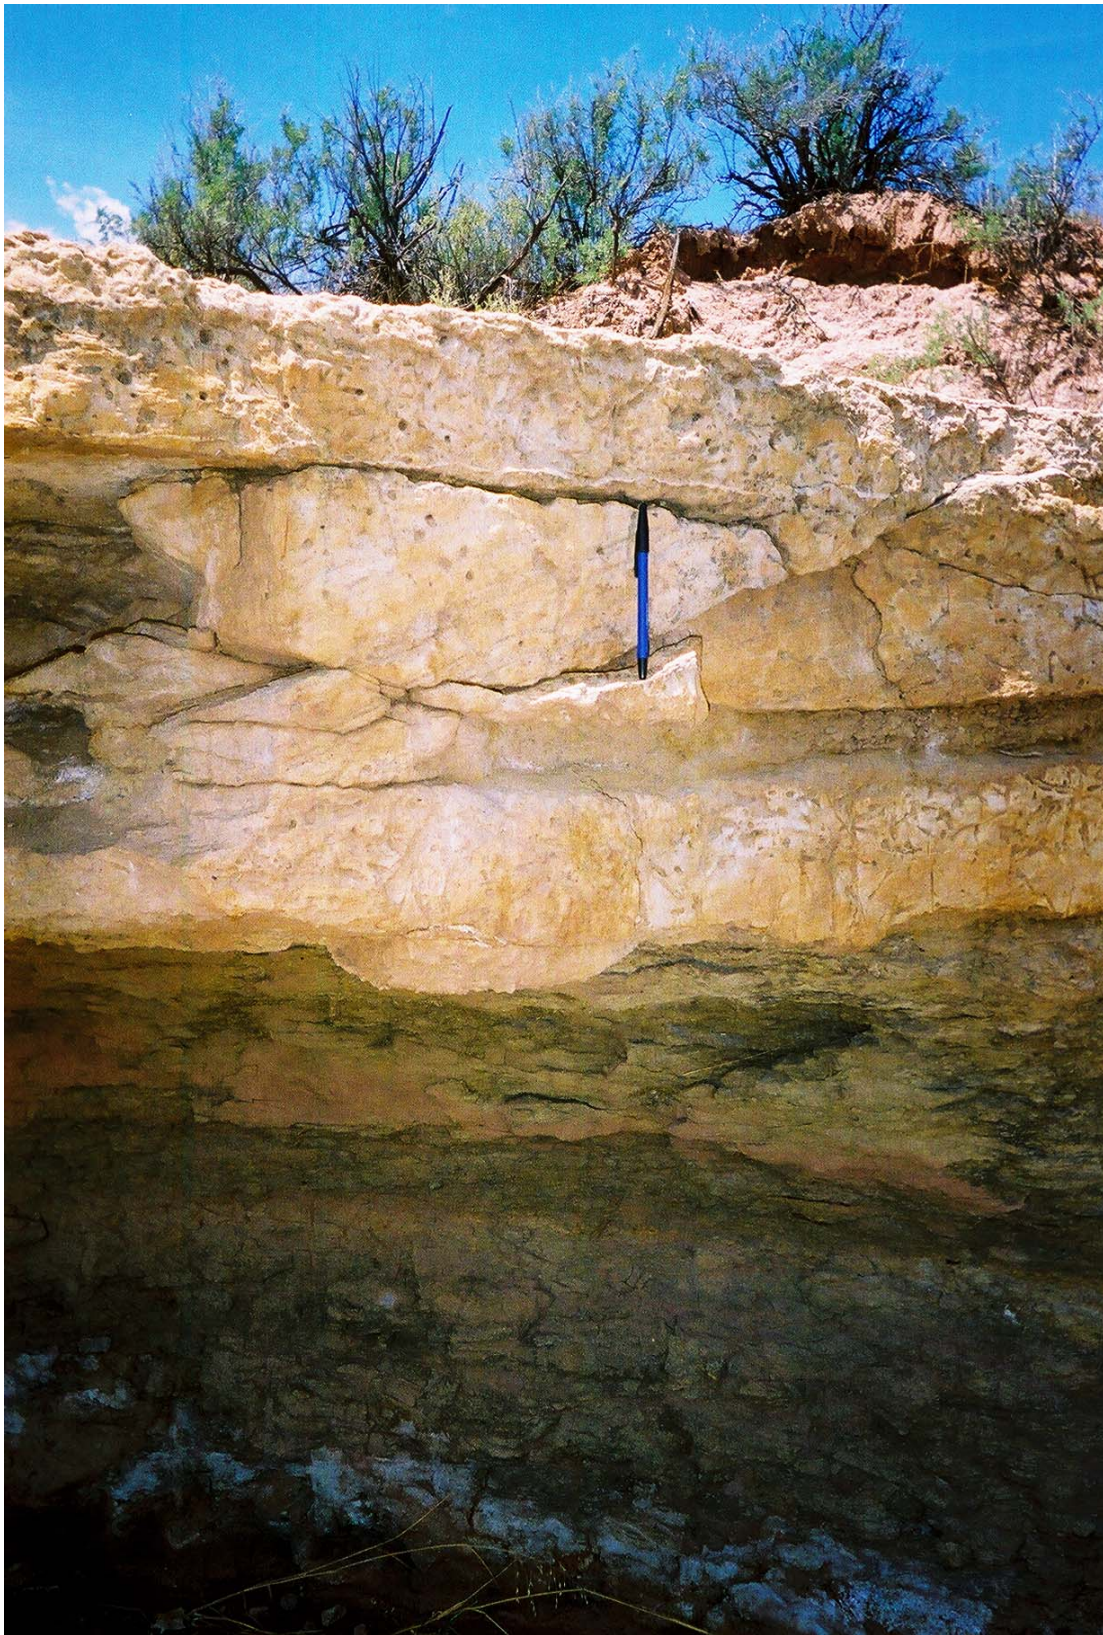
Photograph 09A

Photo	Description
09A	Closer view of sandstone caprock layer at upper cataract area. Pen for scale; cap oriented upward. Note horizontal to subhorizontal joints and bedding planes, cross-stratification, and considerable bioturbation in sandstone. Iron staining and calcite present.
08A	Cross section exposed at southeast portion of upper cataract. Note subvertical continuous, iron-stained joint in center of photo. Clipboard for scale.
07A	View of small hillside descending to cataract area from northeast. Surficial materials very clay-rich.
06A	Large boulder northeast but proximal to the upper cataract area. Notebook for scale. Near side and upper surface appear to be joint-controlled with extensive slickensiding.
05A	View of lower cataract layer, facing west-northwest.
04A	View of Dry Creek main channel, facing approximately south, towards site. Mancos Hill visible in right-center portion of photo. Surficial and channel bed material unconsolidated sediment, predominantly clay and silt, with fine-grained sand.

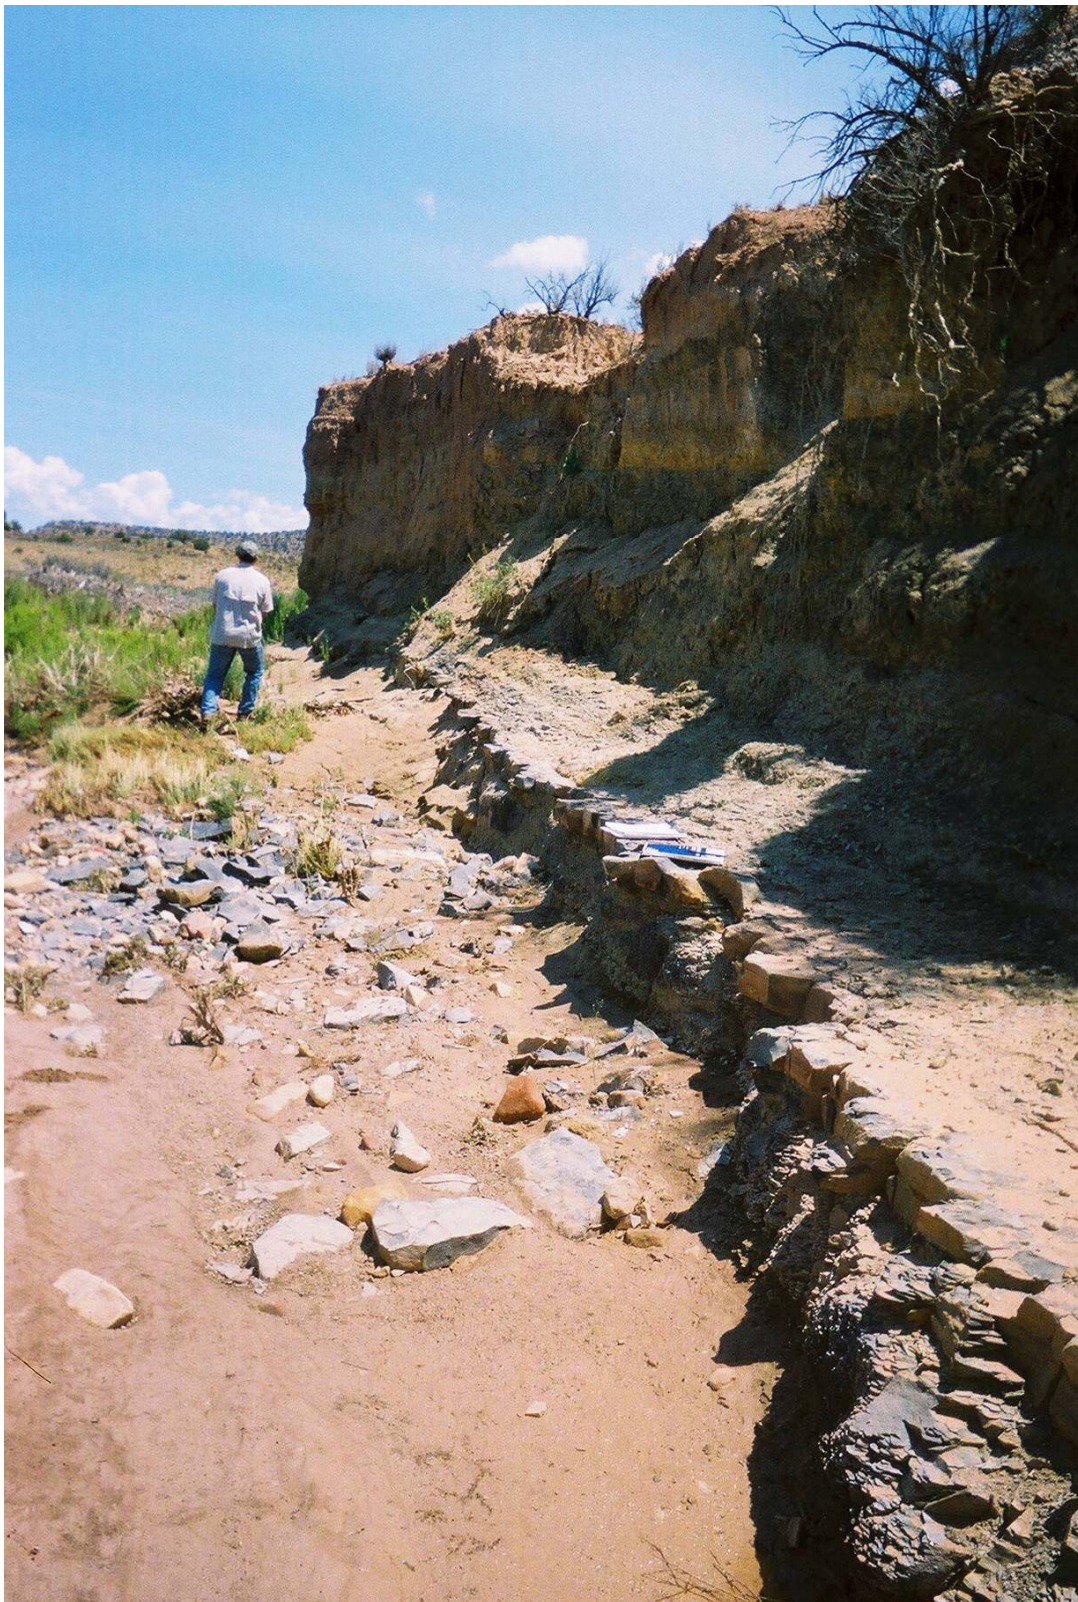
Photograph 03A

03A	View of incised Dry Creek channel upstream and southwest of cataract area. Photo facing northeast, with Dry Creek off photo to left (north). Note near-vertical scarps of alluvial material penetrated by root systems, underlain by bench of more resistant horizontally bedded claystone and shale layers. This area representative of transition from Quaternary alluvium to Mancos Unit. Surficial materials below bench fine-grained sand with silt and clay. Near vertical, north to northwest-trending joint sets present in bench exposure, spaced at approximately 6- to 12-inch intervals (visible in near-ground of photo).
02A	Closer view of claystone/shale bench in Photo 03A; same features evident.
01A	View of alluvium in upper portion of section exposed in Photo 03A. Note root penetration and prominent horizontal soil change center of photo. Possible paleo-surface. Calcite present and increasing in proportion towards bottom of upper soil horizon. Pen for scale; cap oriented upward.

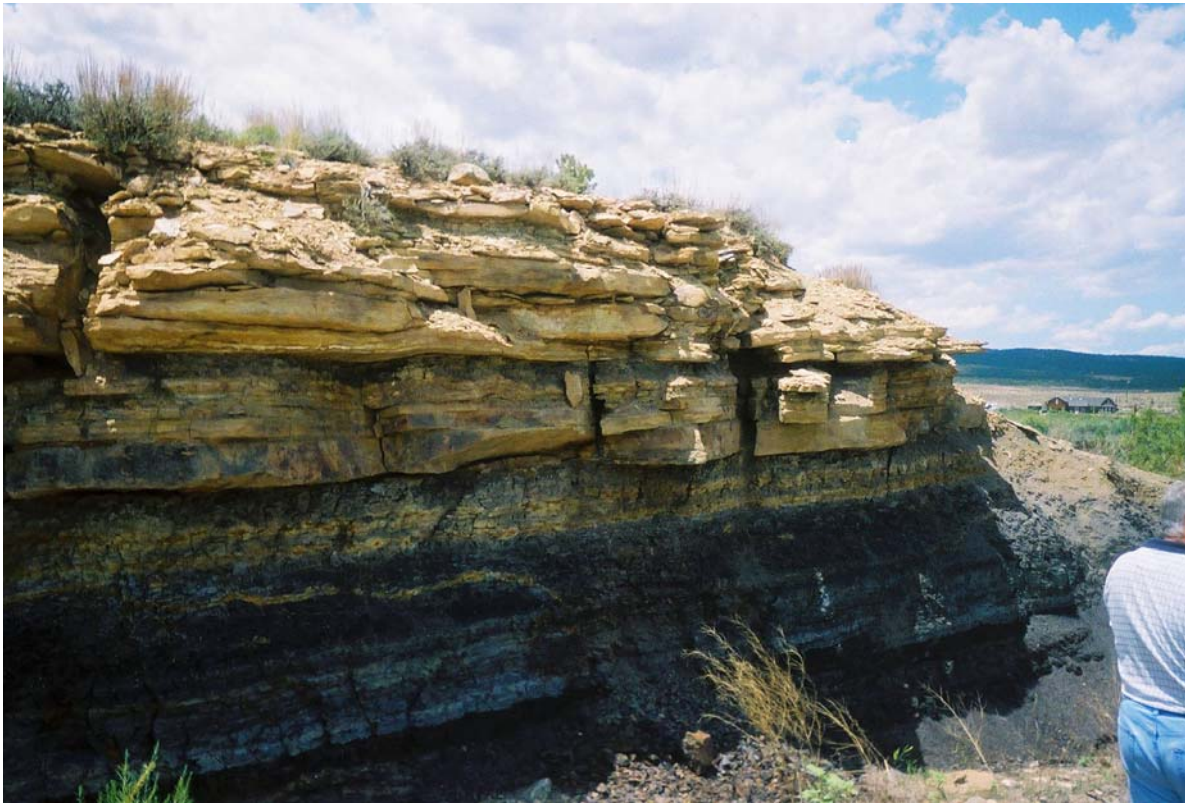
Photograph 0A

0A	View of road cut on west side of access road, facing west-northwest, approximately 2,000 feet north of site. Coke Oven Ranch buildings visible in right-center portion of photo. Upper portion of cut exposes Mancos/Dakota interbeds. Note prominent fractures oriented northwest into plane of photo, some with apertures of several inches. Darker layer near base of section is near-anthracite coal layer, diagnostic of Dakota Formation.
00A	View of site from Highway 90, facing southeast. Mancos Hill visible slightly right of center of photo.
