**DRAFT COMPLETION REVIEW REPORT**

**Hecla Mining Company Durita Facility**

**Montrose County, Colorado**

**March 30, 2015**

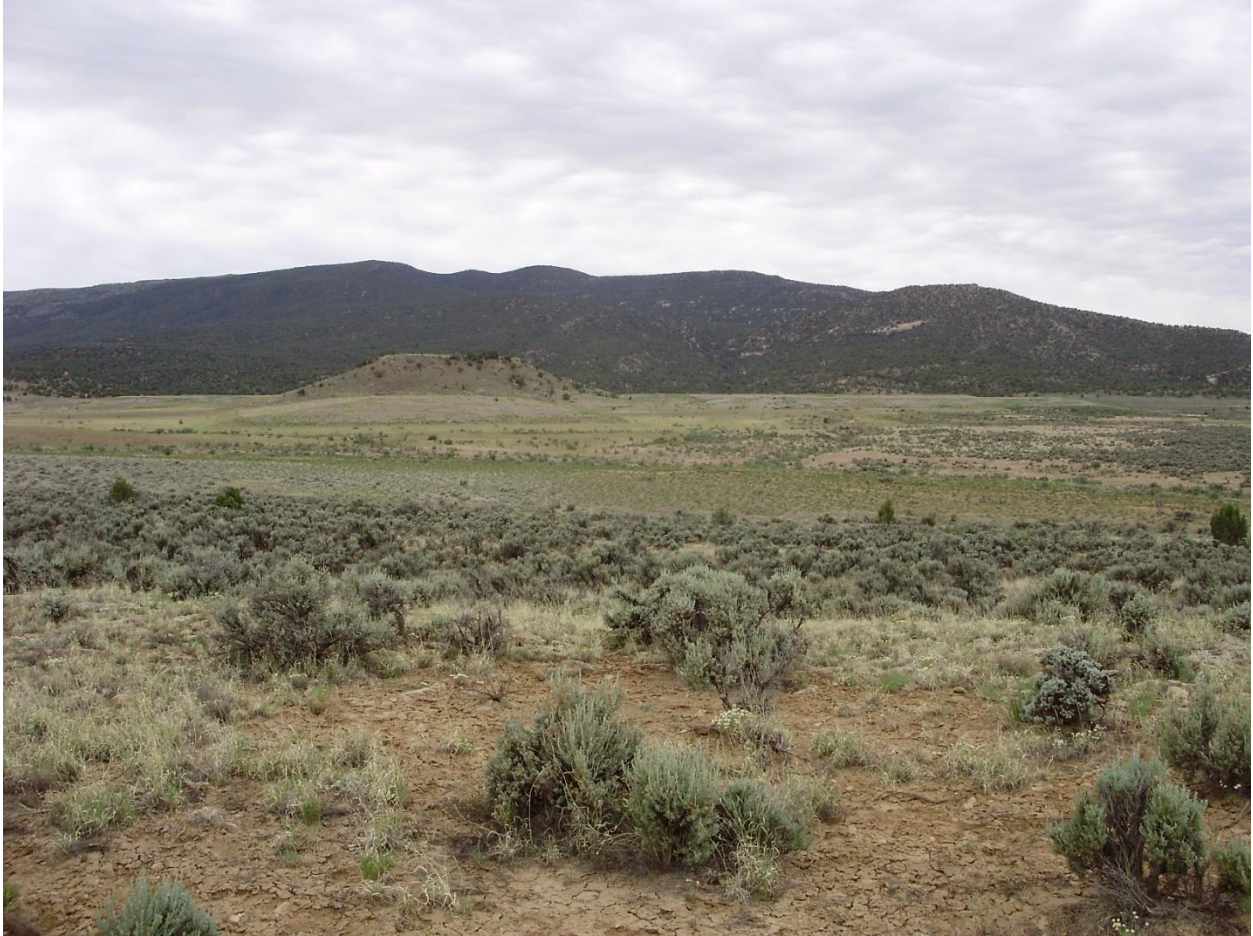
Photograph 1: View of the Durita site looking southwest. Mancos Hill is visible in the middle distance. The disposal cell is between the viewer and Mancos Hill. Leach pads LT-201 and LT-202 are to the right of Mancos Hill and leach pad LT203 is to the left and behind Mancos Hill.
