FINAL COMPLETION REVIEW REPORT

**For the Hecla Mining Company Durita Facility
Montrose County, Colorado**

Colorado Radioactive Materials License No. 317-02

March 2, 2016

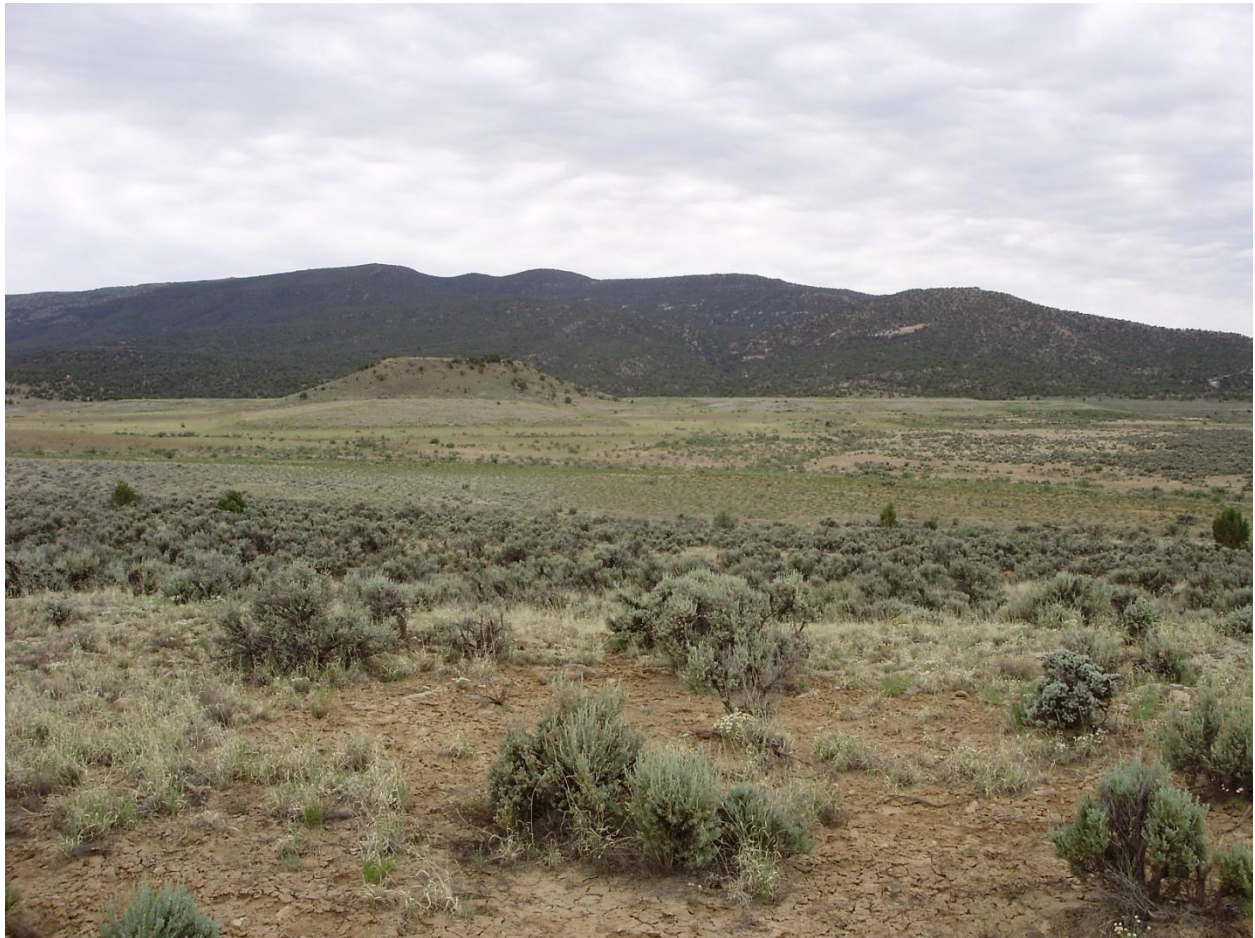
Photograph 1: View of the Durita site looking southwest. Mancos Hill is visible in the middle distance. The disposal cell is between the viewer and Mancos Hill. Leach pads LT-201 and LT-202 are to the right of Mancos Hill and leach pad LT203 is to the left and behind Mancos Hill.

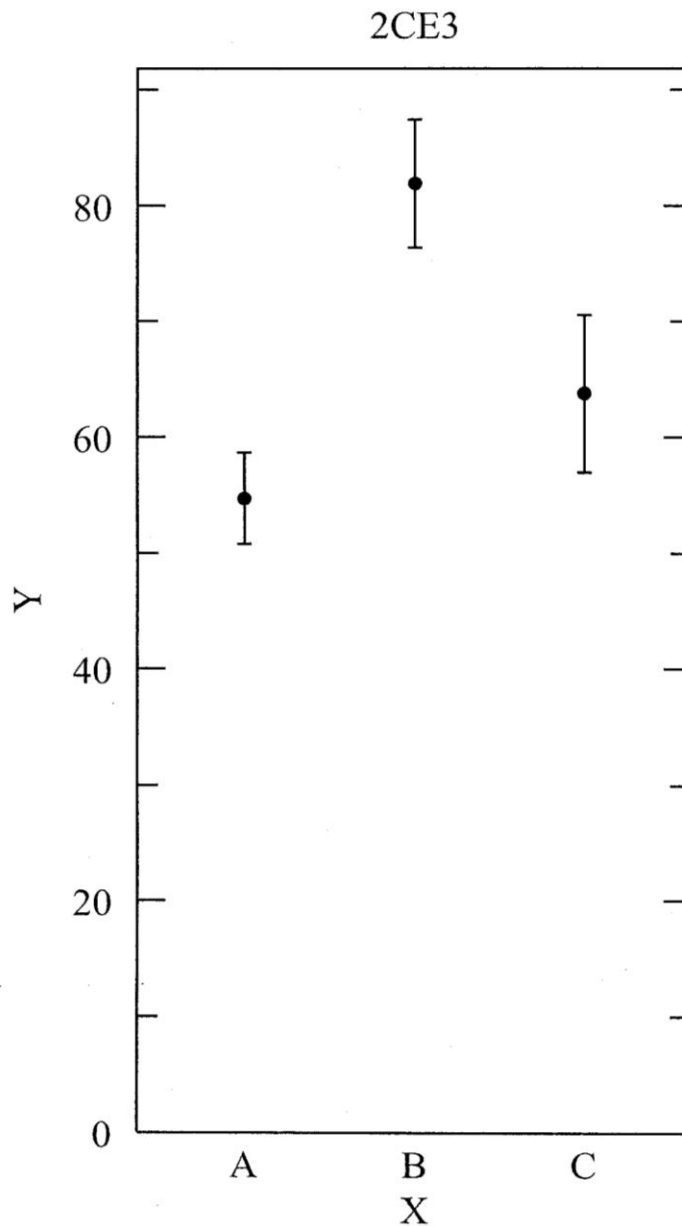
Plot of means with 95 percent confidence interval of the chloride content populations for monitor well MW-4. Population A is the analyses from April 1977 to August 1986. Population B is the analyses from November 1986 to October 1989. Population C is the chloride analyses from December 1989 to November 1991. Population B shows a distinct statistical character from population A and C.

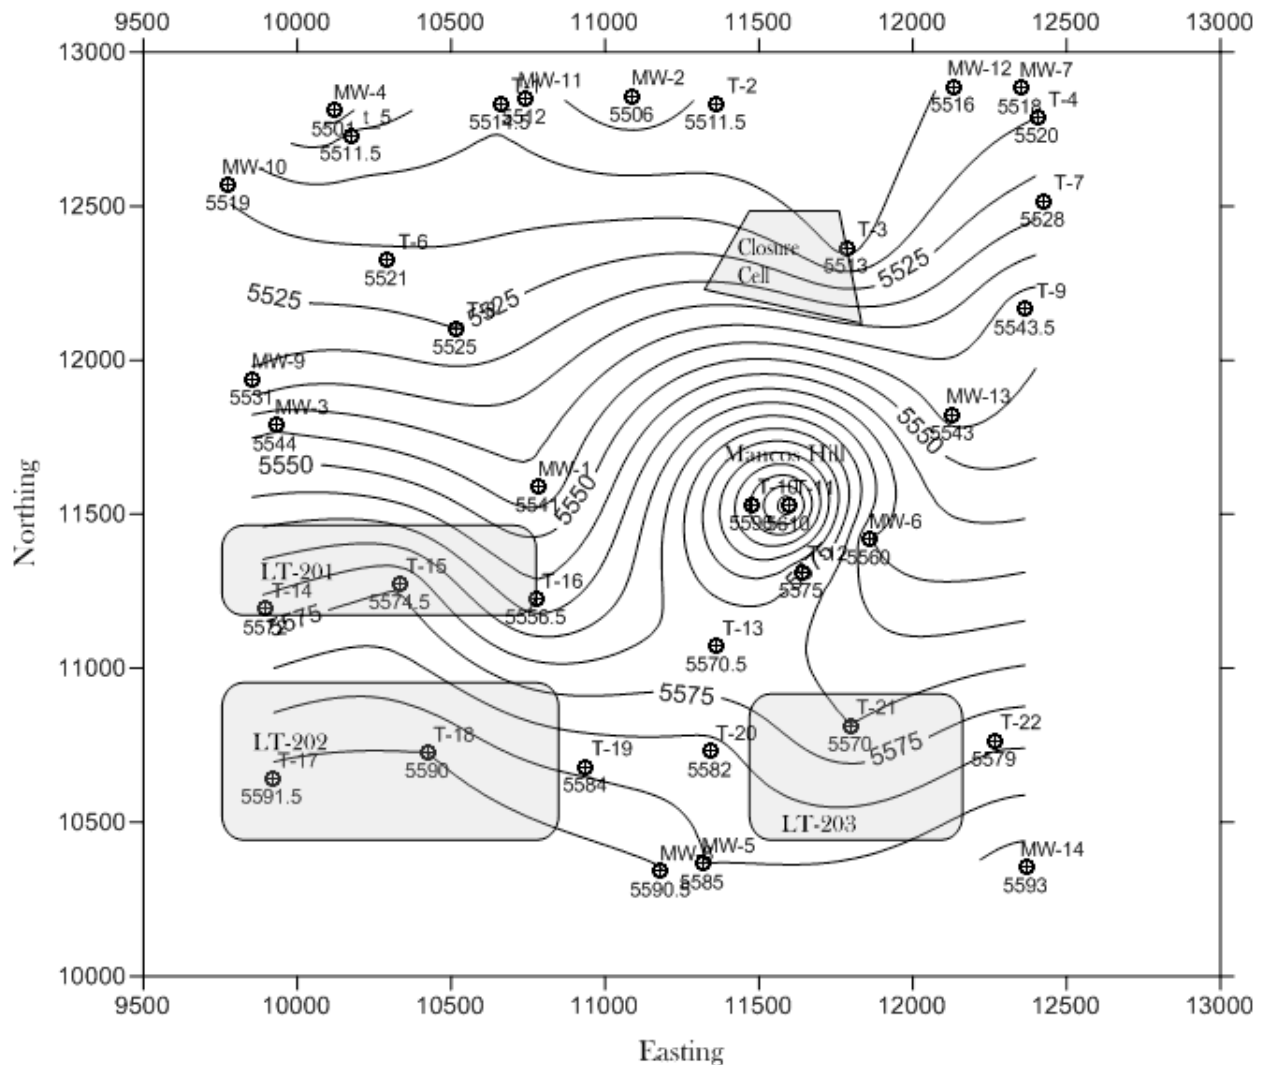
Figure 7.3. The drilling description of MW-1 shows the presence of unconfined groundwater at this interface. MW-1 appears to be in the channel of this aquitard surface. This aquitard-surface channel appears to go from the vicinity of MW-8 through MW-1 to the vicinity of MW-4 and MW-10. This channel collects the unconfined flow from the area between T-22 and T-15. Water in the low point of the aquitard surface was seen during the drilling program conducted in Four Corners Environmental Research and reported in 1977. Because of the location of test holes, the prominent positive feature associated with Mancos Hill is displaced to the south.
