Subject: IE Bulletin No. 79-13 - Cracking in Feedwater Piping
Thirty (30) Day Report on the Examination, Evaluation
and Corrective Action at R.E. Ginna Nuclear Power Plant
Docket No. 50-244

Response to IE Bulletin No. 79-13 - Cracking in Feedwater Piping
and Request by DOR Staff During a July 24, 1979 Meeting
Bethesda, Maryland
Thirty (30) Day Report on Examination, Evaluation,
and Corrective Action at R. E. Ginna Nuclear Power Plant
Docket No. 50-244
July 27, 1979

SUBJECT: Materials Laboratory Analysis of "A" Steam Generator
Feedwater Piping Cracks

Robert Emmett Ginna, Loop B -
Summary of Metallurgical Evaluations

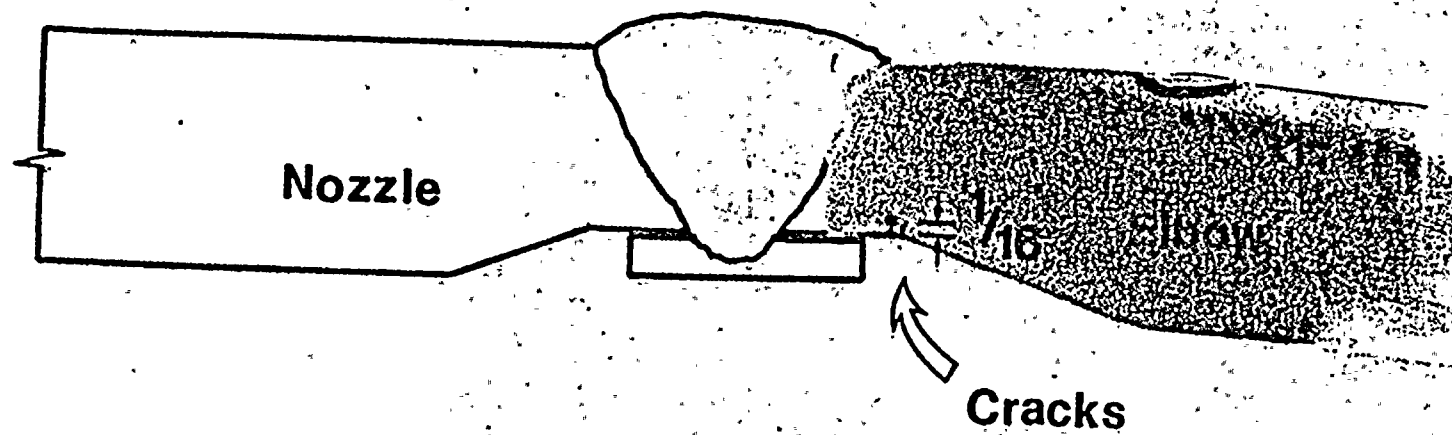
**Ginna Sta S/G Feedwater
Elbow Cracks**

Figure 1 is a composite photograph of a macrosection taken from the Feedwater System elbow and a drawing representation of the nozzle and weld configuration. The two cracks shown on the elbow side of the weld are located from the point of the weld prep counterbore and the transition to the nominal wall thickness of the elbow.

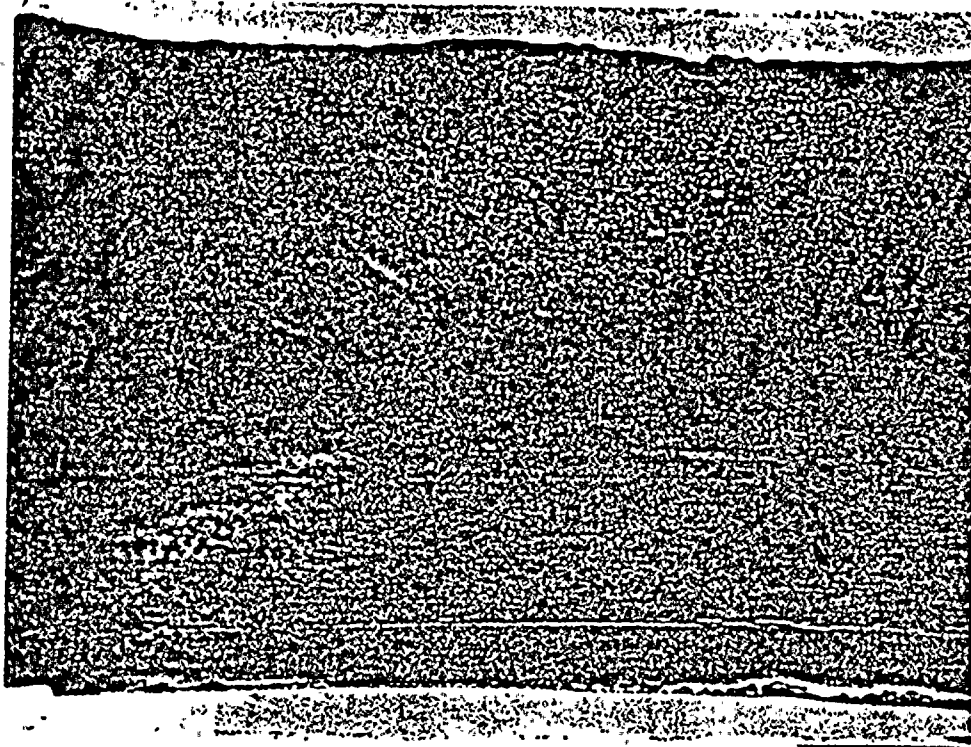
Inside Surface of Elbow .5X
Figure 2

Figure 2, taken looking down on the inside surface of the elbow, is a photograph of the counterbore transitioning to the elbow nominal thickness. Near the bottom of the photo a distinct line can be seen. It is at this point that the cracks begin. The roughness of the machined transition surface should also be noted.

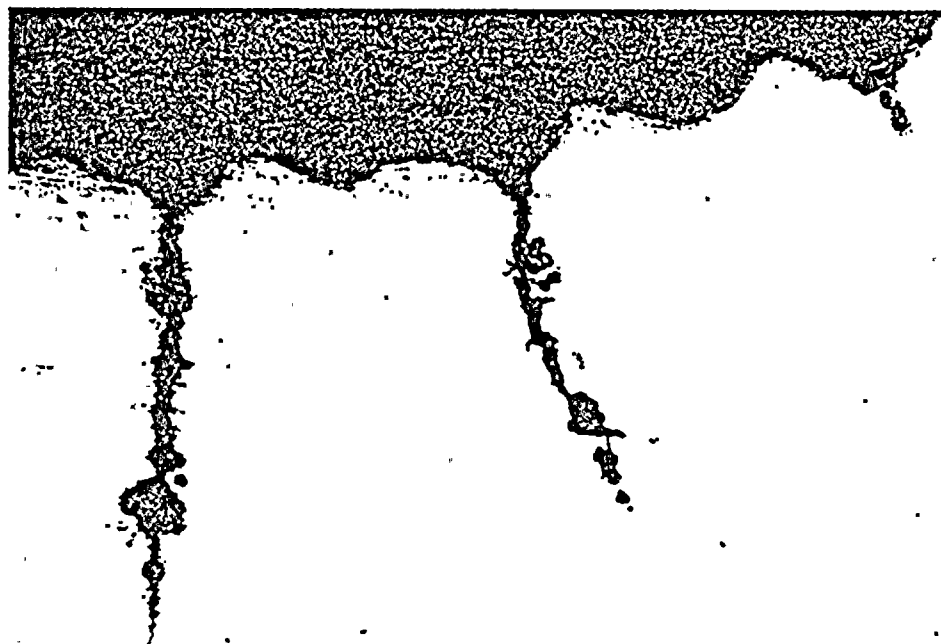
As Polished 40X
Figure 3

Figures 3 and 4 are forty magnification cross-sectional views of the two detected cracks. Note the roughness of the machined surface and the existence of the cracks at the bottom of the machined cuts where maximum stress can be expected. The depth of the deeper crack measured approximately .065 inches. Note also in Figure 3 the presence of a very small crack (approximately .015 inches) in the upper right corner.

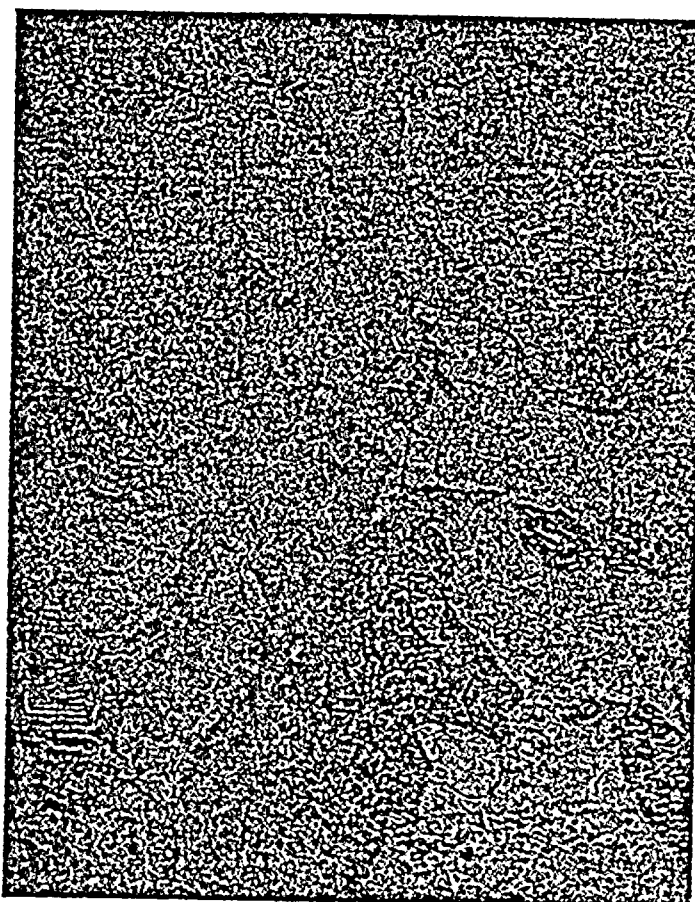
Figure 5 is a 500 magnification photomicrograph of the larger crack's tip. This photo clearly shows the mechanism behind these cracks to be corrosion.

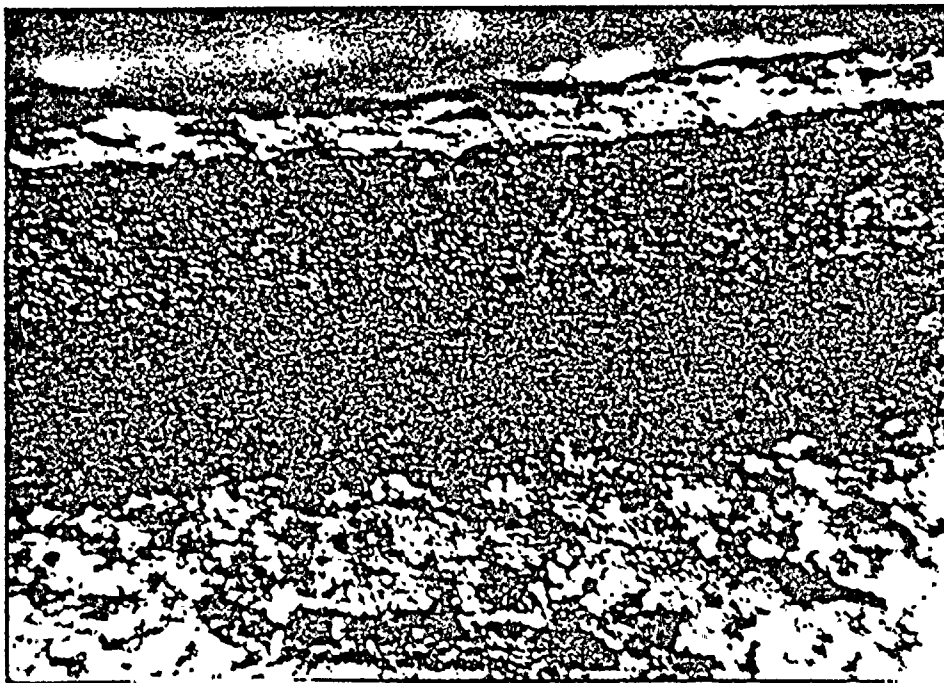
Figure 6 is a view of the internal surface of the crack after the specimen was separated. Note the layered appearance which indicates the gradual progression of the crack.
