SUBJECT: Forwards Apr 1980 steam generator insp rept & evaluation of results, in response to NRC request.

Subject: Steam Generator Inspection Results and Analysis  
R. E. Ginna Nuclear Power Plant, Unit No. 1  
Docket No. 50-244

### April 1980 Steam Generator Inspection

Attachment B  
Evaluation of Results

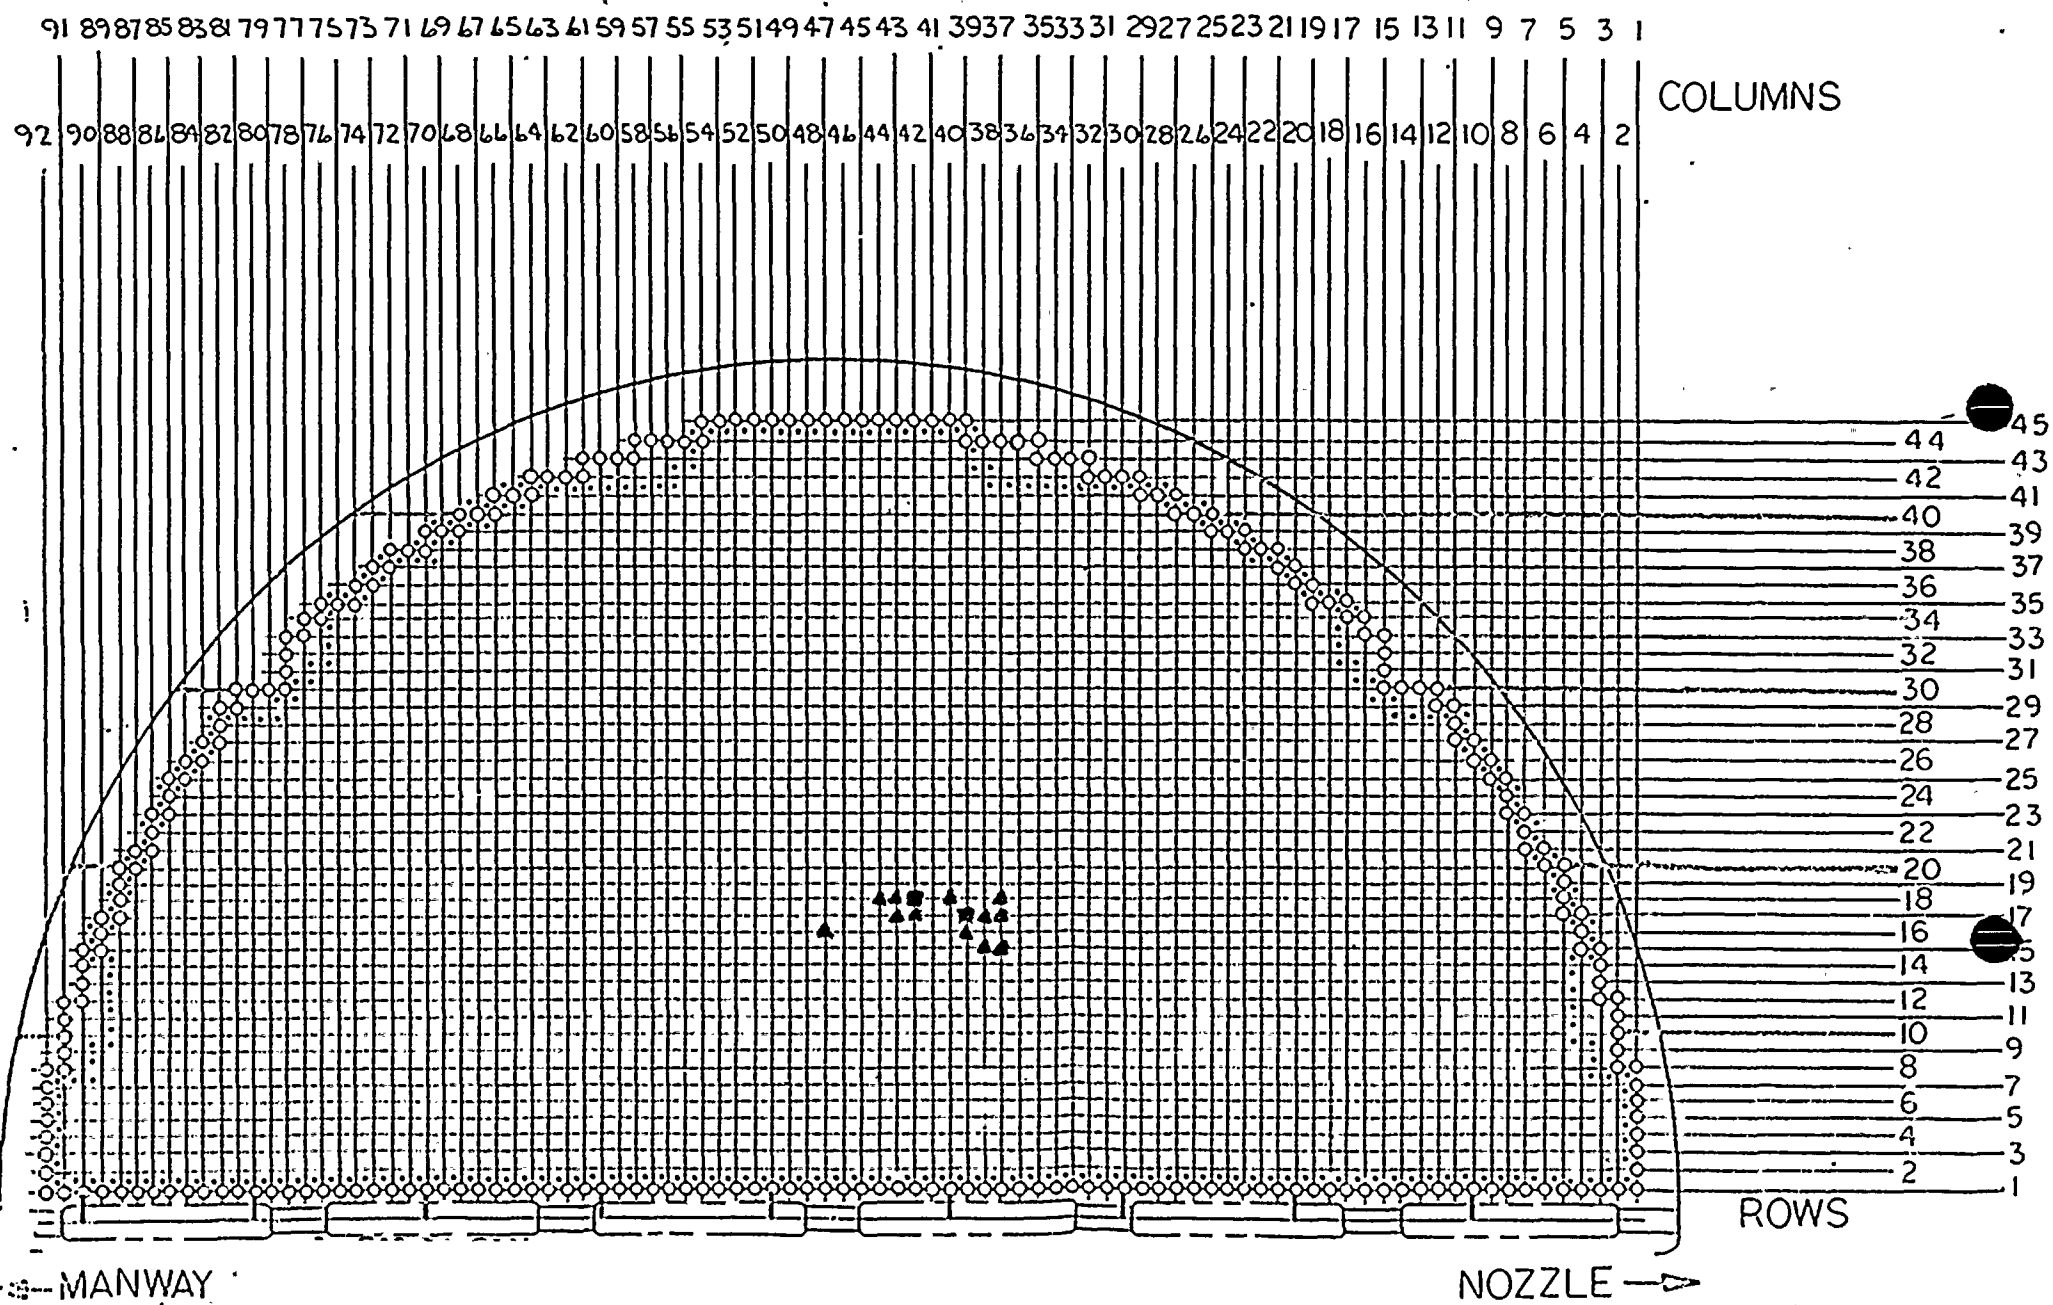
Figure I

The "B" steam generator, which had two (2) crevice indications in April of 1979 and eleven (11) crevice indications in the December 1979 showed thirty one (31) crevice indications at this time. These indications fall into two categories, the first being 13 indications which were identified at all examination frequencies and are as follows:

These 31 tubes with crevice indications, with the exception, of three R24C45, R24C46 and R21C54, all fit into a pattern with the previous 13 tubes found in the two examination in 1979, as shown

RG&E Steam Generator - B Inlet  
Crevice Indications

● - March 79 - 2  
▲ - December 79 - 11

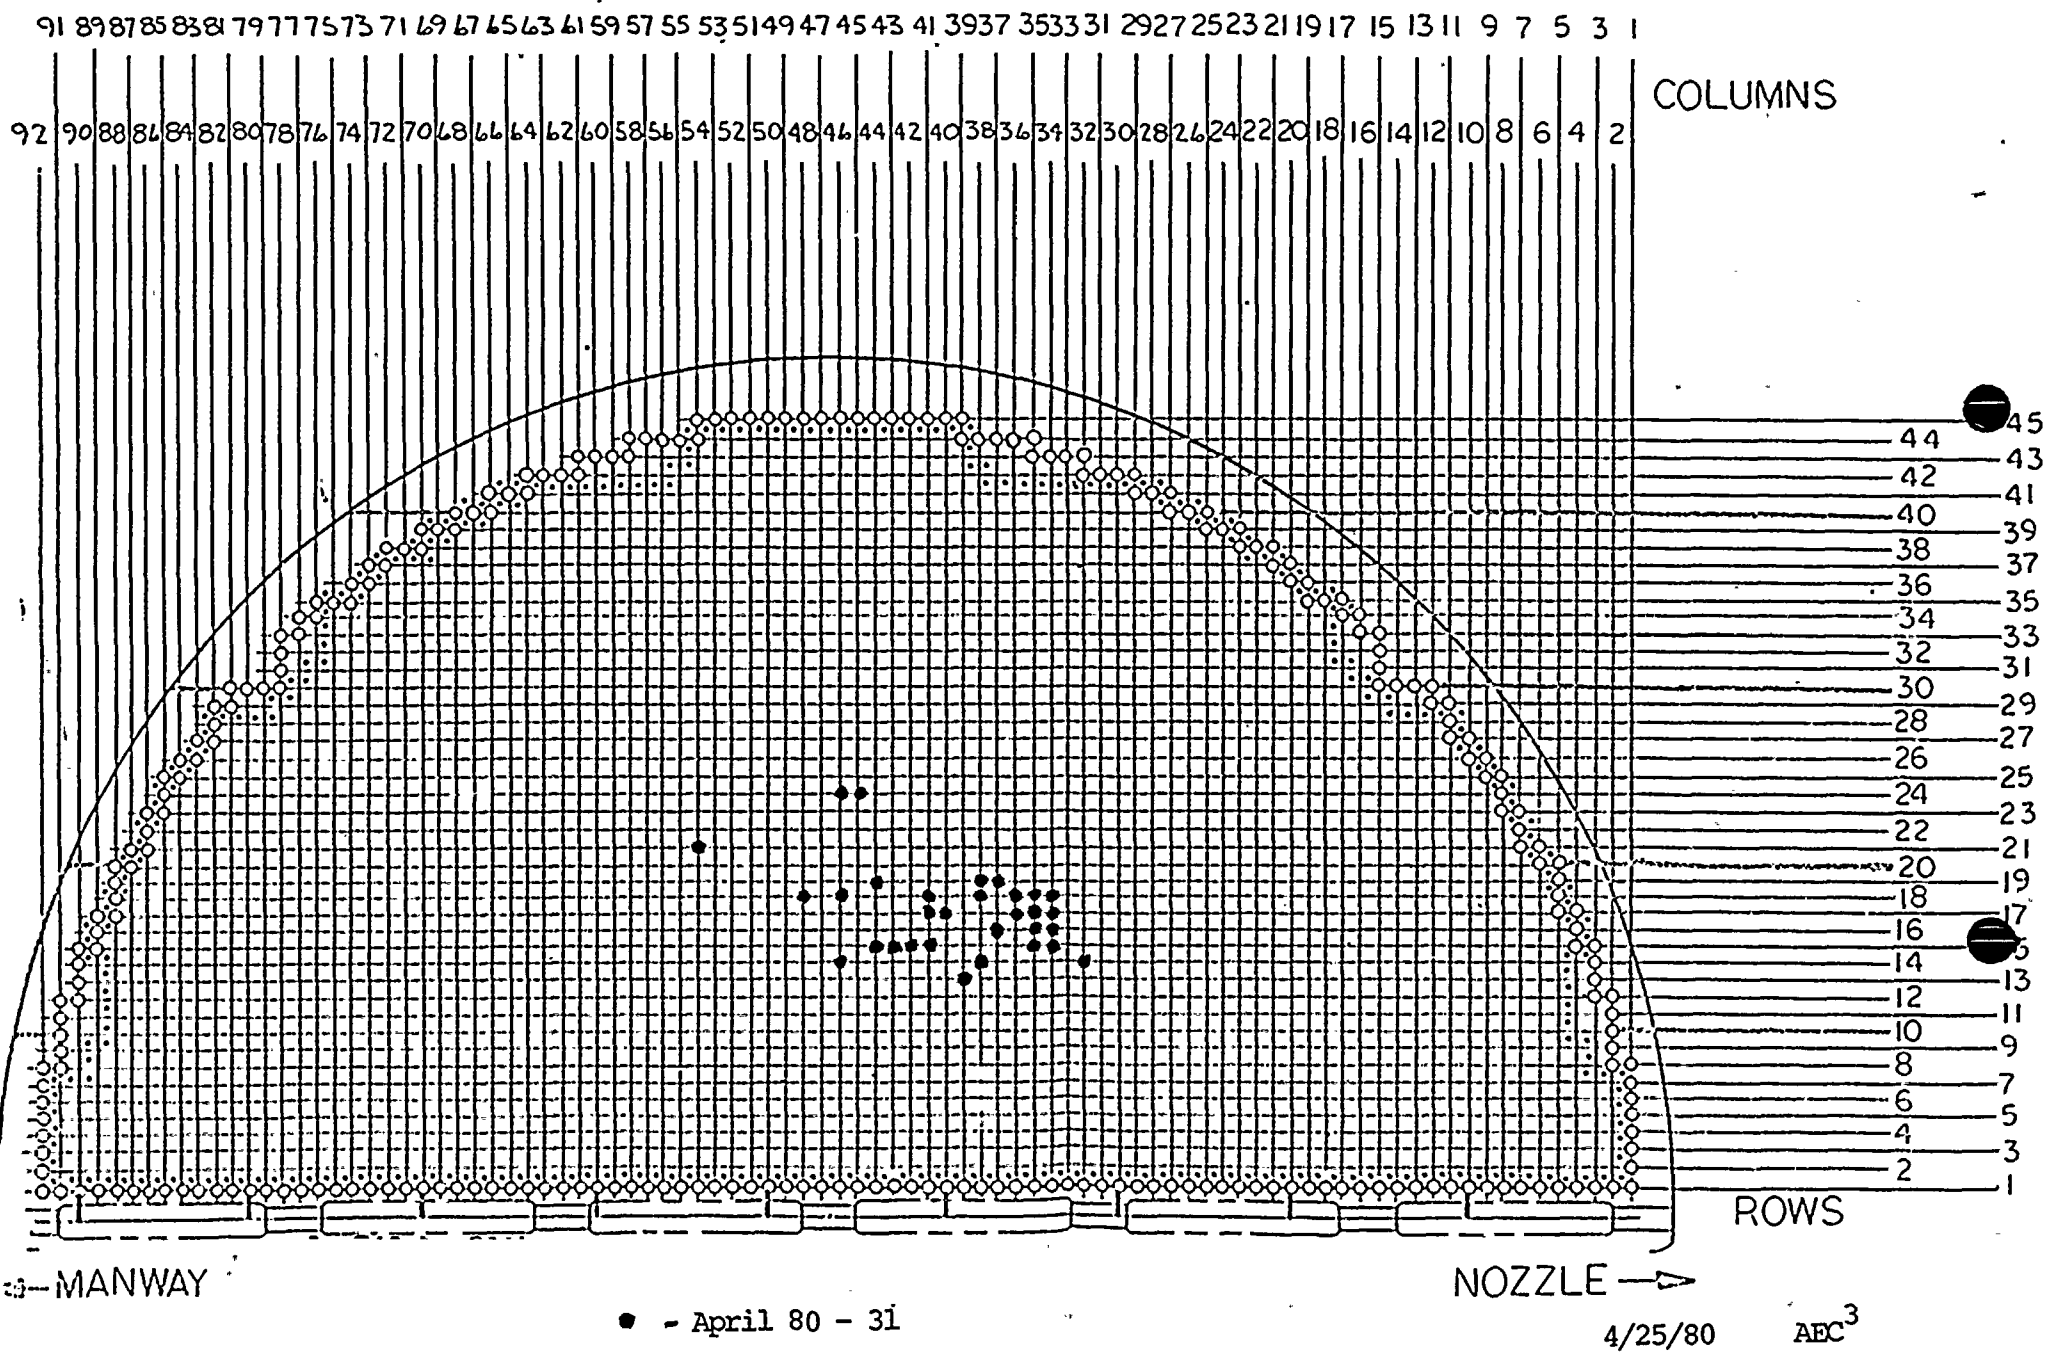
Figure II

RG&E Steam Generator - B Inlet  
Crevice Indications
