September 7, 2017

SUBJECT: BWXT NUCLEAR OPERATIONS GROUP - NUCLEAR REGULATORY
COMMISSION SPECIAL INSPECTION REPORT NUMBER 70-27/2017-007

Report No.: 70-27/2017-007

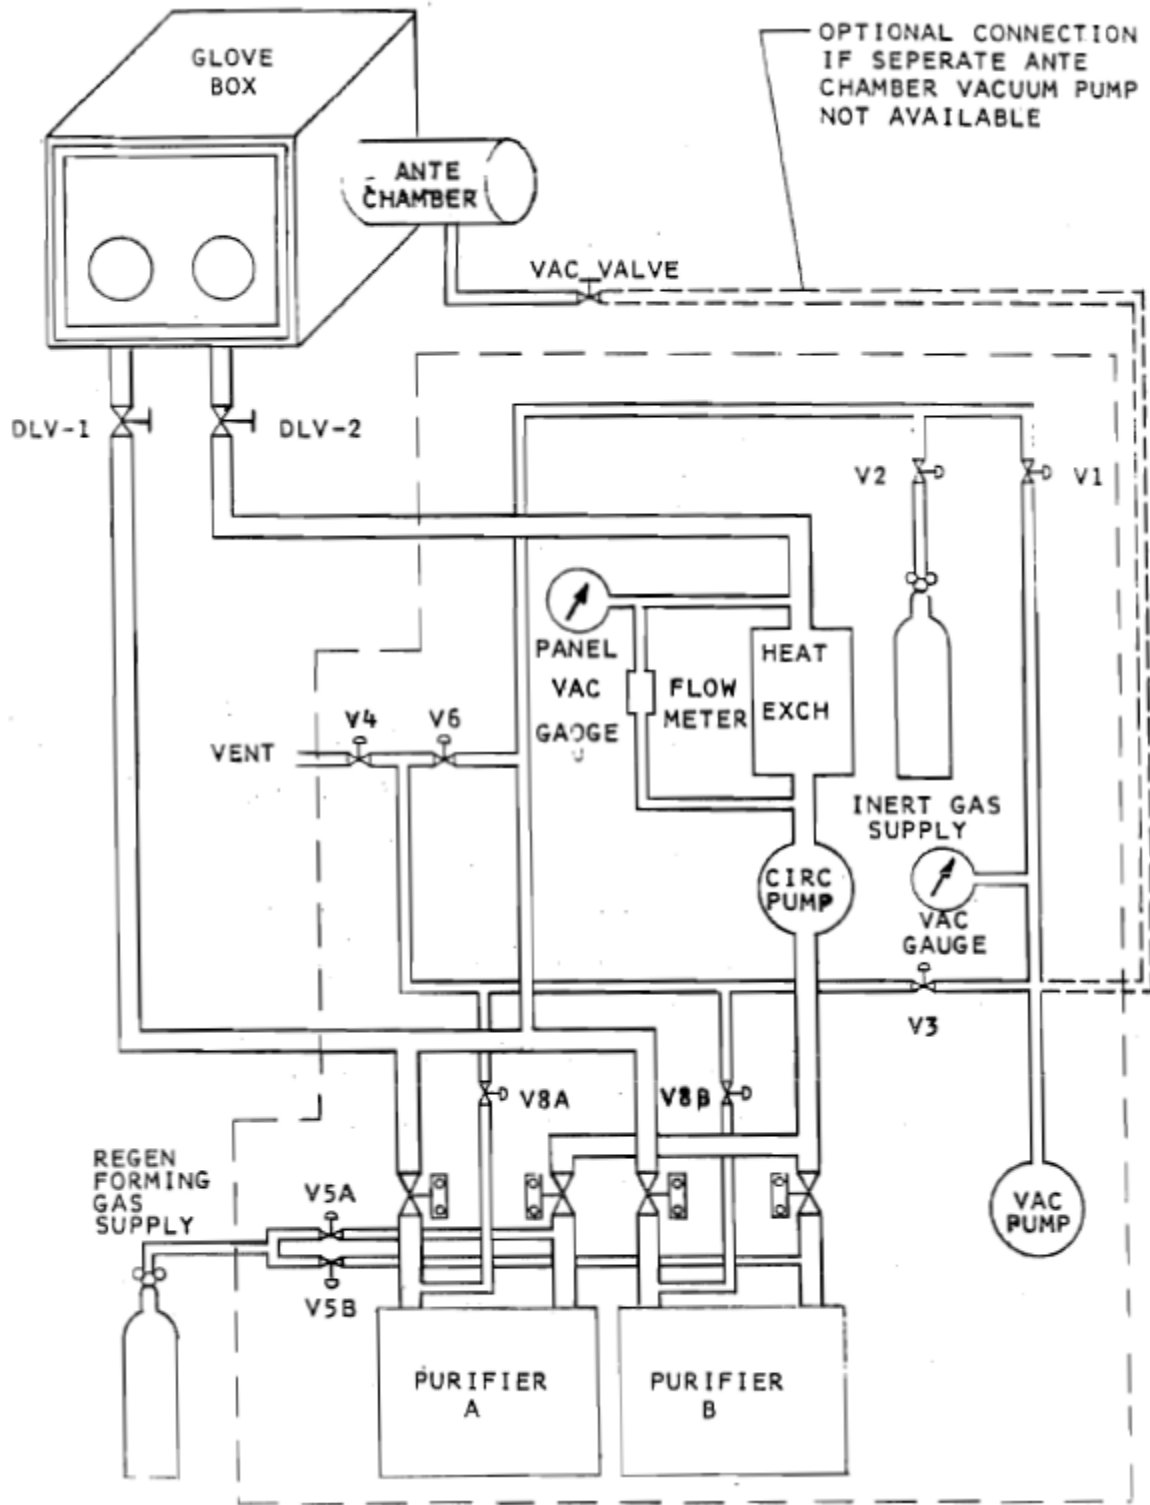
A simplified drawing of the purification system taken from, Dri-Train Technical Manual, Model MO-120-2, is shown below in Figure 1. The purification system used two desiccant vessels (labeled Purifier A and Purifier B in Figure 1) that were filled with desiccant beads that could absorb water and oxygen. The desiccant vessels are filled with two different types of beads as shown in Figure 2, which was also taken from the vendor manual.

Figure 1: Conceptual Drawing of Purifier System

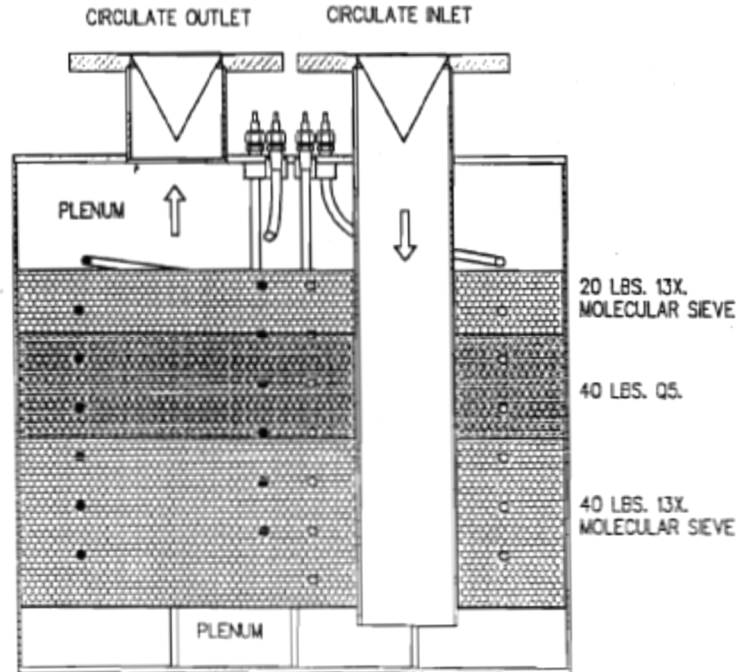
Figure 2: Purifier Vessel Desiccant Loading
