ROCHESTER GAS & ELECTRIC CORPORATION
RESEARCH AND SCIENCES DEPARTMENT
MATERIALS ENGINEERING DIVISION

1986 STEAM GENERATOR EDDY CURRENT

EXAMINATION SUMMARY REPORT

R.E. GINNA NUCLEAR POWER PLANT

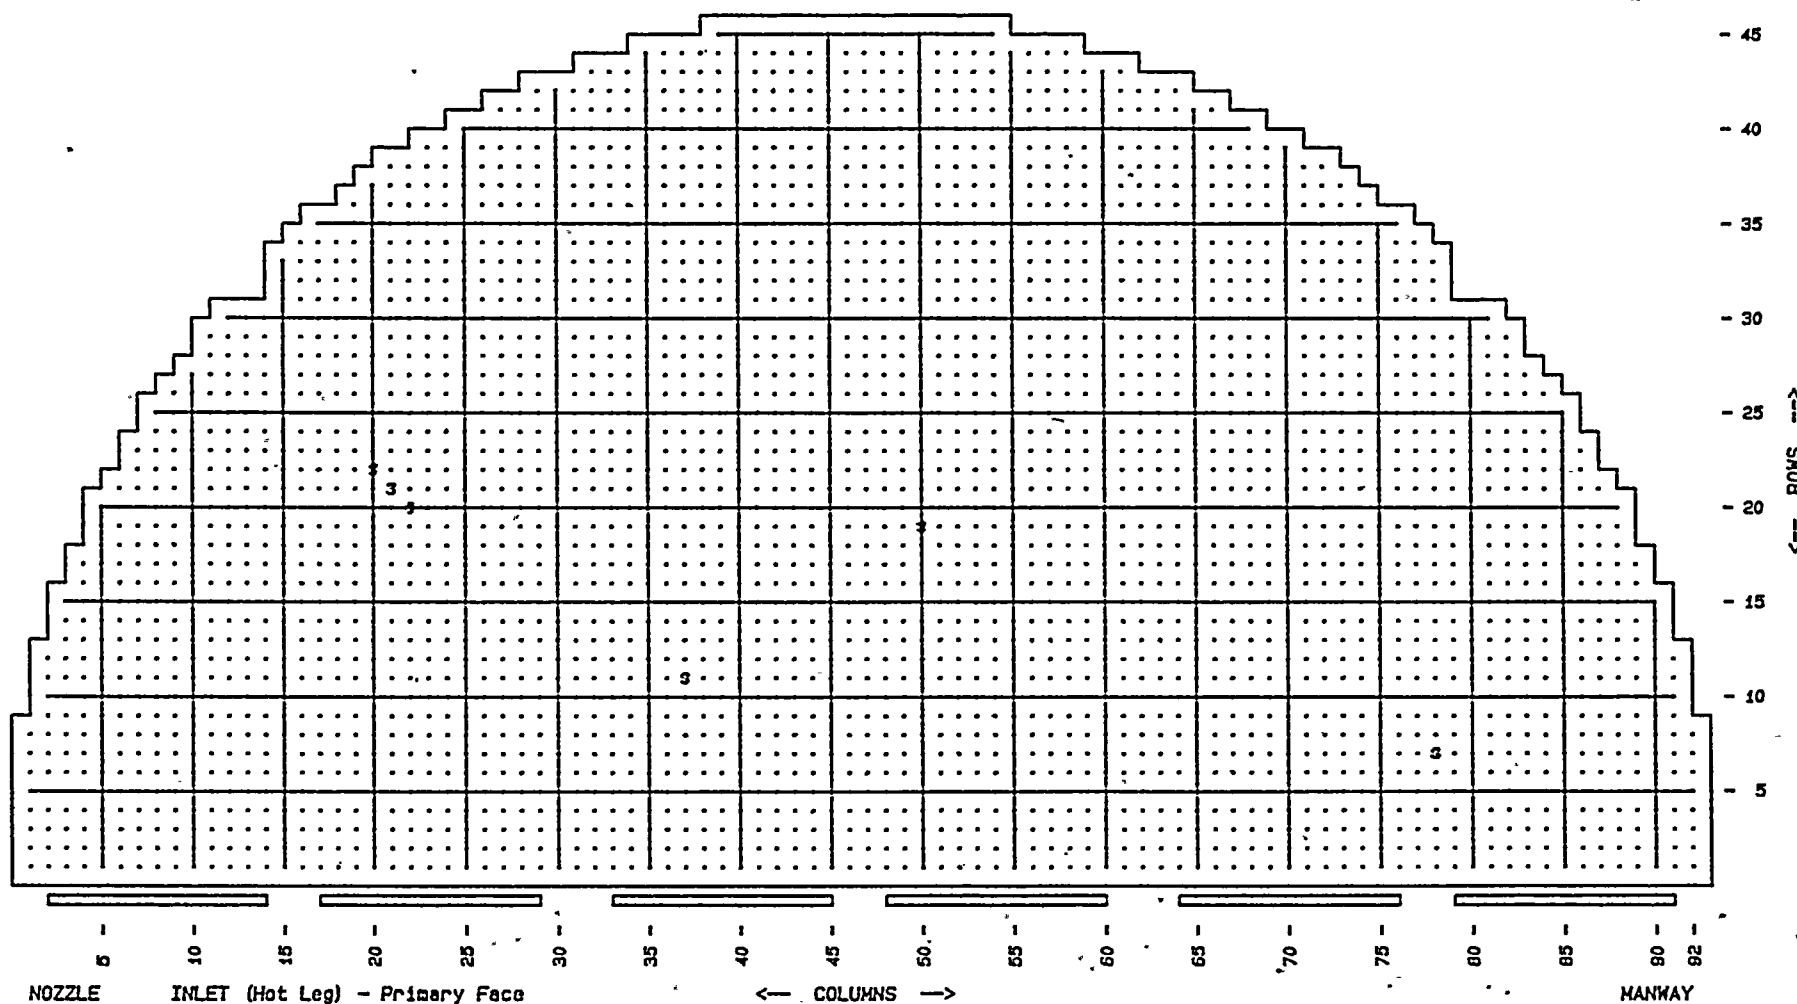
STEAM GENERATOR "A" TUBES RECEIVING CORRECTIVE ACTION - FEBRUARY 1986

ACT	ROW	COL	VOLTS	DEG	IND	CH	ELEV	INCHES	COMMENTS	EXTENT	REEL	PS	ID
SLV	22	20	1.56	71	UDS	M 2	HTS	- 17.2	IGA #1 TSP H		2	740	HL
SLV	21	21	3.87	89	72	1	HTS	- 18.9	SCC #1 TSP H		2	740	HL
SLV	20	22	4.33	55	UDS	M 2	HTS	- 14.9	IGA #1 TSP H		2	740	HL
SLV	11	37	1.28	165	13	1	HTS	- 16.5	#6 TSP H		6	740	HL
SLV	19	50	5.54	128	46	1	HTS	+ 1.8	#1 TSP H		8	720	HL
SLV	7	78	0.60	173	8	1	HTS	- 17.9	SCC #1 TSP H		11	720	HL

<u>ROW</u>	<u>COL</u>	<u>1986</u>	<u>LOCATION</u>	<u>CORRECTIVE ACTION</u>
22	20	UDS (IGA)	HTS - 17.2	CE SLEEVE
21	21	72	HTS - 18.9	CE SLEEVE
20	22	UDS (IGA)	HTS - 14.9	CE SLEEVE
11	37	13	HTS - 16.5	CE SLEEVE
19	50	46	HTS + 1.8	CE SLEEVE
7	78	8 (SCC)	HTS - 17.9	CE SLEEVE

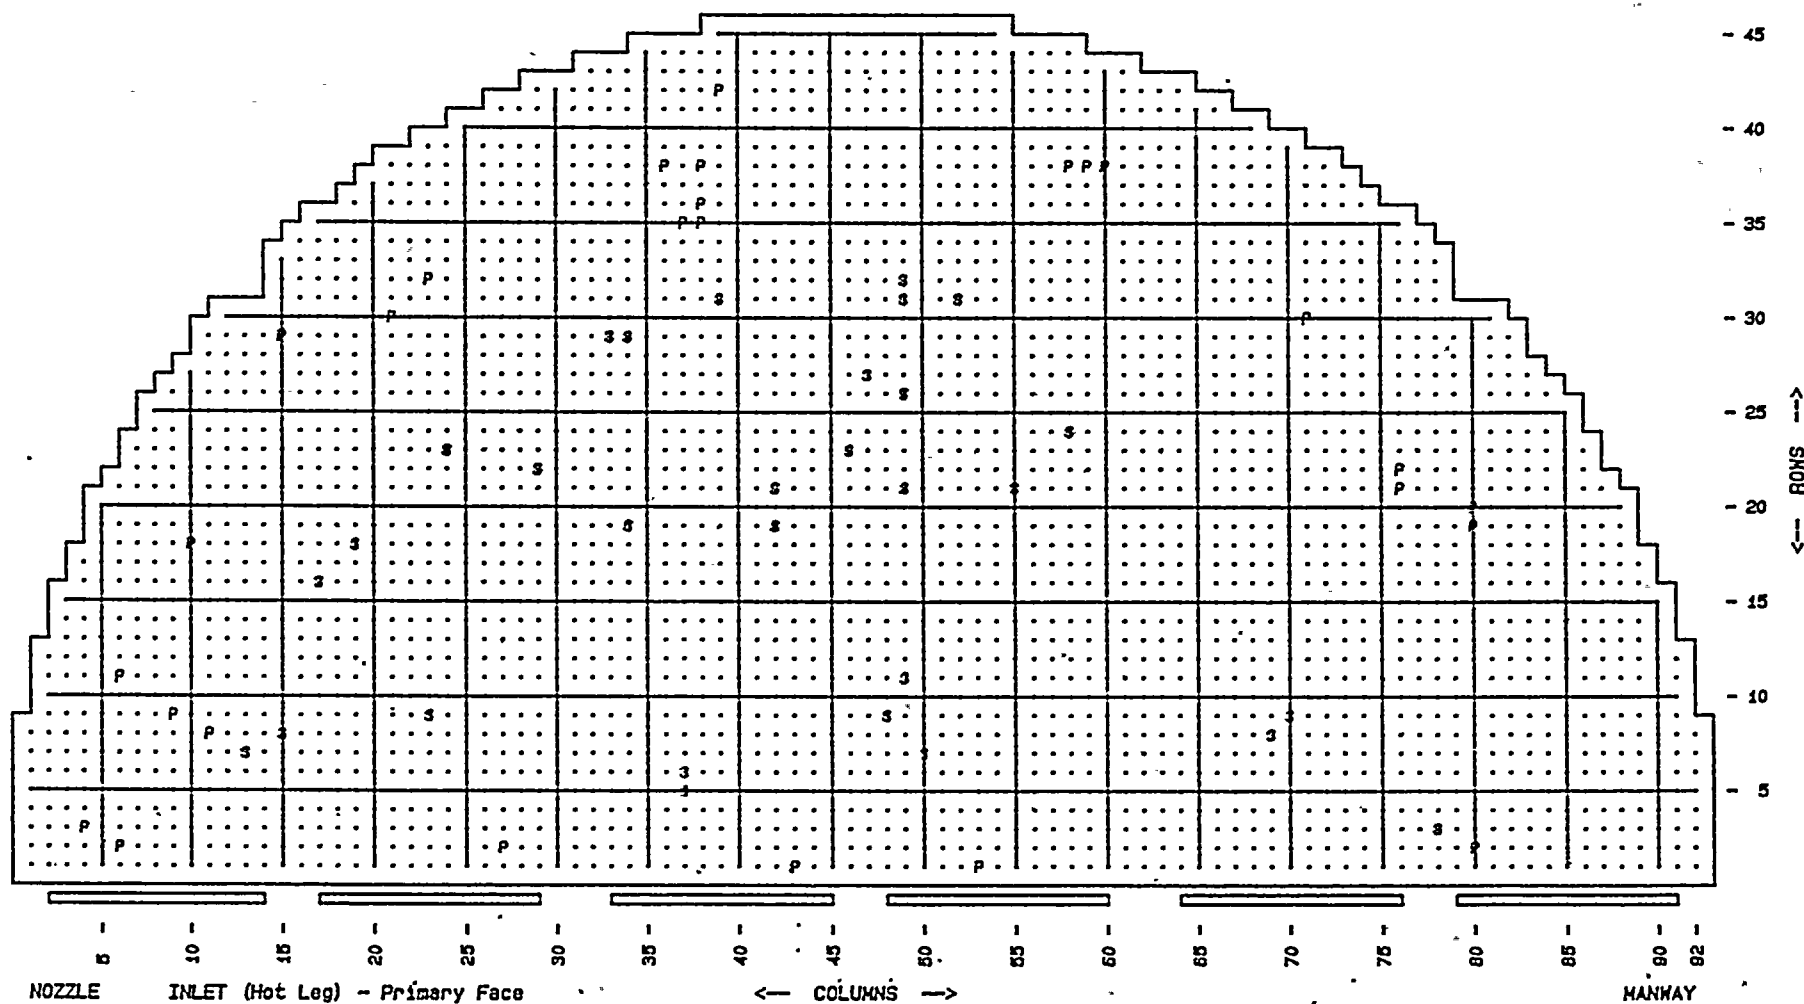
STEAM GENERATOR "B" TUBES RECEIVING CORRECTIVE ACTION - FEBRUARY 1986

ACT	ROW	COL	VOLTS	DEG	IND	CH	ELEV	INCHES	COMMENTS	EXTENT	REEL	PS	ID
PLG	3	4	0.96	102	62	1 HTS	-	17.5	SCC #1 TSP H	H	1	740	HL
	3	4	1.00	67	83	M 1 HTS	-	18.0	SCC #1 TSP H	H	1	740	HL
PLG	2	6	3.54	70	56	M 2 HTS	-	17.3	SCC #1 TSP H	H	1	740	HL
PLG	11	6	0.52	45	97	1 HTS	-	16.7	SCC #1 TSP H	H	1	740	HL
PLG	9	9	0.58	68	84	1 HTS	-	18.3	SCC #1 TSP H	H	1	740	HL
PLG	18	10	4.89	68	59	M 2 HTS	-	16.9	SCC #1 TSP H	H	1	740	HL
PLG	8	11	0.85	31	UDS	HTS	-	19.1	PDRT SCC #1 TSP H	H	2	740	HL
SLV	7	13	0.72	97	65	M 1 HTS	-	17.3	#1 TSP H	H	2	740	HL
SLV	8	15	1.31	57	72	M 2 HTS	-	7.1	#1 TSP H	H	2	740	HL
PLG	29	15	0.81	23	71	M 2 HTS	-	19.2	PDRT SCC #1 TSP H	H	2	740	HL
SLV	16	17	2.36	052	78	M 2 HTS	-	15.3	#1 TSP H	H	2	740	HL
SLV	18	19	0.69	157	19	1 HTS	-	17.5	SCC #1 TSP H	H	8	740	HL
PLG	30	21	1.14	60	88	1 HTS	-	17.3	SCC #1 TSP H	H	8	740	HL
SLV	9	23	0.93	92	SQR	M 2 HTS	-	16.0	#1 TSP H	H	8	740	HL
	9	23	1.58	88	27	M 2 HTS	-	14.1	#1 TSP H	H	8	740	HL

PLG	32	23	3.06	22	64	M 2 HTS	-	16.2	IGA #1 TSP H	H	8	740	HL
SLV	23	24	0.42	135	42	1 HTS	+	2.3	WAS #6 TSP H	H	9	740	HL
PLG	2	27	0.36	43	UDS	M 2 HTS	-	18.5	PNDD IGA #6 TSP H	H	4	740	HL
SLV	22	29	2.34	163	49	1 HTS	+	1.4	P 10% WAS #6 TSP H	H	4	740	HL
SLV	29	33	0.40	99	69	1 HTS	-	18.5	CPR SCC #6 TSP H	H	5	740	HL
SLV	19	34	1.82	93	72	1 HTS	-	8.3	RPG SLV #4 TSP C	C	27	720	HL
SLV	29	34	1.26	72	83	1 HTS	-	18.2	SCC CPR #6 TSP H	H	6	740	HL
PLG	38	36	0.95	33	UDS	1 HTS	-	18.1	IGA #6 TSP H	H	6	740	HL
SLV	5	37	0.50	60	UDS	1 HTS	-	18.4	IGA #6 TSP H	H	7	740	HL
SLV	6	37	0.91	68	85	1 HTS	-	17.9	SCC #6 TSP H	H	7	740	HL
PLG	35	37	4.03	47	84	M 2 HTS	-	18.4	SCC CPR #6 TSP H	H	6	740	HL
PLG	35	38	1.37	168	SQR	1 HTS	-	18.3	SCC #6 TSP H	H	7	740	HL
PLG	36	38			UDS	HTS	-	17.0	IGA #6 TSP H	H	7	740	HL
	36	38	0.79	56	92	1 HTS	-	19.2	SCC #6 TSP H	H	7	740	HL
PLG	38	38	2.55	85	UDS	1 HTS	-	18.9	DRT #6 TSP H	H	7	740	HL
SLV	31	39	0.52	47	UDS	1 HTS	-	17.2	IGA #6 TSP H	H	7	740	HL

PLG	42	39	3.70	63	UDS	M 2 HTS	-	16.0	IGA #6 TSP H	H	7	740	HL
SLV	19	42	5.62	63	UDS	M 2 HTS	-	7.9	IGA #1 TSP H	H	7	740	HL
SLV	21	42	1.58	86	77	1 HTS	-	9.9	RPG SLV #6 TSP C	C	27	720	HL
PLG	1	43	0.63	115	56	1 HTS	-	16.6	SCC CPR #1 TSP H	H	7	740	HL
SLV	23	46	0.59	113	55	1 HTS	-	18.2	SCC #1 TSP H	H	8	740	HL
SLV	27	47	2.12	56	73	M 2 HTS	-	18.0	SCC #1 TSP H	H	9	740	HL
SLV	9	48	0.41	86	77	1 HTS	-	17.3	SCC #1 TSP H	H	9	740	HL
SLV	11	49	0.30	52	91	M 1 HTS	-	16.7	SCC #1 TSP H	H	9	740	HL
SLV	21	49	0.43	75	76	M 1 HTS	-	8.2	SCC #1 TSP H	H	9	740	HL
SLV	26	49	0.23	55	89	M 1 HTS	-	18.2	SCC #1 TSP H	H	9	740	HL
SLV	31	49	2.56	15	SQR	M 2 HTS	-	18.6	SCC #1 TSP H	H	9	740	HL
SLV	32	49	0.40	60	90	1 HTS	-	17.1	SCC #1 TSP H	H	9	740	HL

ACT	ROW	COL	VOLTS	DEG	IND	CH	ELEV	INCHES	COMMENTS	EXTENT	REEL	PS	ID
SLV	7	50	0.73	53	90	M 1	HTS	-	17.4	SCC #1 TSP H	9	740	HL
SLV	31	52	0.96	70	85	1	HTS	-	16.3	SCC #1 TSP H	10	740	HL
PLG	1	53	2.07	30	SQR	M 1	HTS	-	17.5	CHT SCC #1 TSP H	11	720	HL
SLV	21	55	1.32	74	83	1	HTS	-	5.6	RPG SLV #6 TSP C	27	720	HL
SLV	24	58	0.58	58	91	1	HTS	-	13.8	SCC #1 TSP H	10	740	HL
PLG	38	58	3.23	51	79	M 2	HTS	-	16.9	SCC #1 TSP H	10	740	HL
PLG	38	59	1.08	88	75	1	HTS	-	18.0	SCC #1 TSP H	10	740	HL
PLG	38	60	0.95	77	81	1	HTS	-	17.4	SCC #1 TSP H	10	740	HL
SLV	8	69	1.03	88	61	M 1	HTS	-	17.7	SCC #1 TSP H	11	720	HL
SLV	9	70	0.70	72	75	M 1	HTS	-	14.6	SCC #1 TSP H	11	720	HL
PLG	30	71	1.90	77	79	1	HTS	-	17.6	CPR SCC #1 TSP H	12	720	HL
PLG	21	76	1.04	58	90	1	HTS	-	17.4	SCC #1 TSP H	12	720	HL
PLG	22	76	1.15	92	70	1	HTS	-	17.3	SCC #1 TSP H	12	720	HL
SLV	3	78	1.76	72	82	1	HTS	-	17.6	SCC #1 TSP H	12	720	HL
PLG	2	80	6.69	38	89	M 2	HTS	-	17.9	SCC #1 TSP H	12	720	HL

PLG	19	80	0.61	56	91	1	HTS	-	16.7	SCC #1 TSP H	12	720	HL
PLG	20	80	0.75	42	94	M 1	HTS	-	16.8	SCC #1 TSP H	12	720	HL

<u>ROW</u>	<u>COL</u>	<u>1986</u>	<u>LOCATION</u>	<u>CORRECTIVE ACTION</u>
3	4	62	HTS - 17.5	CE MECH PLUG
3	4	83	HTS - 18.0	
2	6	56	HTS - 17.3	CE MECH PLUG
11	6	97	HTS - 16.7	CE MECH PLUG
9	9	84	HTS - 18.3	CE MECH PLUG
18	10	59	HTS - 16.9	CE MECH PLUG
8	11	UDS (SCC)	HTS - 19.1	CE MECH PLUG
7	13	65	HTS - 17.3	CE SLEEVE
8	15	72	HTS - 7.1	CE SLEEVE
29	15	71	HTS - 19.2	CE MECH PLUG
16	17	78	HTS - 15.3	CE SLEEVE
18	19	19 (SCC)	HTS - 17.5	CE SLEEVE
30	21	88	HTS - 17.3	CE MECH PLUG
9	23	SQR	HTS - 16.0	CE SLEEVE
9	23	27	HTS - 14.1	
32	23	64	HTS - 16.2	CE MECH PLUG
23	24	42	HTS + 2.3	CE SLEEVE

<u>ROW</u>	<u>COL</u>	<u>1986</u>	<u>LOCATION</u>	<u>CORRECTIVE ACTION</u>
2	27	UDS (IGA)	HTS - 18.5	CE MECH PLUG
22	29	49	HTS + 1.4	CE SLEEVE
29	33	69	HTS - 18.5	CE SLEEVE

* 19	34	72	HTS - 8.3	CE SLEEVE
29	34	83	HTS - 18.2	CE SLEEVE
38	36	UDS (IGA)	HTS - 18.1	CE MECH PLUG
5	37	UDS (IGA)	HTS - 18.4	CE SLEEVE
6	37	85	HTS - 17.9	CE SLEEVE
35	37	84	HTS - 18.4	CE MECH PLUG
35	38	SQR	HTS - 18.3	CE MECH PLUG
36	38	UDS (IGA)	HTS - 17.0	CE MECH PLUG
36	38	92	HTS - 19.2	
38	38	UDS (DRT)	HTS - 18.9	CE MECH PLUG
31	39	UDS (IGA)	HTS - 17.2	CE SLEEVE
42	39	UDS (IGA)	HTS - 16.0	CE MECH PLUG
19	42	UDS (IGA)	HTS - 7.9	CE SLEEVE

* 21	42	77	HTS - 9.9	CE SLEEVE
1	43	56	HTS - 16.6	CE MECH PLUG
23	46	55	HTS - 18.2	CE SLEEVE
27	47	73	HTS - 18.0	CE SLEEVE
9	48	77	HTS - 17.3	CE SLEEVE
11	49	91	HTS - 16.7	CE SLEEVE
21	49	76	HTS - 8.2	CE SLEEVE
26	49	89	HTS - 18.2	CE SLEEVE
31	49	SQR	HTS - 18.6	CE SLEEVE
32	49	90	HTS - 17.1	CE SLEEVE
7	50	90	HTS - 17.4	CE SLEEVE
31	52	85	HTS - 16.3	CE SLEEVE
1	53	SQR	HTS - 17.5	CE MECH PLUG
